# REPAIR AND RETROFIT OF BRIDGES DAMAGED BY THE 2010 CHILE MAULE EARTHQUAKE

Shigeki UNJOH<sup>1</sup>

**ABSTRACT:** The Chile Maule earthquake with magnitude 8.8 occurred off the coast of the Maule Region of Chile on February 27, 2010. Several bridges were heavily damaged by the strong shaking. Typical and important damage was the rotation and the unseating of superstructures found at skewed bridges supported by rubber pad bearings. Based on such damage experiences, the Chilean Seismic Standards for the Design of Bridges were revised in June 2010. This paper presents the repair and retrofit of bridges damaged by the 2010 Chile Maule earthquake with application of the New Seismic Standards.

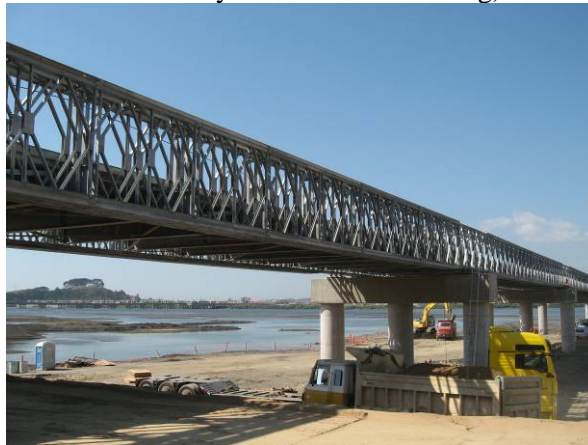
Photo 19 New Bridge Construction (Chacabuco Bridge) to cross BioBio River

The lateral stoppers were provided at the pier caps. The seat supports was also widened by adding reinforced concrete. Some of the reinforced concrete columns were jacketed by fiber sheets to repair the flexural cracks and to enhance the shear and ductility capacity. It should be noted that a new bridge was also under construction to cross Biobio river in Concepcion city as shown in Photo 19.
