# BEHAVIOR OF LIQUEFIED SOIL NEAR BOUNDARY OF BACKFILLED BASIN DUE TO MAIN AND FOLLOWING MUXIMUM AFTERSHOCK

**ABSTRACT**: Reclaimed lands backfilled by the remainder which collected iron content in the iron ore sand deposits were liquefied in Asahi City, Chiba Prefecture due to the 2011 off the Pacific coast of Tohoku Earthquake. Based on the site investigations and the numerical analysis, the behaviors of the liquefied soil at the brinks of the backfill basins were classified into three types, namely heave, cave-in and landslide. The mechanism of these behaviors was attributed to the relationship between the predominant direction of displacement of liquefied soil and the location of the excavation boundary.

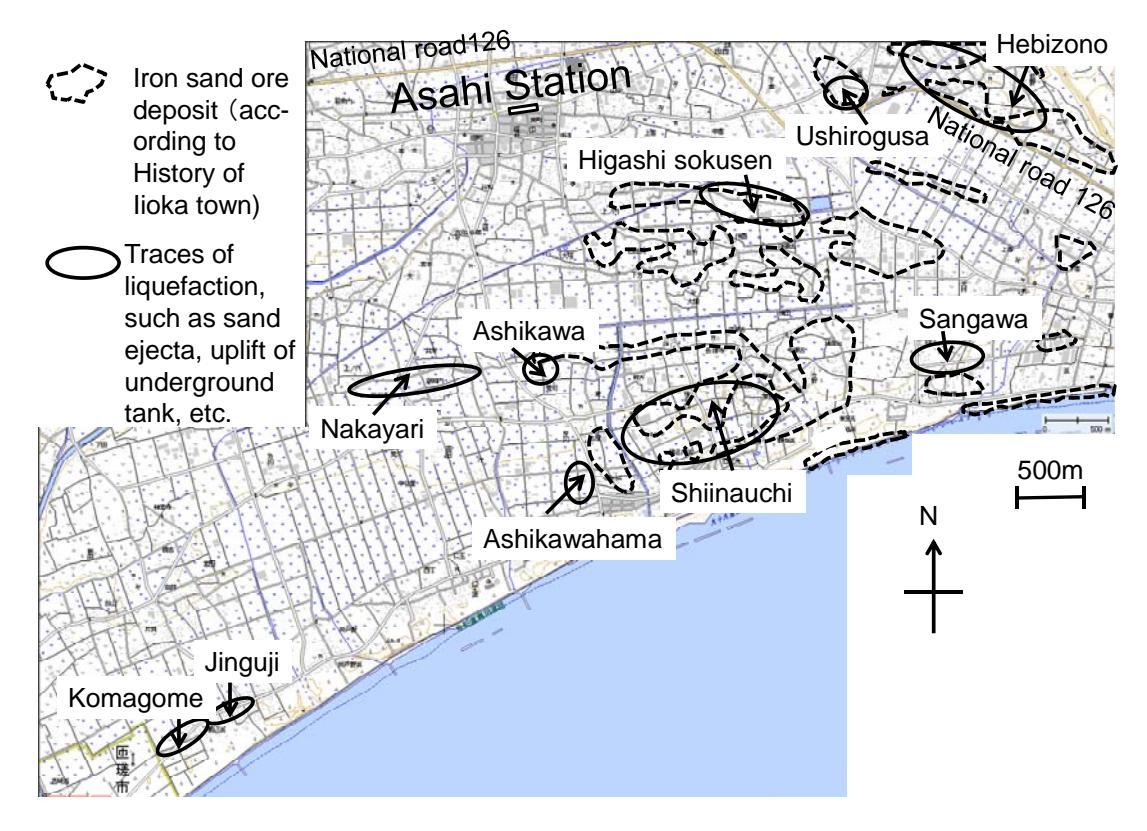
The areas where liquefaction damage was remarkable in Asahi-city are shown by the ellipses in Fig.1. The iron ore sand deposits located in old Iioka-town are described in the History of Iioka-town (Iioka-town 1981). Although all the locations of these iron ore sand deposits were indicated in Fig. 1 with broken lines, some of them have not been excavated in the past as a mine. Moreover, although there are many places where a liquefied area does not overlap with the position of the ore deposit on a map, at least all the liquefied lands were reclaimed by iron ore sand according to the reports of the earthquake victims. The areas where iron sand has been excavated are, therefore, more than those indicated in Fig. 1 including ellipses indicated in old Asahi-city (left half of Fig. 1).

Fig.1 Liquefied areas and distribution of iron ore sand deposits in Asahi city

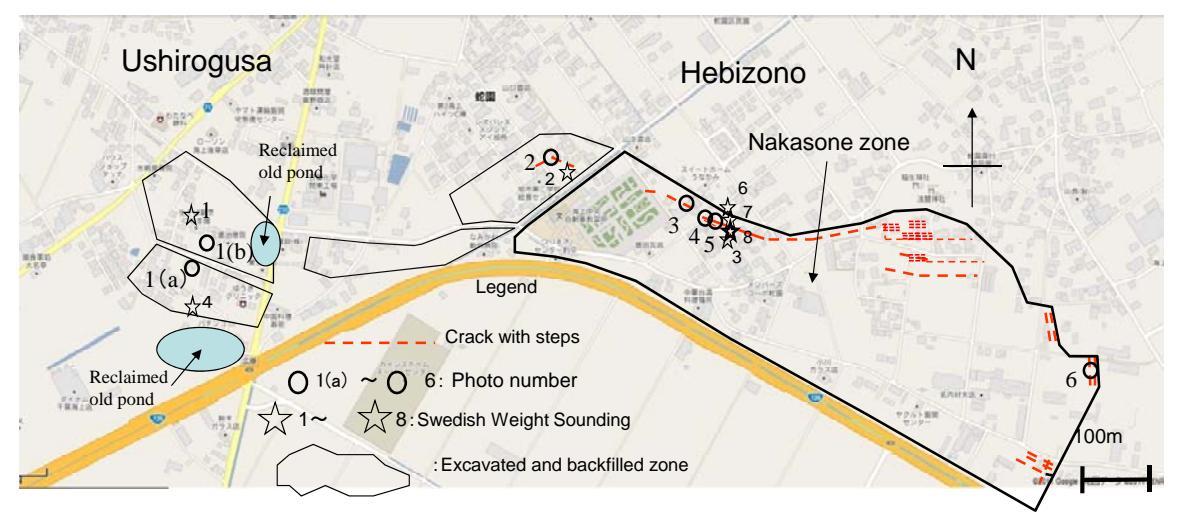
Out of many liquefied areas shown in Fig.1, a close view of the Ushirogusa and Hebizono areas where quite a few houses suffered great damage due to liquefaction are shown in Fig. 2. The Nakasone zone in the Hebizono area shown in the region surrounded by the solid line was a residential area developed on the land backfilled after iron ore mining. This zone suffered such devastating damage that 40 houses out of totally 48 houses were judged to be totally destroyed. According to explanations given by both owners of excavated land and unexcavated land, the boundary of the excavated and backfilled area is the solid lines in Fig. 2.

Fig.2 Location of soil investigations, photos and remarkably damaged foundations

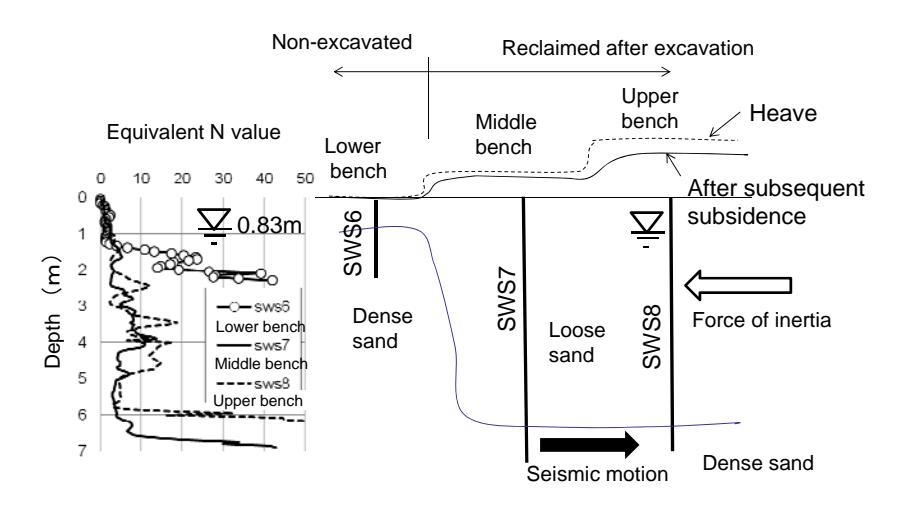
The mechanism of the ground upheaval all at once at the inside of the excavation boundary is considered to be as follows: The foundation had not reached near complete liquefaction with sand ejection, though the excess pore water pressure increased to considerably large. It liquefied almost completely and the sand was ejected during the following largest aftershock. When the liquefied soil moved toward the un-excavated foundation, it heaved up because it was blocked in the hard stratum and rose. It is imagined that the ground heaved up to the broken line indicated in Fig.5 just after rising and subsided to the solid line with increasing elapsed time. Along the survey line D - D', the maximum value of upheaval was 80cm here.

Figure 5 Schematic picture of upheaval mechanism

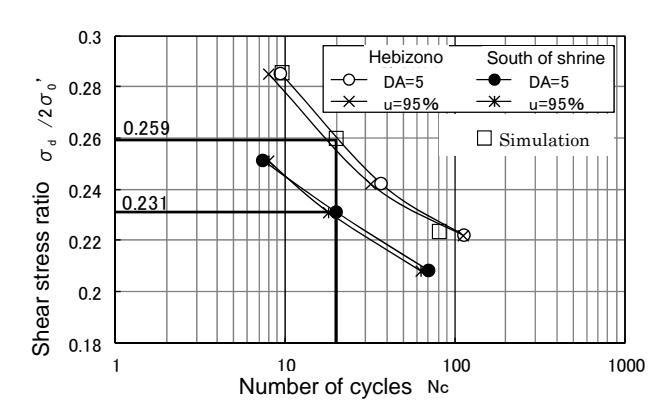
The intact samples were taken at the point, SWS 7, by penetrating short thin-wall samplers with a length of 25 cm into the sand layer after removing the surface soil with a thickness of 80 cm at the middle step of the agricultural field shown in Fig.5. These samples are called "Hebizono". Other intact samples were taken below a depth of 80 cm in the same manner at Point F' shown in Fig.6. These samples are called "South of Shrine". The liquefaction strength and the dynamic deformation properties were shown in Fig.8 and Fig.9, respectively. According to Fig.8, liquefaction resistance of the soil at Hebizono is larger than that at South of Shrine.

Fig.8 Liquefaction strength of excavated and backfilled iron sand (Hebizono zone)

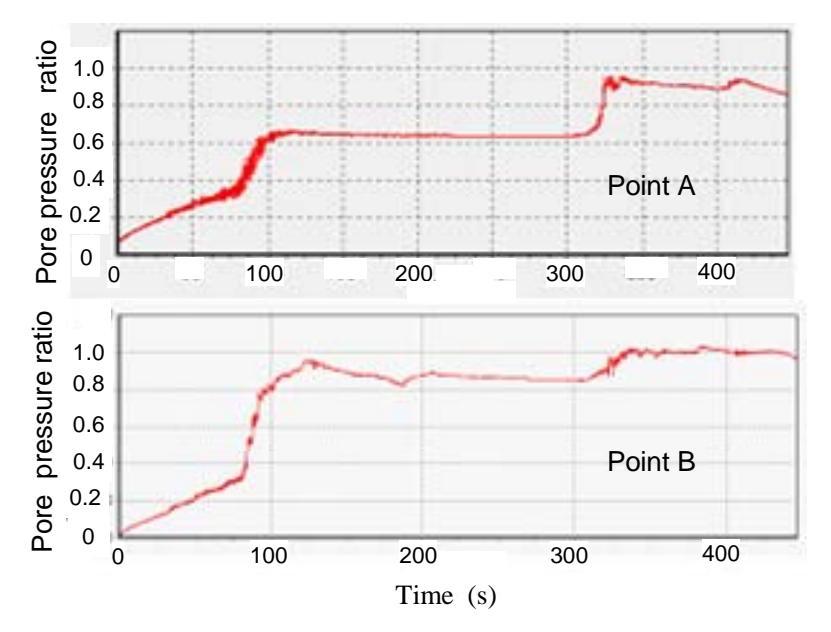
Figure 13 shows the time histories of excess pore water pressure ratio at points A and B. At Point A, the excess pore water pressure ratio increased to 0.64 during the main shock and kept almost constant after the main shock. It reached then 0.95 during the largest aftershock. In contrast, at Point B, the maximum excess pore water pressure ratio during the main shock reached 0.95, indicating almost liquefaction. It lowered to 0.85 after the main shock and then increased once again to reach complete liquefaction. The numerical results support the testimonies of eyewitness that sand boiling occurred during the main shock at some places and during the largest aftershock at other places.

Fig.13 Time histories of excess pore water pressure ratio at points A and B shown in Fig.10
