THE CHARACTERISTICS OF THE TRIGGERED 2011 VAN-EDREMIT EARTHQUAKE AND INDUCED DAMAGE

Ömer AYDAN¹, Halil KUMSAR², Reşat ULUSAY³, Onur KÖSE⁴ and Mehmet ÇELEBİ⁵

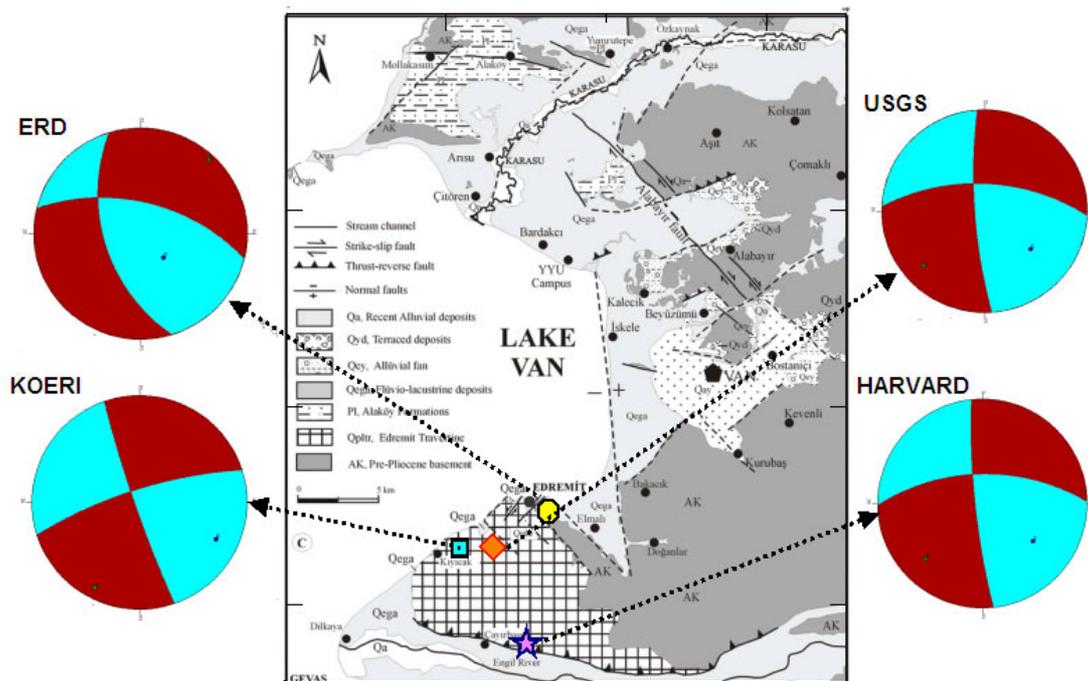
Fig. 1 shows the geological conditions of the City of Van and its close proximity. Van is mainly located over a mainly alluvial fan (Qey), and the area along the lakeshore and in the vicinity of Karasu River is mainly composed of recent alluvial deposits (Qa). The shear wave velocity of alluvial deposits of recent alluvial deposits (Qa) is estimated to be ranging between 250-300 m/s while the shear wave velocity of alluvial deposits (Qey) is about 350 m/s. The town of Edremit, close to the epicenter, is located over travertine deposits (Qpltr).

Fig. 1 Geology of Van and its close vicinity and faulting mechanisms for the Van-Edremit earthquake estimated by different institutes (base map from Özkaymak et al., 2004)

Fig. 1 also shows the focal mechanisms obtained by USGS (2011), ERD (2011), KOERI (2011) and HARVARD (2011). All focal mechanisms solutions indicated that the faulting mechanism of this earthquake was due to strike-slip faulting. Although the solutions yield two fault planes, NW-SE trending fault may be the causative fault. In view of the seismicity since November 09, 2011 shown in Fig. 2 and recognized fault traces in the field, a sinistral NW-SE trending steeply dipping fault should be the causative fault. This fault probably is located to the east of Edremit.

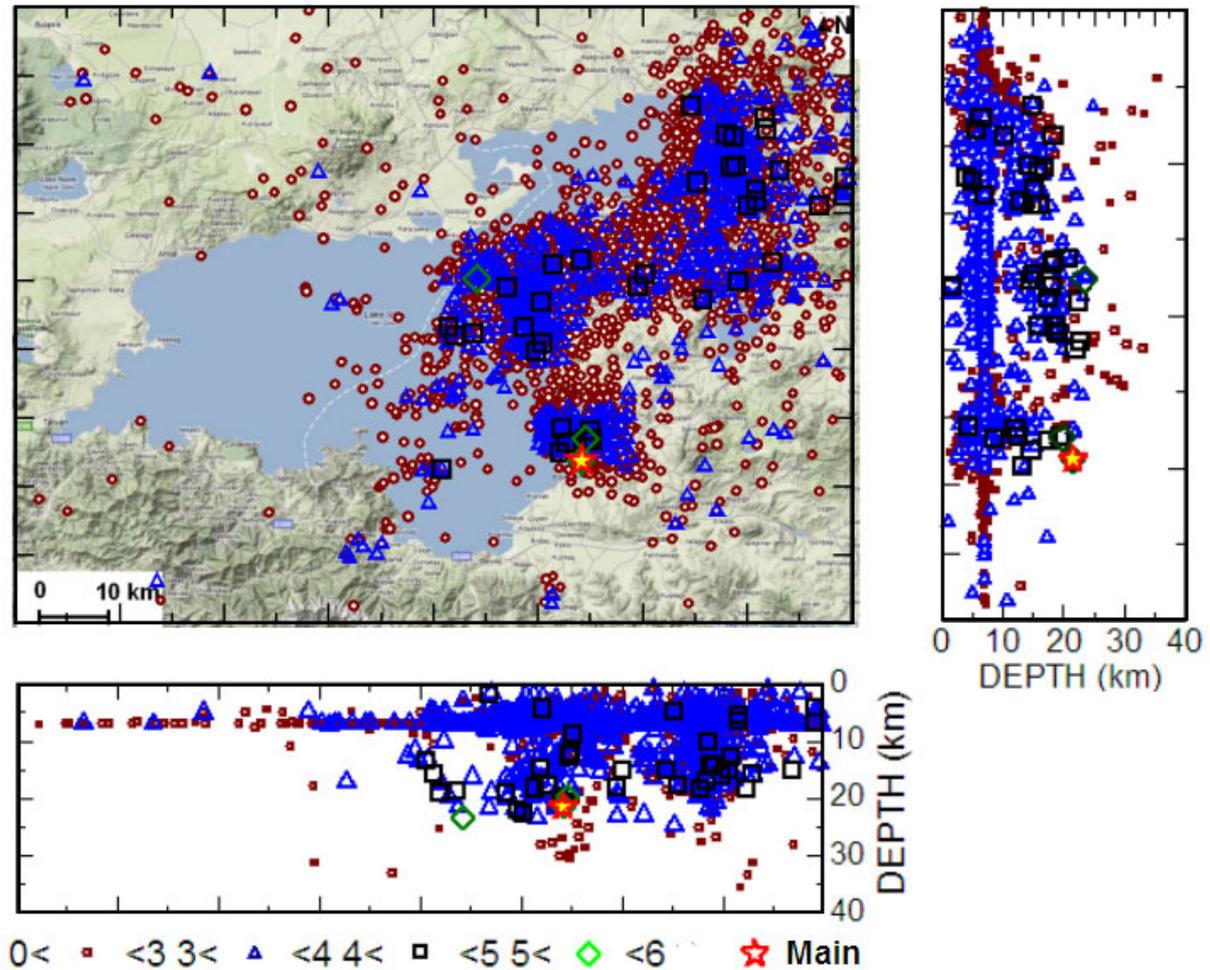
Fig. 2 Seismicity of epicentral areas of Nov. 09, 2011 and Oct. 23, 2011 since Nov. 09, 2011

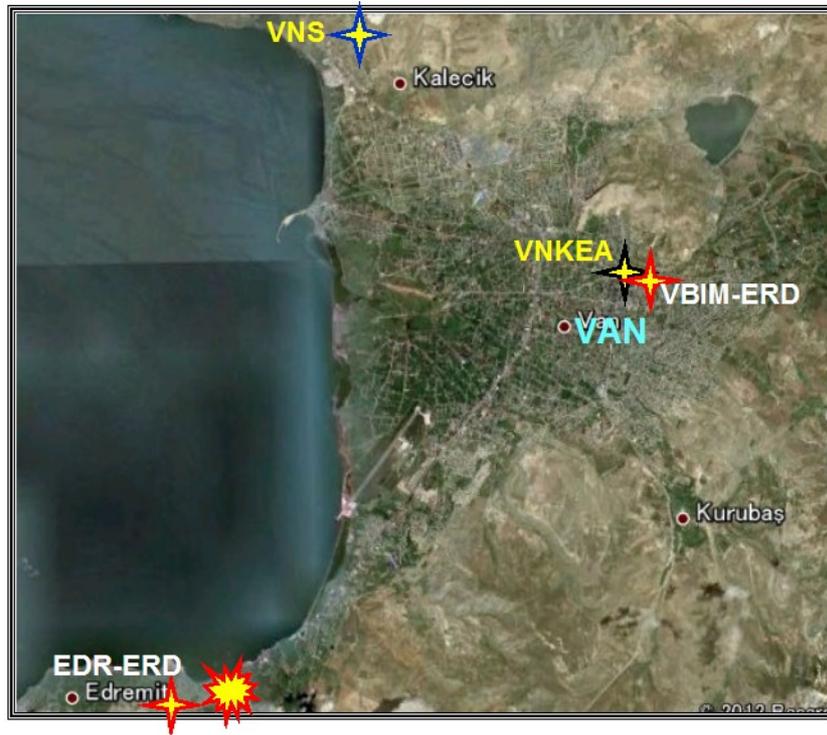
Fig. 3 Locations of strong motion stations (base map from Google earth)

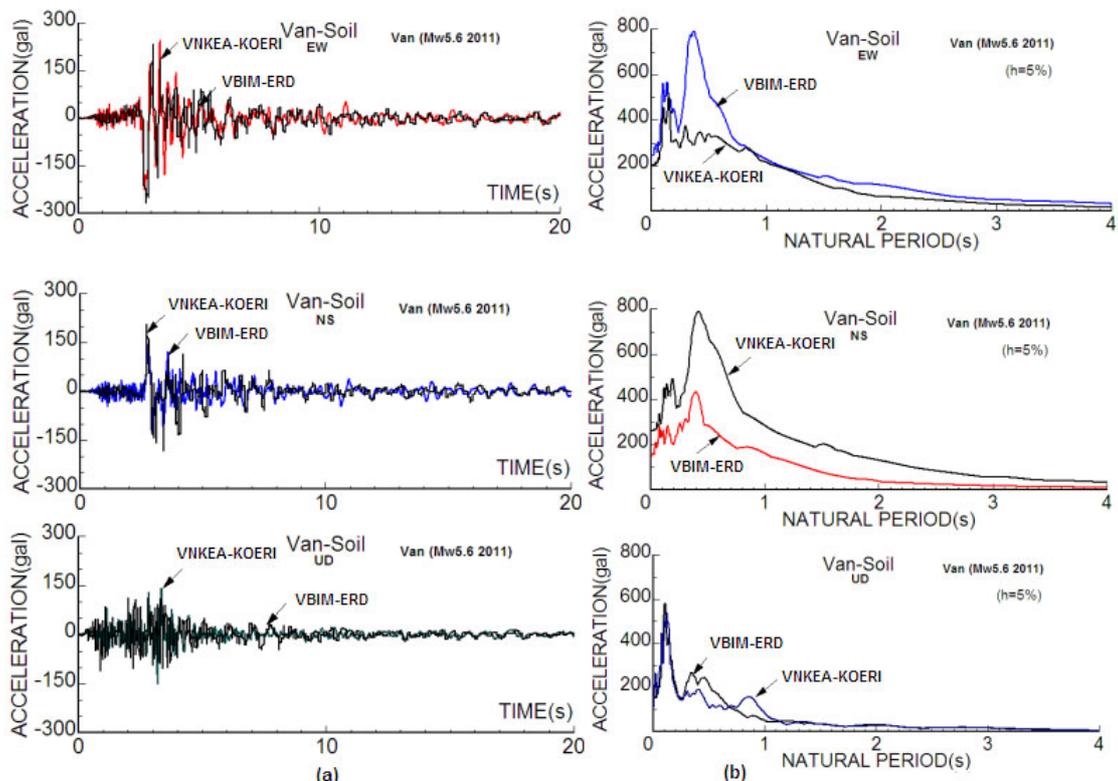
Fig. 4 Comparison of (a) acceleration records and (b) their acceleration response spectra of VBIM-ERD and VNKEA-KOERI stations in Van

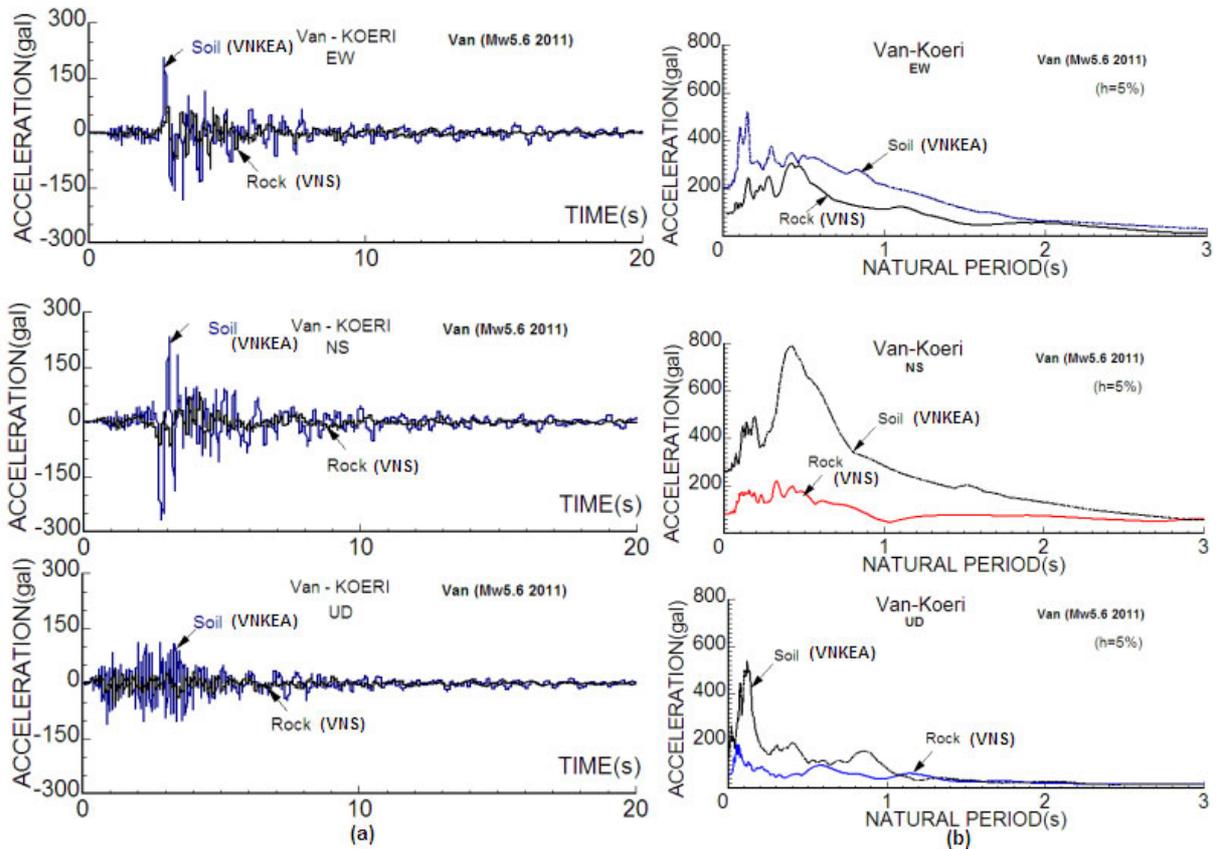
(VNS). Although the amplitudes of waves are slightly different, the records are quite similar to each other. Furthermore, the accelerations are amplified for periods of 0.1-0.15s and 0.35-0.4s.

Fig. 5 Comparison of the acceleration records and their acceleration response spectra on soil (VNKEA) and rock (VNS) stations in Van

The comparison of raw acceleration records and their acceleration response spectra indicated that the amplifications were 2.4 and 3.6 times, respectively. Furthermore, the maximum spectral accelerations roughly correspond to those of periods of 0.36-0.4 s, which generally corresponds to the natural periods of 6-8 story reinforced concrete buildings.

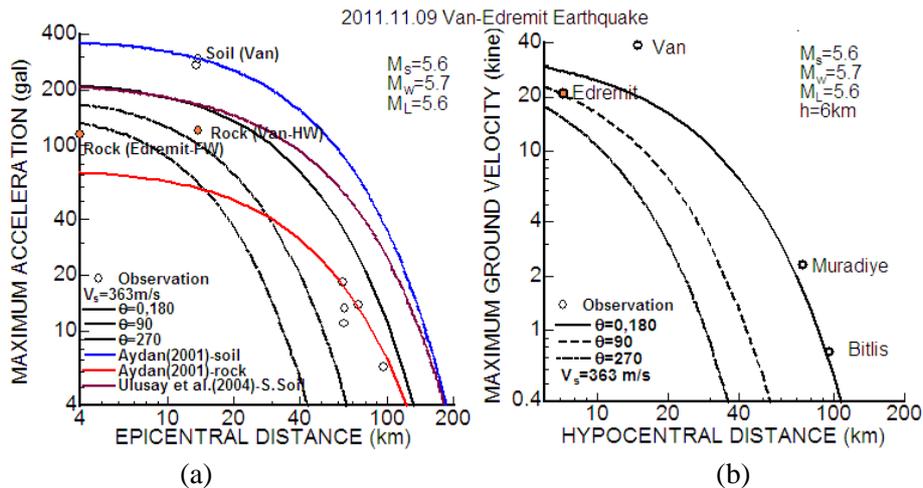
Fig. 5 shows the attenuation of strong motions recorded by the ERD and KOERI with the empirical relations of Aydan (2001), Aydan and Ohta (2011a) and Ulusay et al. (2004). The maximum ground acceleration on soil is well predicted by the attenuation relation proposed by Aydan (2001) while the relations by Aydan and Ohta (2011a) using the shear velocity of Van strong motion station and Ulusay et al. (2004) underestimated the maximum ground accelerations by 30-40% less.

One of important observations in Fig. 5 is the effect of the fault orientation. While Edremit station is on the stationary or footwall, Van station is on the mobile or hanging wall side. The maximum ground accelerations are almost same, the distances of the Edremit and Van strong motion stations to the fault are 4 and 12 km, respectively. This fact also illustrates the fundamental reason for seemingly scattering of observed data when spherical and cylindrical attenuation relations are employed.

Aydan and Ohta (2011a) improved the attenuation relations of Aydan (2007) by considering the dip angle and fault length also. The attenuation relations of Aydan and Ohta (2011a) for maximum ground velocity are compared in Fig. 5. The computed maximum ground velocity values at Edremit, Muradiye and Bitlis are well estimated by the attenuation relations of Aydan and Ohta (2011a). However, the observed value of Van strong motion station is somewhat higher than the estimations when the shear wave velocity (V_{s30}) of 363 m/s is used. Therefore, the concept of using the shear wave velocity for top 30 m ground as the representative value of site conditions is very questionable. Similar conclusion is valid for the records taken in Japan.

Fig. 5 Comparison of some empirical attenuation relations for maximum ground acceleration and maximum ground velocity with observations

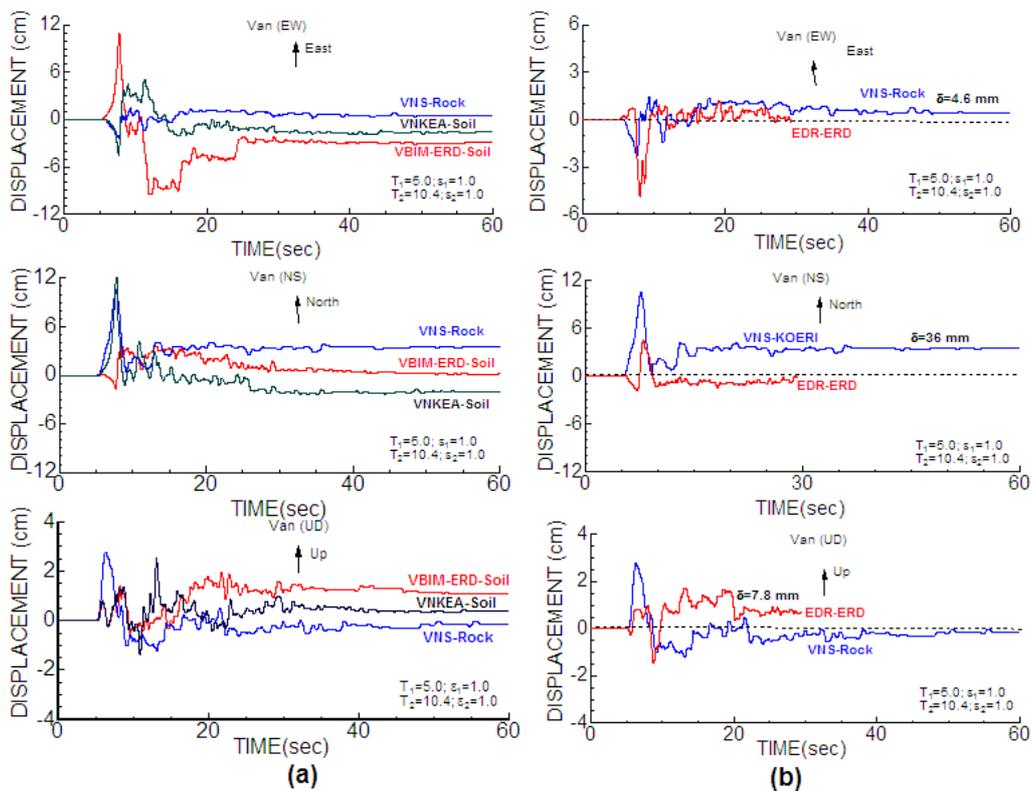
Aydan and Ohta (2011b) modified slightly their original method called EPS method (Ohta and Aydan, 2007) to estimate the behaviour of ground during earthquake and to compute the permanent ground deformation from strong motion records. This method was applied to near field stations, specifically VBIM-ERD, EDR-ERD, VNS-KOERI and VNKEA-KOERI, around the epicentral area Fig. 6(a) compares the responses for three different directions in the City of Van, which is located on the mobile side of the fault. It is interesting to note that the top soil may even move opposite direction compared to that of rock base. This further implies that ground shaking may cause the plastic deformation of top soil layer.

Fig. 6 Displacement responses of strong motion stations computed from EPS method (a) The City of Van, (b) Rock ground at Edremit and Van

Next the deformation responses of stations (EDR-ERD and VNS-KOERI) located over rock are compared as shown in Fig. 6(b). If the mobile side of the N-S trending fault is the east block, the strike slip faulting implies that there should be considerable permanent ground displacement at VNS-KOERI station as compared with that at EDR-ERD station. The net permanent displacement of the VNS-KOERI is about 37 mm northward while that of the EDR-ERD is almost null. This conclusion may also be of great value to explain why there was huge damage in the City of Van as compared to the light damage in Edremit.

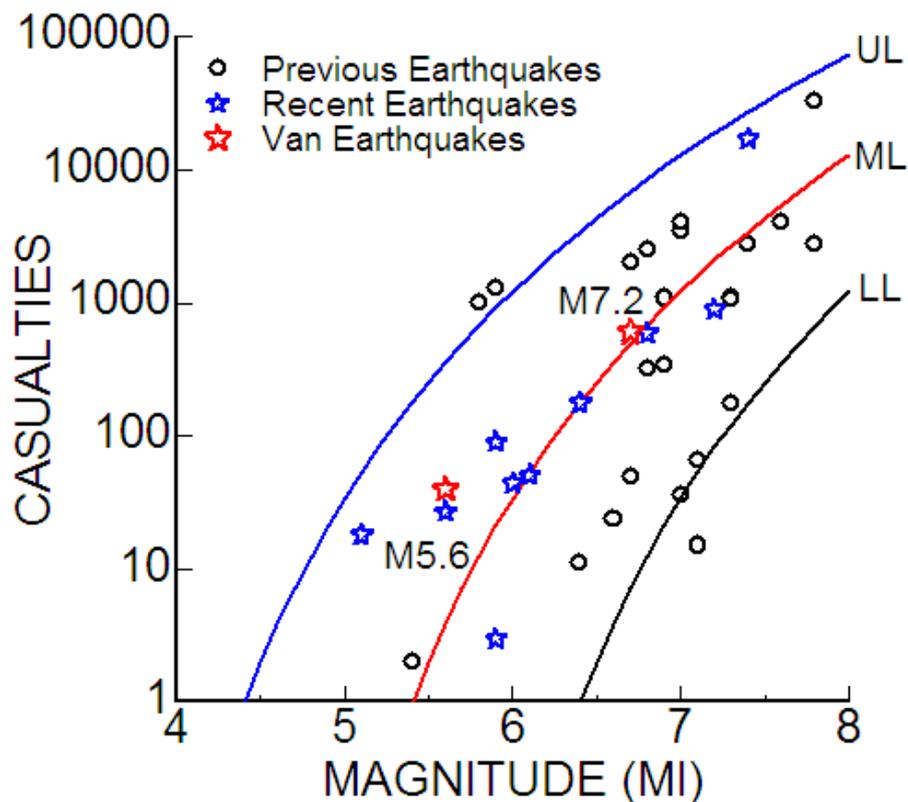
This earthquake resulted in the loss of 38 lives as it happened at 21:23 in the evening. On the other hand, the 23 October 2011 Van-Erciş earthquake resulted in the loss of 604 people and occurred at 13:41 on Sunday. Fig. 7 shows the relations between local magnitude and casualties. The estimations for upper (UL), mean (ML) and lower (LL) limits are computed from the following function proposed in this article using the data from various catalogues for Turkey (i.e. Ergin et al. 1967; Soysal et al. 1981; Eyidoğan et al. 1991).

The values of constants A and c are 2 and 7, while the values of constant B are 3.5, 4.5 and 5.5 for UL, ML and LL, respectively. The main reason for such large ranges may be related to the time of earthquake, quality of buildings and ground conditions.

Fig. 7 Relation between local magnitude of earthquakes and casualties

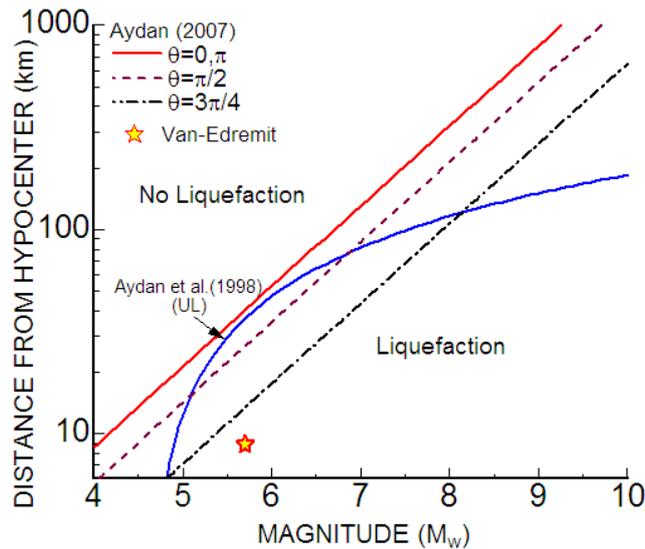
Fig. 8 shows the empirical relations proposed between earthquake magnitude (M_w) and hypocentral distance of liquefaction location proposed by Aydan et al. (1998) and Aydan (2007) with the observation in this earthquake. The observation is within the proposed empirical limits.

Fig. 9 Comparison of empirical relations with observation
