THE CHARACTERISTICS OF GEOTECHNICAL DAMAGE BY THE 2011 VAN-ERCIŞ EARTHQUAKE

Reşat ULUSAY¹, Halil KUMSAR², Kazuo KONAGAI³, and Ömer AYDAN⁴

ABSTRACT: An earthquake with a moment magnitude of 7.1 occurred at 13:41 on local time on October 23, 2011 in the Van province of the Eastern Turkey. Brief outlines of geology, hydrogeology and geotechnical conditions in Erciş town and Van City and along the shore of Van Lake are first given. Then, observed ground liquefactions, associated ground deformations, sand boils and their characteristics are presented. In addition, slope and embankment failures are also presented and their characteristics are compared with available approaches. Finally the effects of geotechnical events on structural damages are given and discussed.

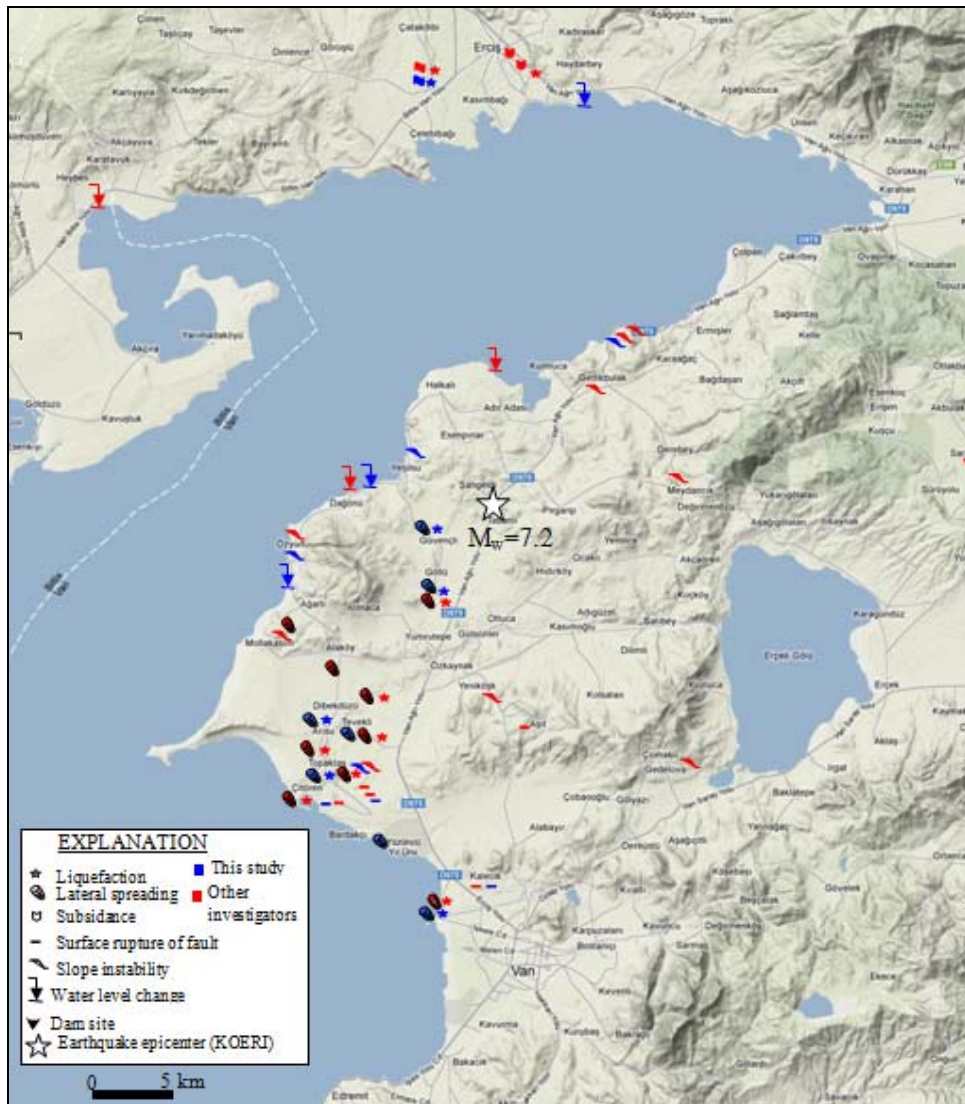
In this earthquake, liquefaction and associated ground deformations were evident and wide spread sand boils were observed particularly in Erciş Plain (Çelebibağı and Kasımbağı villages, and along Zilan stream) and the flood plain of Karasu River (Topraktaş, Arısu, Göllü, Tevekli, Çitören, Mollakasım and Alaköy villages), YYU port, Van Port, Esenkıyı (Fig. 5, Photo 1). Lateral spreading was quite extensive at Çelebibağı and Topraktaş villages.

Fig. 5 Locations of observation on geotechnical damage

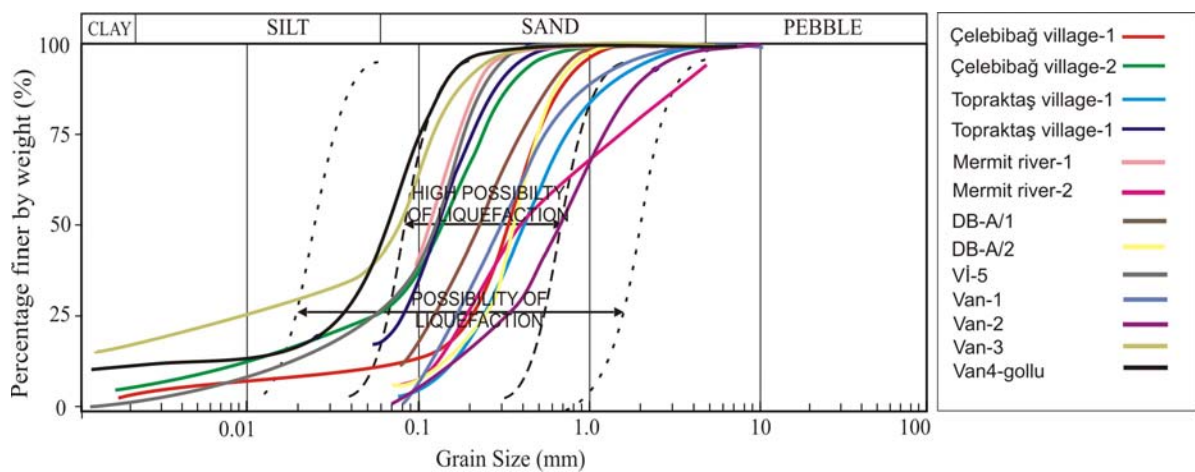
The authors have gathered some samples from sand boils observed during the reconnaissance. Fig. 6 shows the grain size distribution of boiled sand samples. Although some samples have high fine content, they are still within the easily liquefiable bounds.

Fig. 6 Comparison of grain size distribution of boiled sand samples with empirical liquefaction bounds

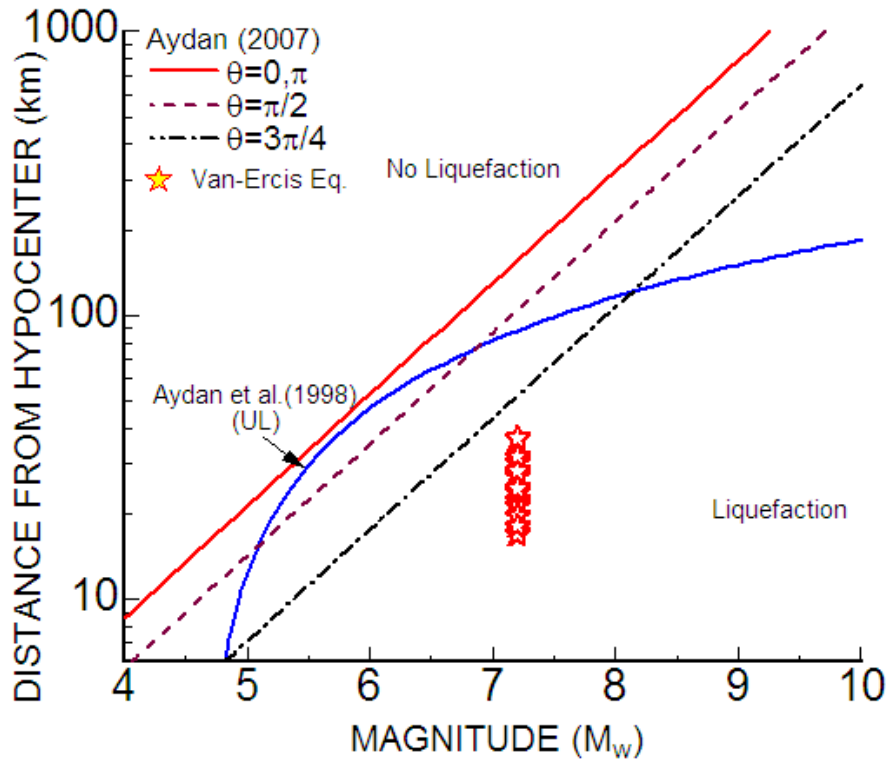
Fig.7 shows empirical relations for the magnitude and hypocenter limit distance for liquefaction with observations. The observations fall into the domain of liquefaction predicted by empirical relations proposed by Aydan et al. (1998) and Aydan (2007). It should be noted that the relations by Aydan (2007) considers the position of observation point with respect to the earthquake fault.

Fig. 7 Comparison of empirical relations for magnitude and liquefaction limits with observations

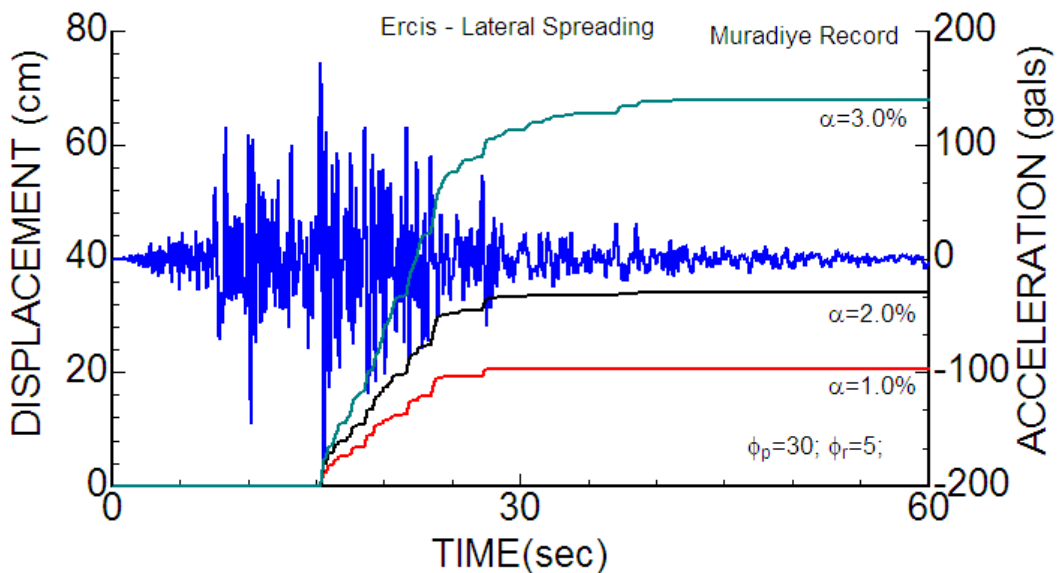
Aydan et al. (2008) proposed an approach to estimate amount of lateral spreading using the strong motion records. A sample computation was carried out for different base inclination of liquefiable layer using the records taken at Muradiye strong motion station and results are shown in Fig. 8. The amount of lateral spreading is about 69 cm for an inclination of 3% while it becomes about 19 cm for the inclination of 1%. As the inclination of liquefiable layer was probably more than 3% at Çelebibağı (Erciş) as seen in Photo 1a, these computational results can explain the possible reason for large deformation at that locality.

Fig. 8 Computed lateral spreading for three inclinations using the records taken at Muradiye

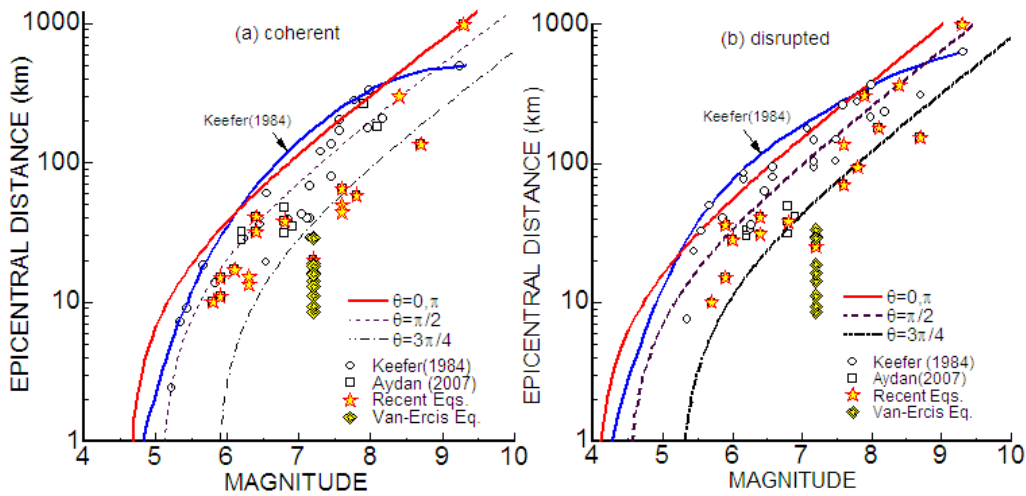
Fig. 9 compares the empirical relations between the earthquake magnitude and limits of slope failures for coherent and disrupted states. The observations are within the bound of the empirical bounds proposed by Aydan (2007) and empirically drawn line by Keefer (1984). The relations proposed by Aydan (2007) considers the effect of fault orientation with respect to the observation point.

Fig. 9 Comparison of observational results with empirical relations between earthquake magnitude and epicentral limit distance for slope failures
