COMPARING LIQUEFACTION PHENOMENA OBSERVED DURING THE 2010 MAULE, CHILE EARTHQUAKE AND 2011 GREAT EAST JAPAN EARTHQUAKE

Ramón VERDUGO¹

¹ Principal, CMGI Ltda. Santiago, Chile
rverdugo@cmgi.cl

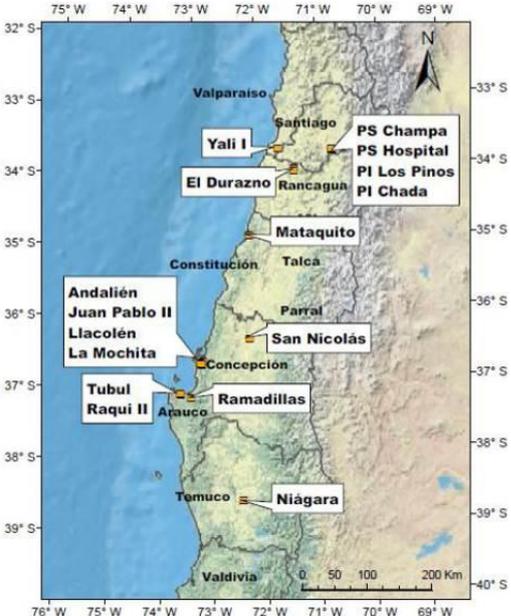
According to all the information that has been collected and analyzed, 12 bridges and 4 overpasses were damaged by ground failure associated with liquefaction of ground foundations or accesses. Bridges affected by liquefaction of soil foundation were Andalién, Juan Pablo II, La Mochita, Niagara, Ramadillas, Raqui II, San Nicolás, Tubul and Yali I. Bridges with ground failure at the accesses were Alhue, El Durazno and Llacolén. Additionally, there were signs of liquefaction (settlements and sand boils) of the natural soil at Mataquito Bridge, which was not affected because the liquefiable soil was not used to support the structure. On the other hand, overpasses affected by the phenomenon of liquefaction were: Chada, Champa, Hospital and Los Pinos.

The location of these bridges and overpasses is shown in Fig. 15. It can be observed that there are two areas where there is a concentration of liquefaction phenomena. Failure of bridges is more concentrated in the Concepción area, whereas failure of overpasses is clearly observed to be concentrated to the south of Paine area, as shown in Fig. 16, where three additional sites liquefied.

Fig. 15.- Bridges and overpasses affected by liquefaction

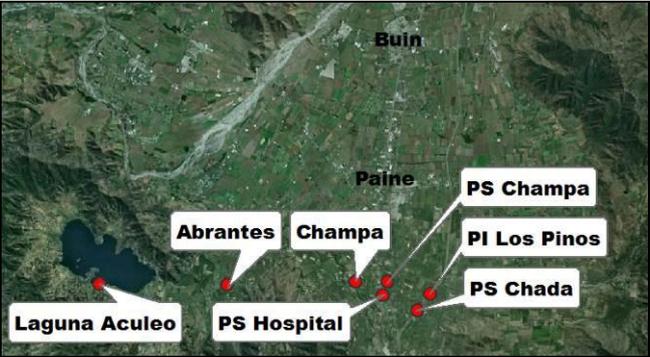
Fig. 16.- Concentration of liquefaction in Paine area
