LESSONS FOR CONCRETE WALL DESIGN FROM THE 2010 MAULE CHILE EARTHQUAKE

Key Words: 2010 Maule Chile Earthquake, concrete wall, boundary element, buckling, crushing, shear, configuration

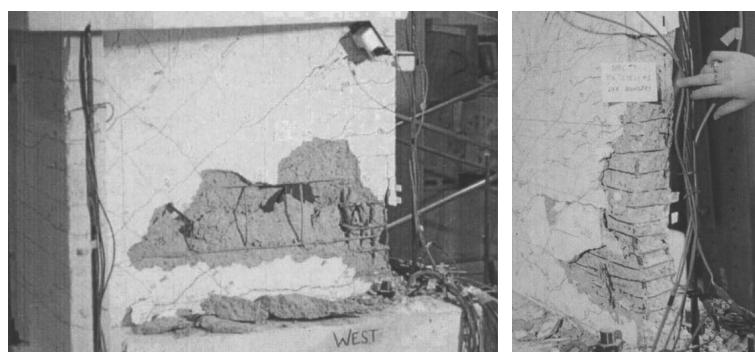
Damage to wall boundary elements, including concrete crushing and/or buckling of longitudinal reinforcing bars (Figs. 2a, 3a)

Overall wall buckling (Figs. 2b, 3b)

Fig. 3 Test specimens from Thomsen and Wallace (2004) (a) Wall boundary element with transverse hoops spaced at $8d_b$, exhibited longitudinal bar buckling and concrete crushing at 1.25% lateral drift. (b) Wall boundary element with hoops spaced at $4d_b$, exhibited more ductile behavior until initiating overall wall buckling at 2.5% drift.

The *buckling-first* interpretation is also consistent with behavior observed in the test specimen by Thomsen and Wallace (2004), shown in Fig. 3a, which showed bar buckling occurring suddenly without significant prior spalling.

These phenomena result from flexural compression and/or cyclic tension and compression. They can be undesirable failure modes because they can lead to strength degradation and irreparable damage. To improve performance, potential modifications to design practice could include providing transverse reinforcement ties at a close spacing and/or providing an increased area of transverse reinforcement in wall boundary elements. Wall sections could also be designed to be governed by tension yielding.
