REPORT ON 2012 VAN (TURKEY) EARTHQUAKES

ABSTRACT: An earthquake of Mw7.2 on 23 October 2011 occurred in the Van region of Eastern Turkey. The mainshock and long series aftershocks caused significant damage and claimed 644 lives. Particular features of the earthquake, damage, losses, rehabilitation and the lessons learned are covered.

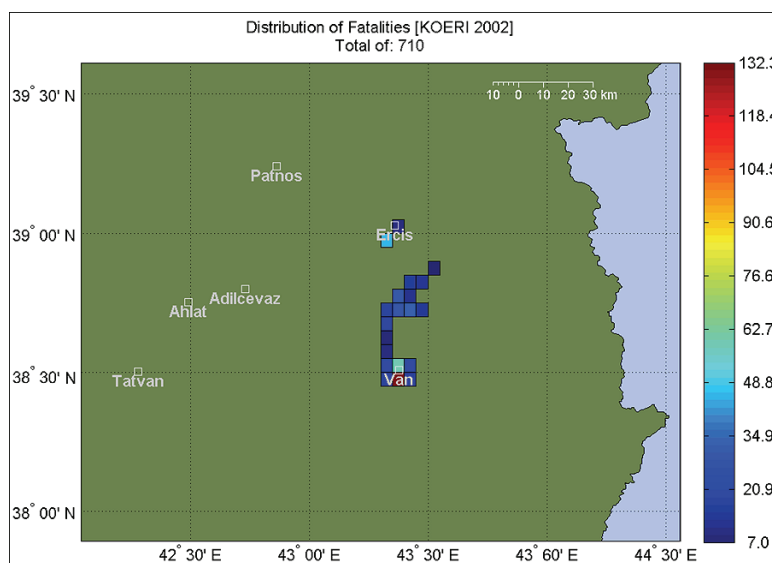
KOERI has successfully provided the rapid estimation fatality as 714 and their geo-cell based distribution (Fig 9) using the ELER routine (Erdik et al., 2010). In contrast, the median fatalities reported by the first issue of the USGS-PAGER system stood in excess of 10,000 and 32% were assigned to fatalities between 10,000 and 100,000. This was possibly due to the USGS location earthquake epicenter (CEDIM reports at www.cedim.de and <http://earthquake-report.com>).

Fig 9. Estimated distribution of fatalities (EQE-KOERI, 2011)

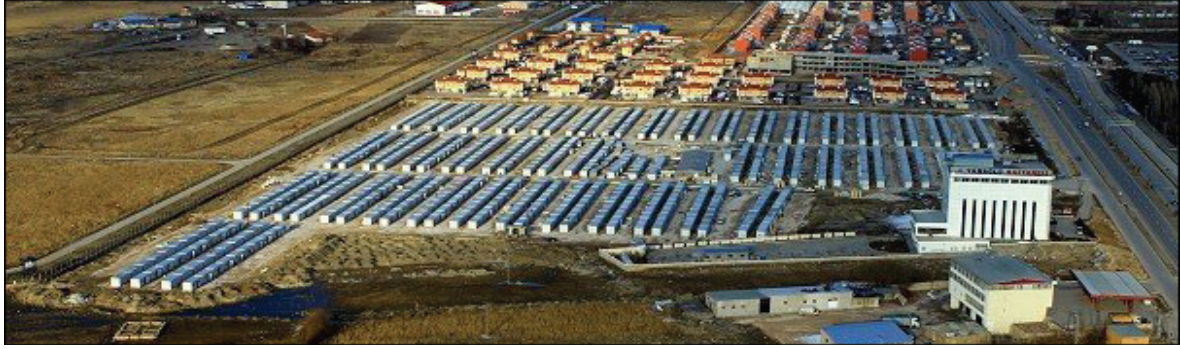
As reported by Emergency Appeal Operation Update Turkey: Van Earthquake – Jan. 9, 2012 (www.ifrc.org), due to damaged housing and fear of aftershocks about two hundred thousand people are residing in temporary shelters (Fig 10), consisting of about 3,800 prefabricated Mevlana houses, about 2700 container houses and tents (14 tent cities and individual tents amounting to 72,500). Health services are provided by about 3000 medical personnel in the sound hospitals and in 11 mobile field hospitals.

Fig 10. Post earthquake temporary housing
