PERFORMANCE OF BURIED HIGH VOLTAGE POWER CABLES DUE TO LIQUEFACTION

John M. EIDINGER¹

ABSTRACT: Buried high voltage power cables failed in many locations in the February 22, 2011 M 6.3 Christchurch earthquake, due to liquefaction. The empirical evidence of these failures is presented. The original design of the cables is considered, and what made the cables so vulnerable. Nonlinear analyses of buried cables are presented to see how they "theoretically" should perform due to liquefaction. Full scale tests are conducted for unreinforced and reinforced buried cable duct banks to examine their relative capability to absorb the effects of liquefaction. Recommendations are made for the design of new buried cables in liquefaction zones.

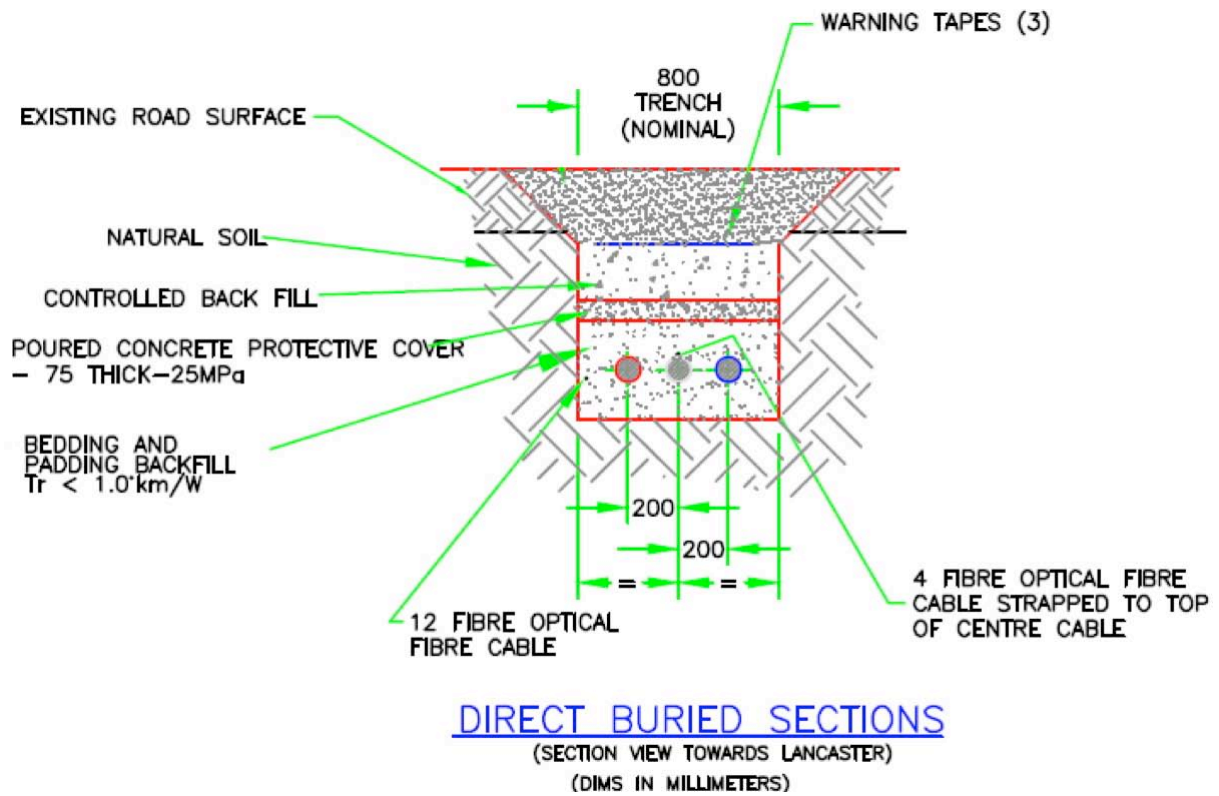
Figure 8. Trench Design 66 kV XLPE-type Cable

The cables used at Locations 4, 5 and 6 are XLPE-type. Cores are 1600 mm² copper. Figures 8 and 9 show the typical trench installation and cross section of the cable.
