DAMAGES OF WOODEN HOUSES CAUSED BY 2011 GREAT EAST JAPAN EARTHQUAKE AND TSUNAMI

Mikio KOSHIHARA¹, Naohito KAWAI², Hiroshi ISODA³ and Takahiro TSUCHIMOTO⁴

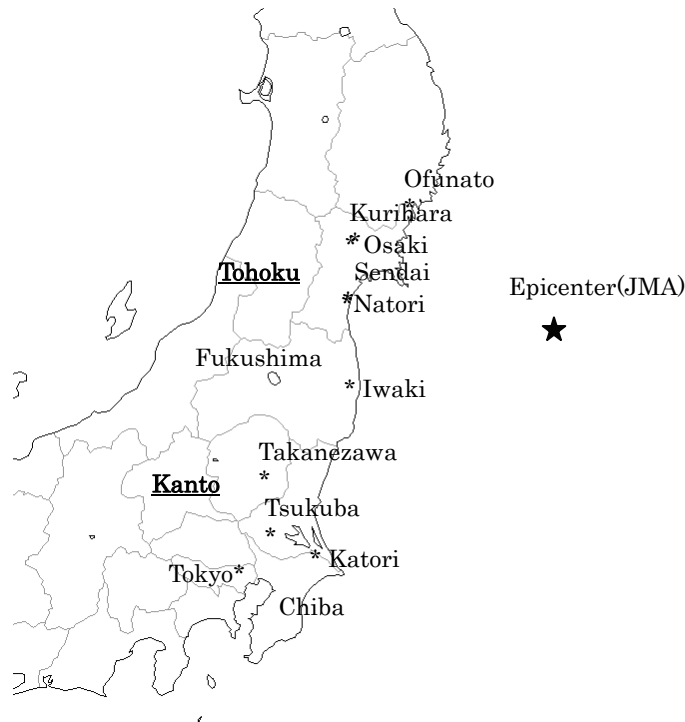
Substantial earthquake damage of buildings and structures, including collapse or other heavy damage to houses, occurred over a wide swath from Tohoku down to northern Kanto (Fig.1), although in only a fairly limited number of clusters. The type of damage is extremely diverse due to differences in site amplification of the ground motion characteristics.

Fig.1 Damaged area

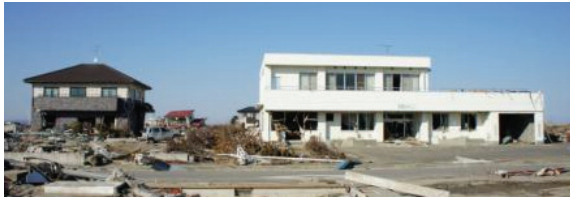
With a few exceptions, most wood houses were completely washed away by the tsunami. Fig.24 shows one of the few wooden houses left standing, due to a location downstream of a reinforced concrete building. Inundation depth estimated from remaining reinforced concrete buildings reached 6 to 8 meters.

Fig. 24 Wood house remained downstream of RC building

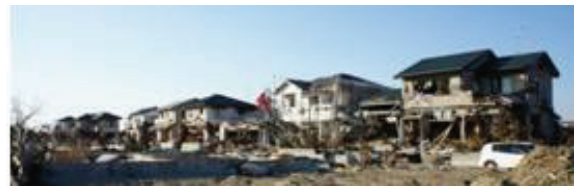
In an area approximately 1.5 km away from the shoreline in Arahama district, many low-rise buildings and dozens of hotels were washed away. In this area, some wooden houses situated in a line the direction of the water flow withstood damage, as shown in Fig. 25. Inundation depth in this area was estimated to be about 4 to 5 meters, with the remaining wooden houses being low-rise and non-residential. On the other hand, there were several cases identified that no buildings were left standing in the direction of the tsunami waves.

Fig. 25 Wooden houses remained in a line

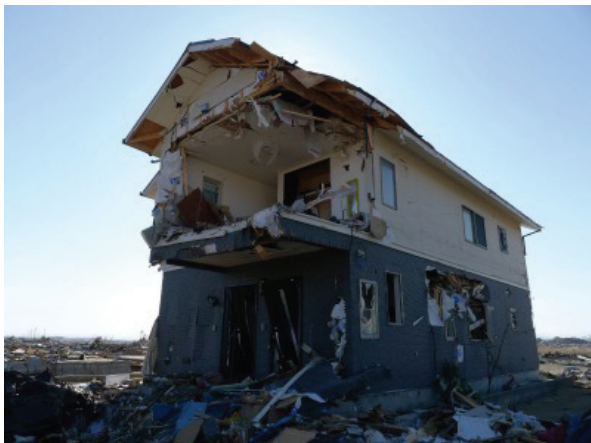
Fig. 26 shows one of the few wooden structures left standing, with damage limited to the walls in the direction of floodwater. The method of construction was relatively new, involving joints with more metal than traditional construction.

Fig. 26 Wooden building escaping complete devastation

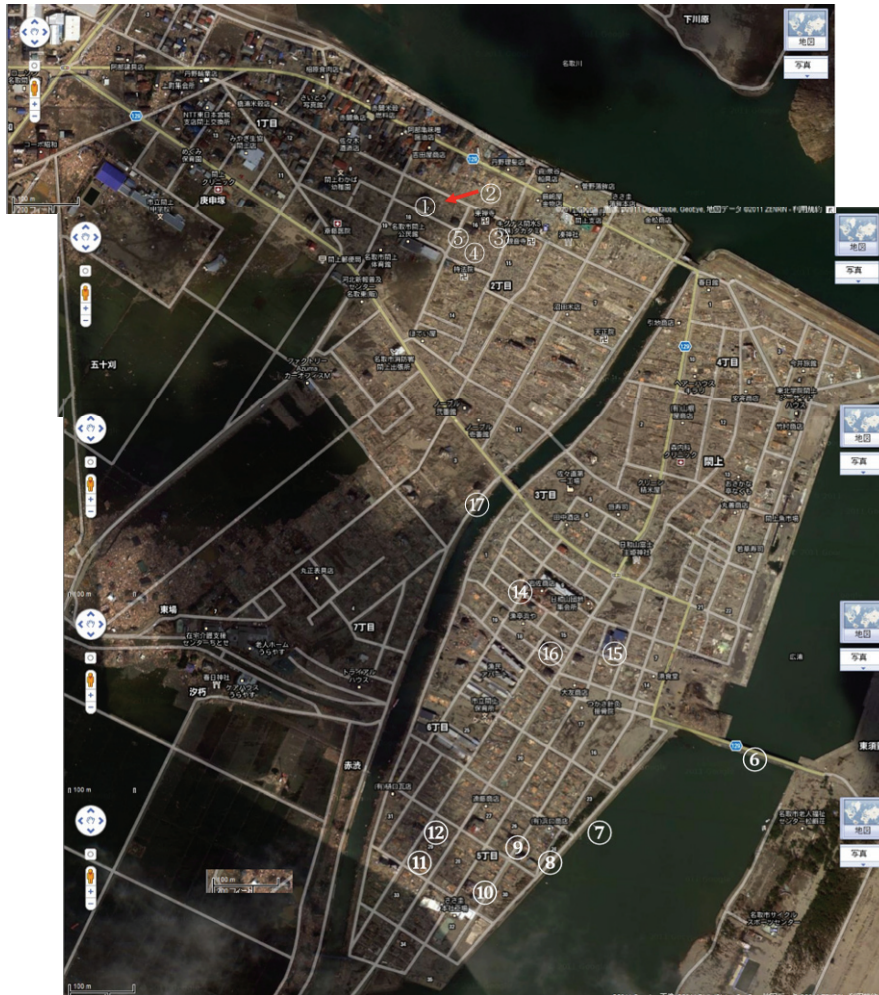
In general, this area experienced widespread catastrophic damage. Fig. 27 shows an aerial photo (from 3/13/2011) of the area surveyed, with the locations of the properties surveyed circled.

Fig. 27 Aerial photograph and the position of investigated buildings in Yuriage, Natori-City

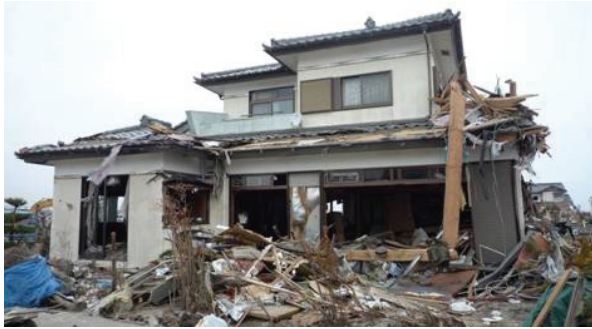
In this same vicinity, the temple and steel building at locations (3) and (4) respectively, were severely damaged but remained in place. The wooden shop with dwelling at location (5) only received slight damage presumably due to being downstream to the temple and steel building. Fig. 30 shows a wooden house in location (10) that withstood the tsunami force without the protection from trees at location (7). This is probably due to the relatively new construction of the house, which was built in the last few years.

Fig. 30 Wood house remaining without the protection of the forest (Location (10))

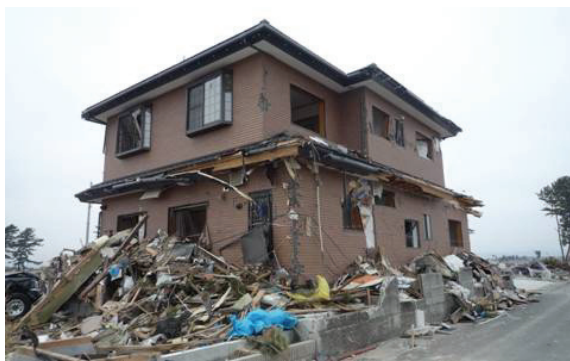
A few wooden houses remained around location (11), downstream of a factory building. Inundation depth is estimated at about 3.5 meters in this area. These buildings are pictured in Fig. 31 and Fig. 32 (Picture taken from location (12)).

Fig.31 Japanese conventional post and beam wood house remaining (Location (11))

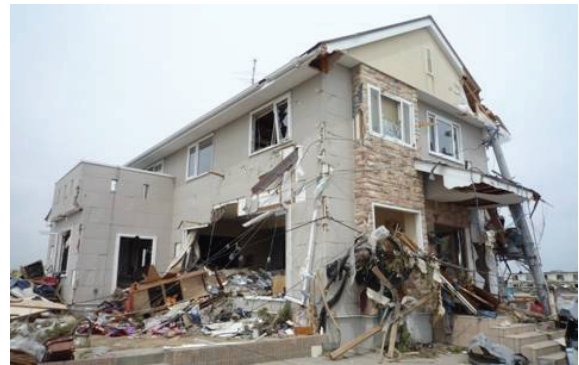
Fig. 32 One of few light frame construction wood houses remaining (Location (11))

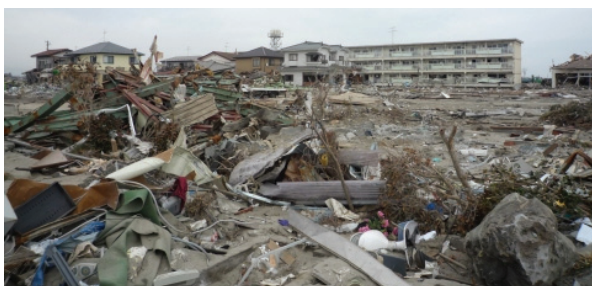
Fig. 33 in location (14) shows a group of houses that remained down-stream of a large factory building. The buildings that survived were a mix of older and newly constructed wooden houses. In addition, the factory building in location (15) protected wooden houses for an even further distance. This is expected to be due to the relatively new construction of these houses that had superior structural specifications. These houses are seen in Fig. 34 taken from location (11). Another wooden house, at location (17), was spared from catastrophic damage presumably due to superior construction.

Fig. 33 Group of wooden houses that escaped damage downstream of a RC structure (Location (14))

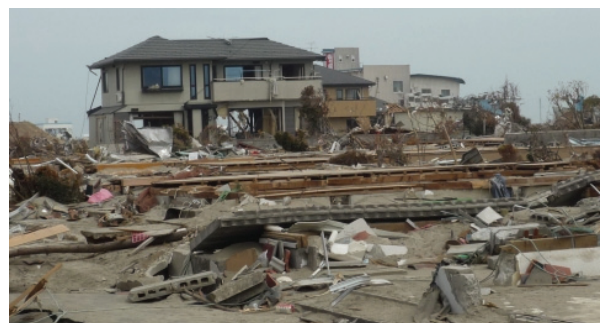
Fig. 34 Wooden houses which avoided being carried away downstream of the factory building (Location (11))

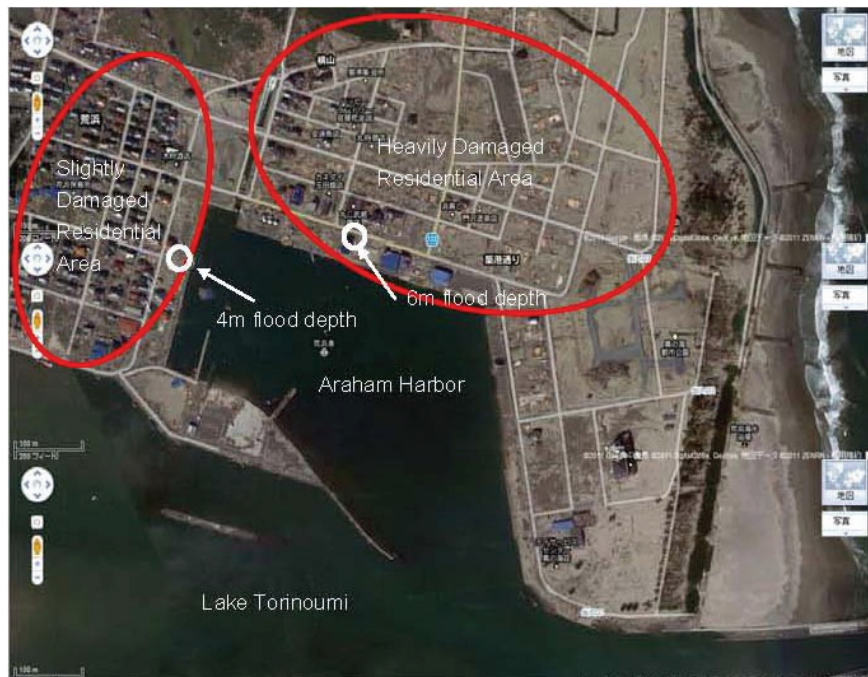
The Araham, Watari-town area is surrounded by the Pacific Ocean on the west and a lake to the South, with a harbor off of the lake, as shown in Fig. 35. The tsunami washed away many of the wooden houses, leaving only the foundation.

Fig. 35 Aerial photograph in Arahama, Watari-machi

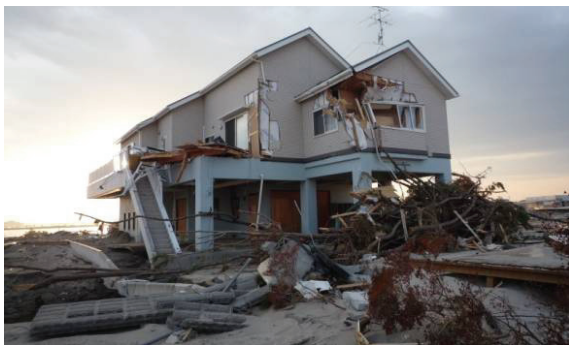
Fig. 38 shows a hybrid construction building that withstood the tsunami force. This building uses reinforced concrete stilts for the first floor and wooden construction on the second floor. Fig. 39 shows a one-story heavy timber structure with glulam frame in which the wooden structure remained intact, but the building was filled with wreckage and building materials.

Fig. 38 Hybrid construction consisting of RC on the 1st floor and wooden construction on the second floor

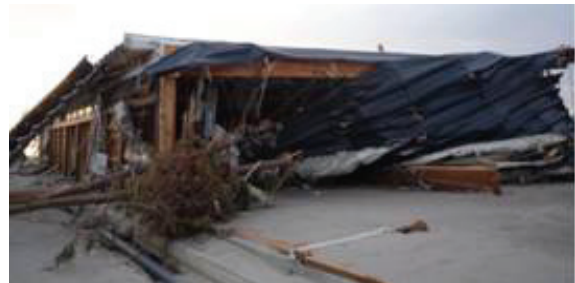
Fig. 39 Heavy timber structure with Glulam frame remaining

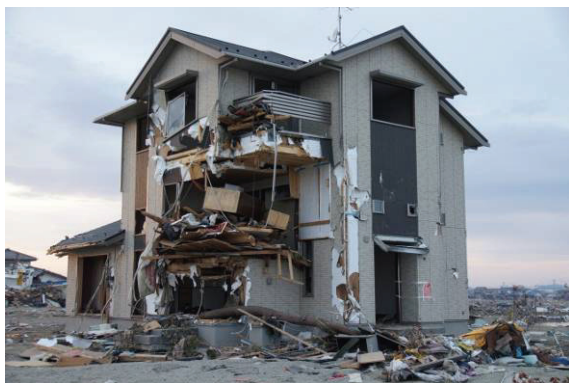
North of the harbor, estimated to have been in 6 meters of floodwater, mostly consisted of detached wooden houses. Fig. 35 shows the impacted area, with very few houses remaining on the north side of the harbor. One of the few that remained, pictured in Fig. 40, was a three-story wooden house that had been design for superior seismic protection. This extra strength is probably responsible for the survival of the building. West of the harbor, estimated to have been in 4 meters of floodwater, had a number of buildings withstand the tsunami force. One of the wooden houses, pictured in Fig. 41, also withstood contact from a ship. This is probably due to relative young age of the house, which presumably has superior structural specification.

Fig. 40 3-story wooden house remaining

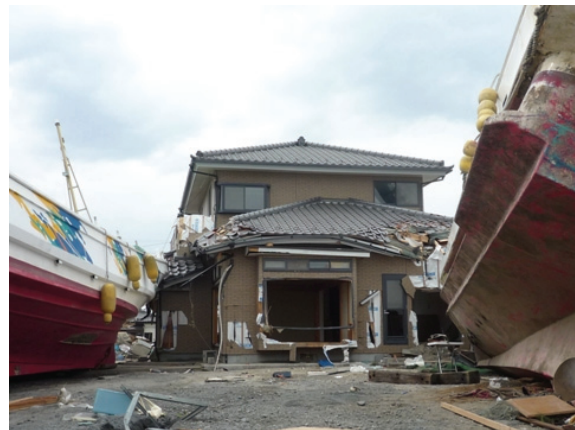
Fig. 41 Wooden house remaining even after collision with ship

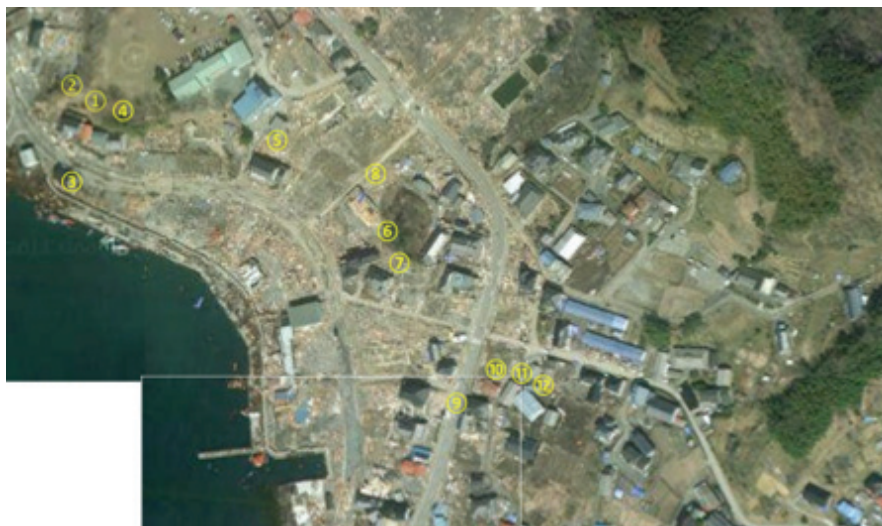
In this section, the damage survey results are only given for Akasaki-machi, Ofunato-city, a village on the east side of the bay of Ofunato situated on a gradual slope. Fig. 42 shows the aerial photograph of the district with the locations of the buildings surveyed.

Fig. 42 Aerial photograph in Ofunato-City

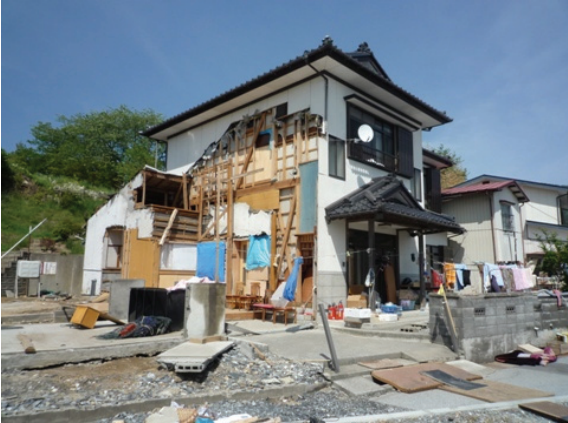
A house in location (1) (Fig. 43), according to residents, was almost completely submerged with inundation depth over 7 meters. The house had some damage but was largely spared overall. An adjacent work shed in location (2) was disconnected from the concrete foundation and moved. The two-story wooden house across the street in location (3) on the ocean side received very little damage (Fig. 44). The hill to the north of these buildings probably reduced the magnitude of the tsunami force.

Fig. 43 Wooden house intact with 7m wave depth

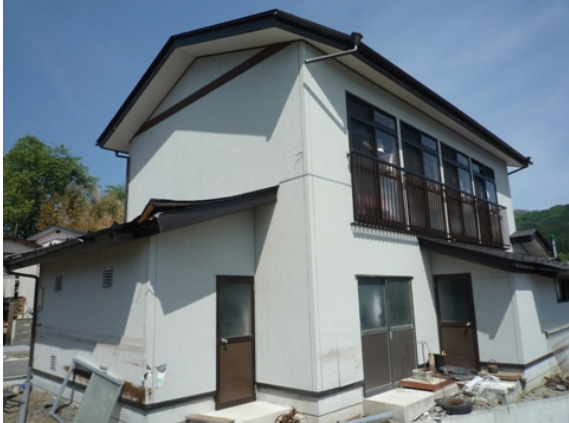
Fig. 44 Wood house without damage with over 7m wave depth

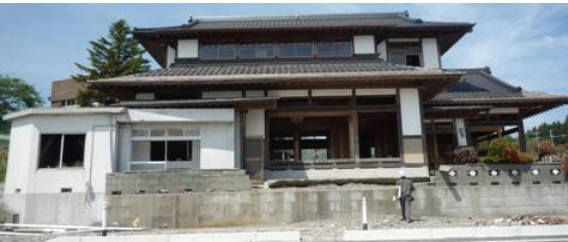
Fig. 45 shows a traditional Japanese wood house in location (5) that survived the inundation depth of about 5-6 meters and it was located 1.5 meters above the road level. Although the walls were destroyed the structure was intact, and there seemed to be little residual deformation in the house. Fig. 46 in location (6) was about 2 meters above the road level. The house was spared despite floodwater levels reaching 6 meters, damaging parts of the roof as well as the house. A relatively new house to the northeast was washed away. This house was equipped with significant tie-down hardware and large partial corrosive pores were observed. This indicates that the tie-down hardware was not sufficient to fix the house to the foundation.

Fig. 45 Traditional wooden house that avoided being carried away under 5-6 m wave depth

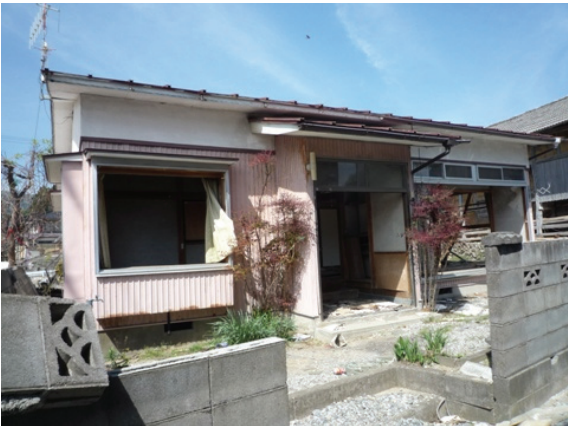
Along the prefecture road up the hill from these buildings, a lightweight steel frame house in location (9) withstood floodwaters up to 5 meters. Adjacent to this building in location (10), a small one-story building that had minor structural specifications survived, pictured in Fig. 47. The house

was con-firmed to have one brace with nailed joints and anchor bolts into the foundation. In addition, despite a 3.8-meter inundation depth, a dilapidated warehouse in location (11) remained standing (Fig. 48). Just to the East in location (12), old houses were rotated about 30 degrees clockwise (Fig. 49). The fact that some of these older buildings withstood these floodwaters suggests that the slope reduced the force of the tsunami in contrast to the lowlands.

Fig. 47 House that survived with minor structural specifications

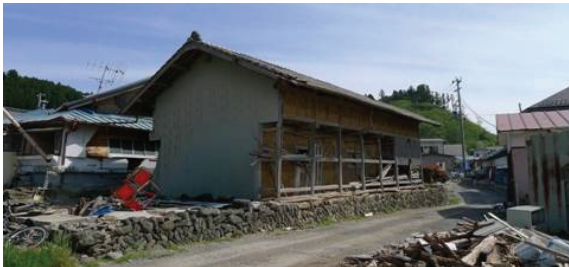
Fig. 48 Warehouse that survived with minor structural specifications
