# LIQUEFACTION IMPACTS IN RESIDENTIAL AREAS IN THE 2010-2011 CHRISTCHURCH EARTHQUAKES

Misko CUBRINOVSKI<sup>1</sup>, Duncan HENDERSON<sup>2</sup> and Brendon BRADLEY<sup>3</sup>

**ABSTRACT:** In 2010 and 2011, the city of Christchurch (New Zealand) was hit by a sequence of strong, local and devastating earthquakes. Widespread and very severe liquefaction affected many of the city suburbs and its central business district. This paper summarizes the characteristics of liquefaction and discusses its impacts on residential houses and buried pipe networks.

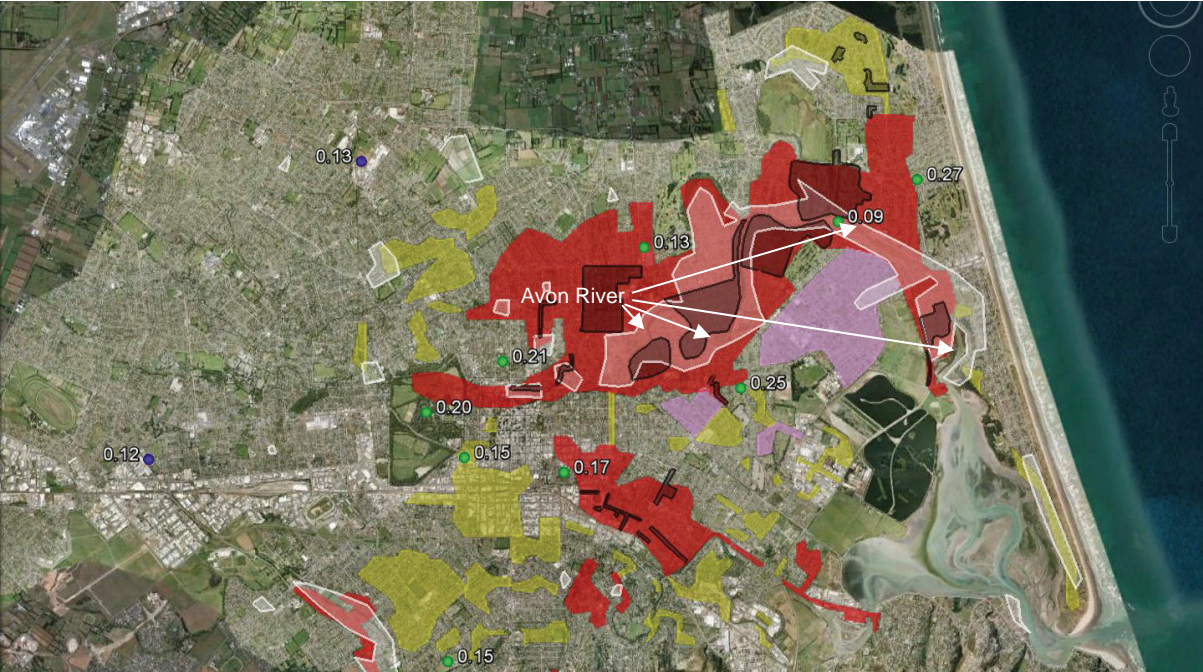
The 2010 – 2011 earthquakes caused repeated liquefaction through the suburbs of Christchurch and its Central Business District. The liquefaction was very severe and widespread (covering nearly one third of the city area) causing extensive damage to residential houses/properties, commercial buildings, lifelines and infrastructure. Figure 4 indicates areas within Christchurch that liquefied during the 4 September 2010 earthquake (white contour/shaded area), 22 February 2011 earthquake (red = moderate to severe liquefaction; yellow = low to moderate liquefaction; magenta = moderate liquefaction predominantly on roads with some on properties; Cubrinovski and Taylor, 2011) and 13 June 2011 earthquakes (dark grey contours/shaded area; Cubrinovski and Hughes, 2011). The extent of liquefaction in the 23 December 2011 earthquake was similar to that in the June 2011 earthquake (the December event map is currently in preparation). The repeated liquefaction was often quite severe and some residents reported that the liquefaction severity increased in subsequent events.

Fig. 4 Liquefaction maps indicating areas of observed liquefaction in the 4 September 2010 (white contours), 22 February 2011 (red, yellow, magenta areas), and 13 June 2011 (black contours) earthquakes; normalized cyclic stress ratios at water table depth,  $CSR_{7.5(wt)}$ , which were calculated using the recorded geometric mean peak ground accelerations and respective earthquake moment magnitude are also shown (green symbols indicate strong motion stations where the 22 February 2011 produced the highest  $CSR_{7.5(wt)}$  value whereas the 4 September 2010 earthquake produced the highest  $CSR_{7.5(wt)}$  value at the SMS depicted with blue symbols)

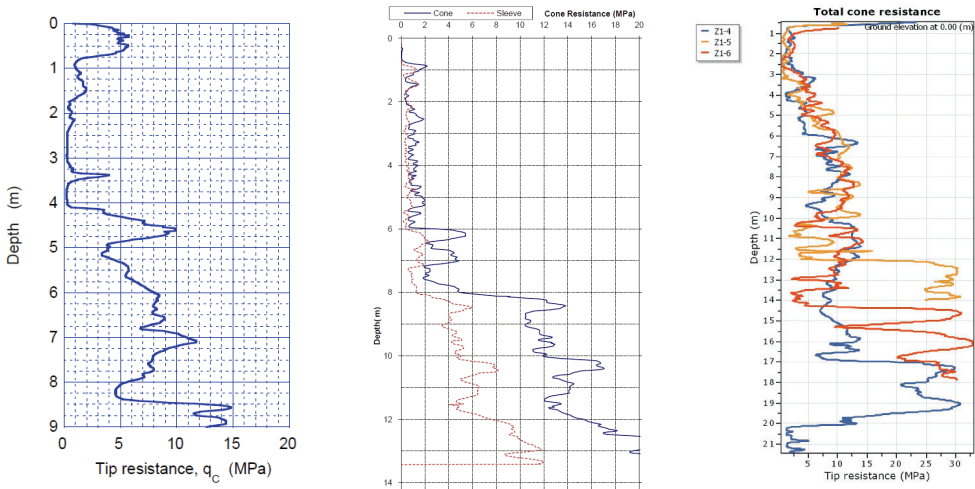
The most severely affected by liquefaction were the suburbs along Avon River to the east of CBD (Avonside, Dallington, Avondale, Burwood and Bexley). The soils in these areas are predominantly loose fluvial deposits of liquefiable clean and fines-containing sands, with fines content predominantly in the range between 0% and 30%. Importantly, the fines are non-plastic silts. The top 5-6 m of the soils are often in a very loose state, with CPT cone tip resistance ( $q_c$ ) of about 2-4 MPa (or an SPT blow count of 4-8). The cone resistance typically increases to 7-10 MPa (approximately 14-20 SPT

blow counts) at depths between 6 m and 10 m, however lower resistances are often encountered in areas close to wetlands. Characteristic penetration resistance for these areas and those within CBD is shown in Figure 5. These areas are within the zone where very severe liquefaction occurred during multiple events.

Fig. 5 Characteristic CPT resistance in areas of severe liquefaction (red area along Avon River and

CBD)

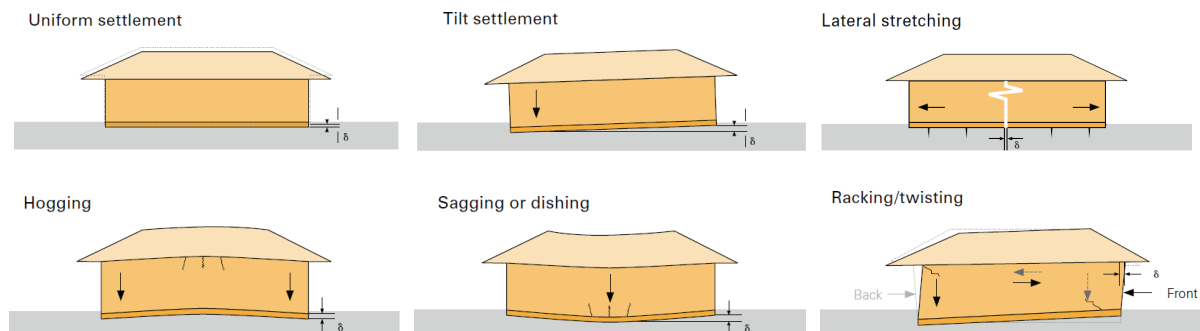
Approximately 20,000 houses were seriously affected by liquefaction, out of which more than 6,000 have been damaged beyond economic repair (in the abandoned areas suffering extensive liquefaction). The worst damage to residential houses was inflicted in areas where severe lateral spreading occurred, however, liquefaction on its own, even in the absence of lateral spreading, caused extensive and often substantial damage beyond economic repair. Some typical damage patterns of house foundations are schematically illustrated in Figure 8 (DBH, 2011).

Fig. 8 Schematic plot of typical damage patterns for house foundations (DBH, 2011)
