QUICK REPORT OF 2011 VAN EARTHQUAKE

Key Words: 2011 Van earthquake, damage reconnaissance, R/C buildings, Masonry buildings, Damage classification

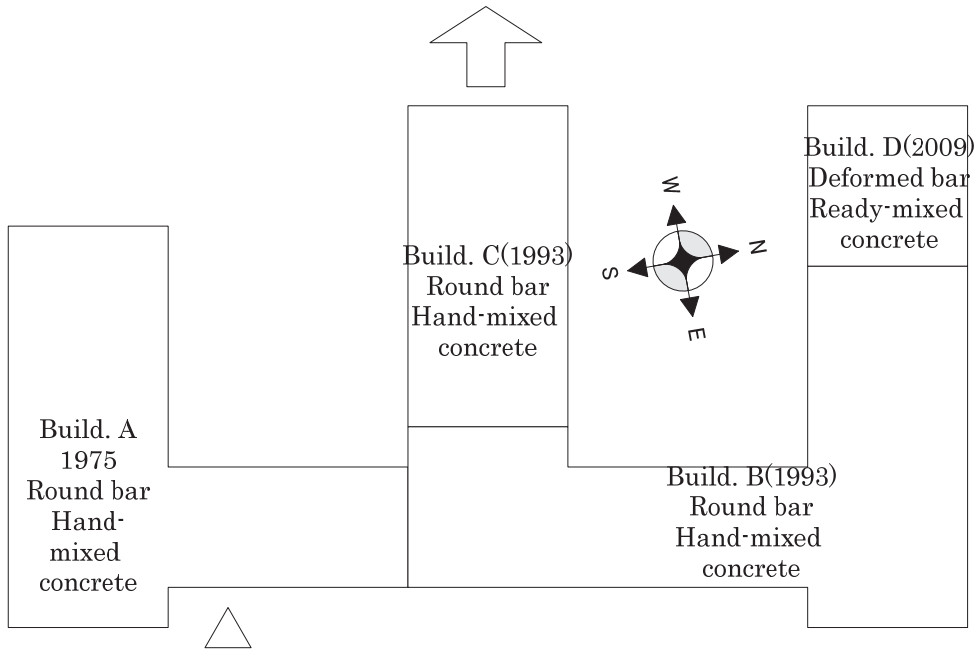
Fig. 4 Plan of the main building

The building has three stories and one semibasement floor. South-east side of the building is shown in Photo 8. The plan of the main building is shown in Fig. 4. The building is separated into three portions. They are not connected but have gap between buildings. Building A was constructed in 1975 with round bar and hand-mixed concrete. Building B and C were constructed in 1993 with round bar and hand-mixed concrete. Building D is new and was constructed in 2009 with deformed bar and ready-mixed concrete.
