STRUCTURAL ASSESSMENT OF A REPAIRED CABLE BRIDGE DAMAGED IN 1999 CHI-CHI EARTHQUAKE

ABSTRACT: The Chi-Lu cable-stayed bridge was damaged during Chi-Chi Earthquake just before completion of its construction. Urgent repairs were made following the earthquake without having made a detailed assessment of the damaged structure. To assess the structural safety, a series of field tests were implemented, including load tests, ambient vibration test and forced vibration test. This paper presents the assessments on the structural safety of the bridge by field tests before the official re-opening, and the health monitoring of this bridge since its reopening to general traffic conditions.

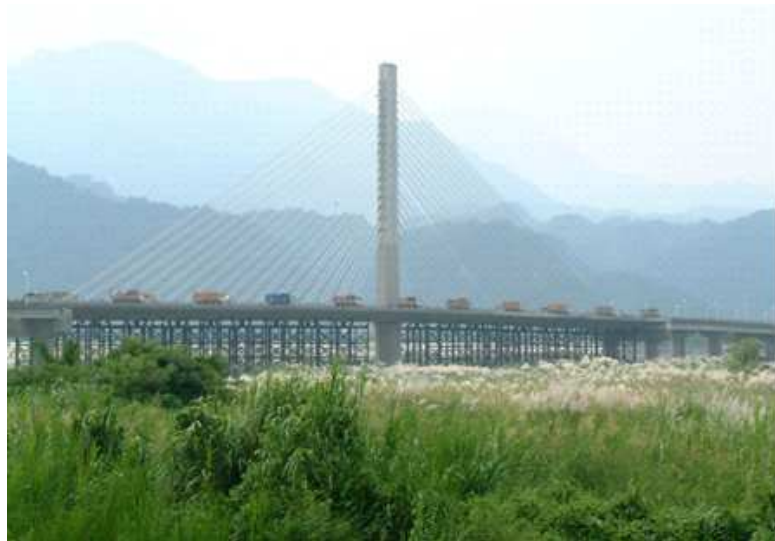
Fig.9 The 1st loading test after Repair Stage 1

After Repair Stage 1, to partially relieve the traffic demand, the bridge owner entrusted NCREE (National Center for Research on Earthquake Engineering) with the 1st truck loading test, as shown in Fig.9. After the 1st loading test, Chi-Lu Bridge was opened to passersby and passenger cars only.

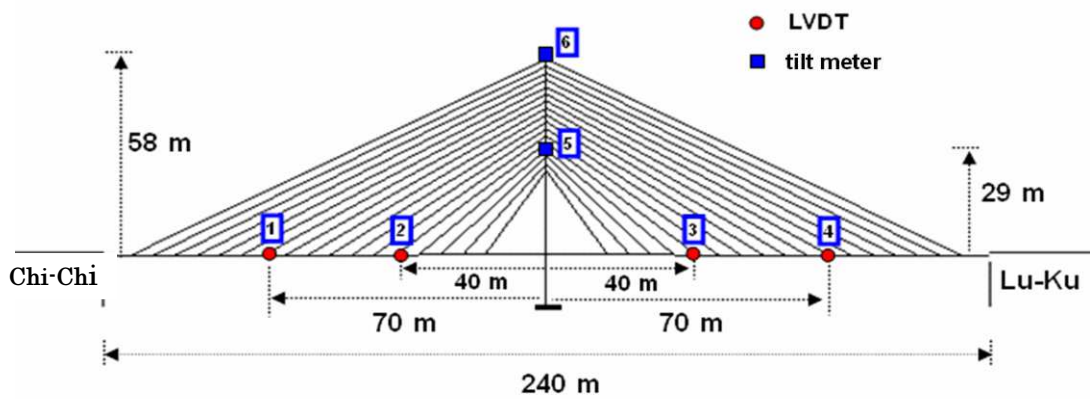
Fig.11 Sensor deployment for the 2nd loading test

After Repair Stage 2, the bridge owner entrusted NCREE for the 2nd truck loading test. After the 2nd loading test, as shown in Fig.10, Chi-Lu Bridge was officially opened to the general traffic. During the 2nd loading test, to measure the response of the girder and pylon, both LVDT and tilt meter were deployed as shown in Fig.11. The LVDT were installed on the top of the scaffoldings, setup above the riverbed. Two critical loading patterns were applied on the deck. One is the two-span loading, and the other is single-span loading, as shown in Fig.10a and Fig.10b, respectively. Table 1 lists both the experimental results and the numerical results by the FEM model used the original design. In the two-span loading pattern, the displacement response is close to that of the design value; in the single-span loading pattern, the displacement response is more conservative than the design value. After the loading test that ensured the safety of the bridge, Chi-Lu Bridge then was officially opened to the general traffic.

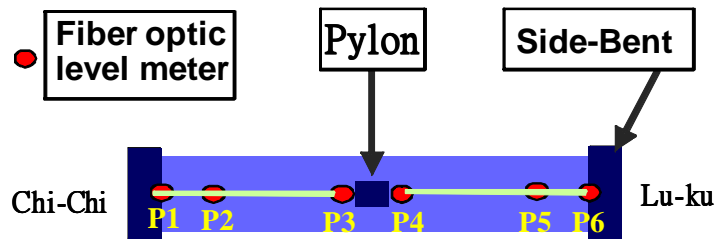
Fig.15 Deployment of FBG-based level sensors

The level sensors were placed inside the girder, shown in Fig.15, where P3 and P4 were immediately beside the pylon and serve as reference points. Beginning at noon one day, and ending at noon the next day, the girder elevation was continually monitored for 24 hours in Fig.16. At 5:00 pm, the bridge temperature peaked, the steel cables lengthened, and P2 and P5 elevations decreased, whereas between 3:00 am and 8:00 am, the bridge temperature was the lowest, the steel cables contracted, and P2 and P5 elevation increased.

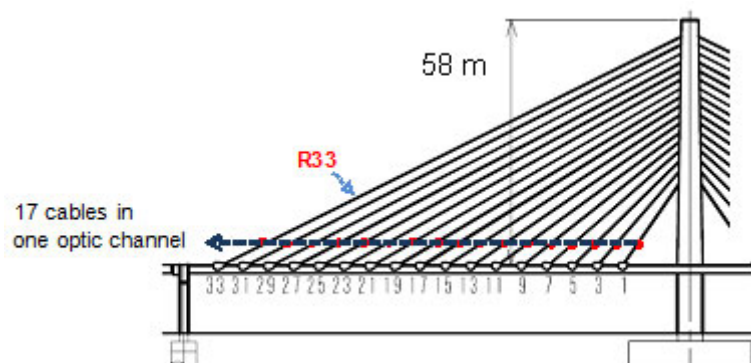
Fig.18 One optic channel measuring 17 cables' vibration

To overcome the difficulties mentioned above, self-assembled FBG vibration sensors are installed on the cables as illustrated in Fig.18. One optic channel measures 17 cables, and only four channels are required for the 68 cables. Through the Internet, the cable vibration spectrum are automatically analyzed and reported back. By this way, all cable forces can be evaluated simultaneously without routine manual labor works. From the measured data, all cable forces are considered to be normal since the bridge's re-opening to the general traffic.
