# **EARTHQUAKE AND TSUNAMI DAMAGE ON STEEL BUILDINGS CAUSED BY THE 2011 TOHOKU JAPAN EARTHQUAKE**

**ABSTRACT:** The 2011 Tohoku Japan earthquake and tsunami caused extensive damage to steel building structures. Large slippage over a large inter-plate fault produced very high tsunami waves that attacked the east coast of Japan. The Committee of Steel Structures of the Architectural Institute of Japan carried out earthquake damage reconnaissance over cities where severe ground shaking was recorded among the prefectures of Miyagi and Fukushima. Tsunami damage reconnaissance was also conducted along the coastlines of Iwate, Miyagi, and Fukushima.

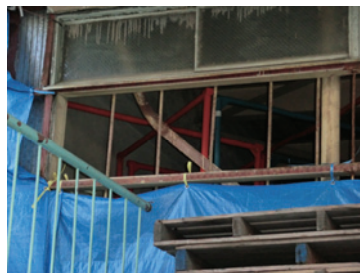
Photo 2 Buckling of double-angle brace (Miyagino, Sendai)

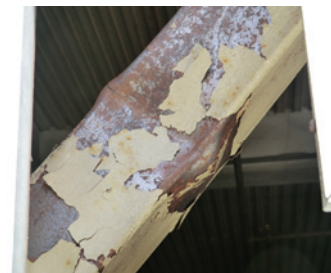
Photo 3 Local buckling in square-HSS brace (Aoba, Sendai)

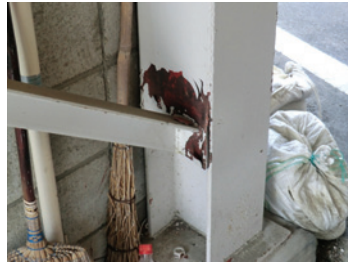
Photo 8 Yielding of column web near bracing connection (Koriyama)

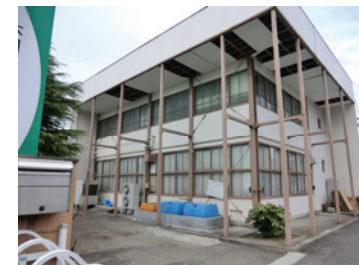
Photo 23 Fallen ceiling on the outside of a building (Wakabayashi, Sendai)

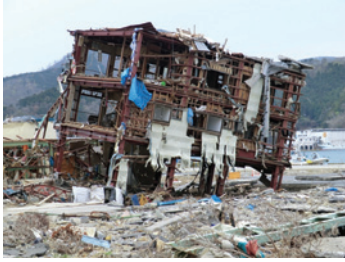
Observations: Residual drift exceeding 1/20. East frame collapsed.

Photo 40 Building A: external view showing large tilt.

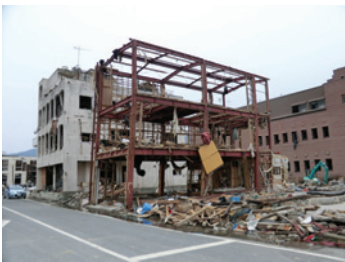
Photo 46 Building D: external view.

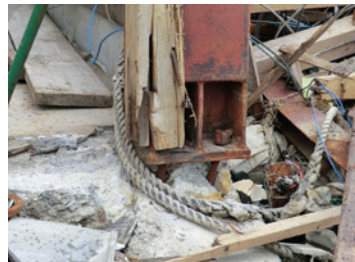
Photo 47 Building D: column base lifted and anchor bolts deformed.

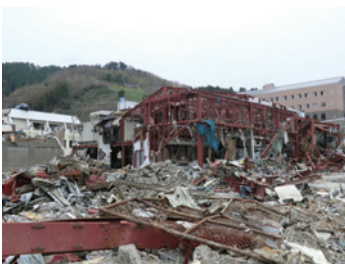
Photo 49 Building E: external view.

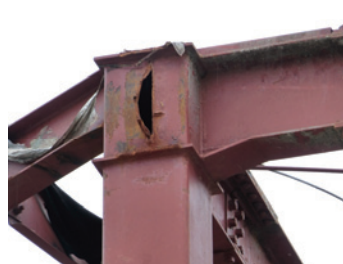
Photo 50 Building E: beam-to-column connection.

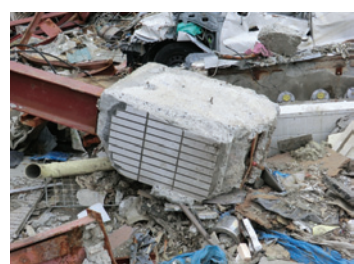
Photo 51 Building E: column base.

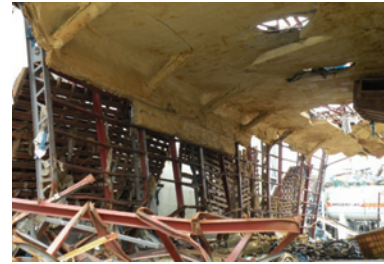
Photo 54 Warehouse A:  
inside view.

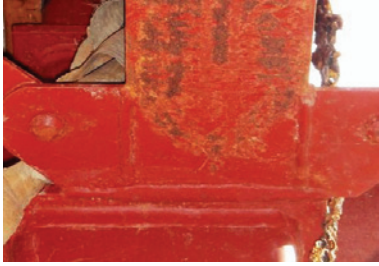
Photo 65 Store A: slight yielding of beam near beam-to-column connection.

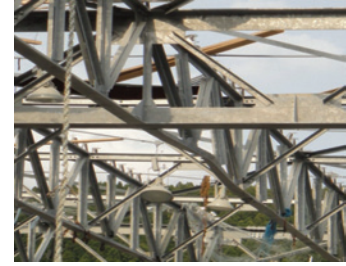
Observations: Wall closest to shore line was pulled toward the shore. Roof truss buckled and collapsed. Anchor bolts in column base fractured. Bolts joining roof truss members fractured. Adjacent 3-story R/C school building completely subsided during tsunami attack.

Photo 67 Factory A: buckled chord members in roof truss.

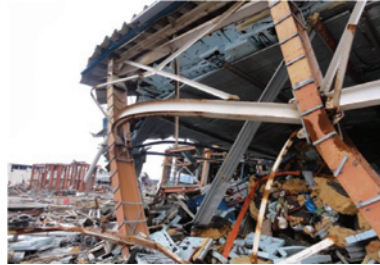
Observations: Collapsed in Y-direction. Yielding in column bases and panel zones and gable frame beams

Photo 72 Warehouse C: deformed columns and beams.

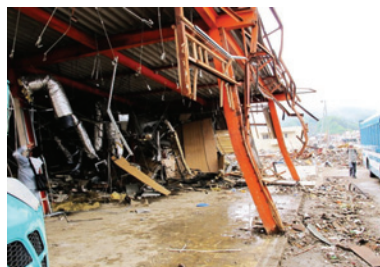
Photo 78 Store C: distorted columns.

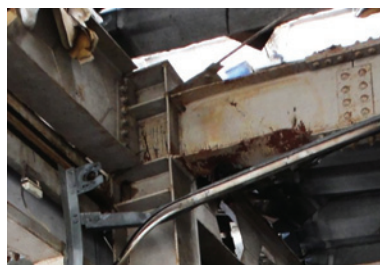
Photo 81 Factory B: yielding in beam-to-column connection.

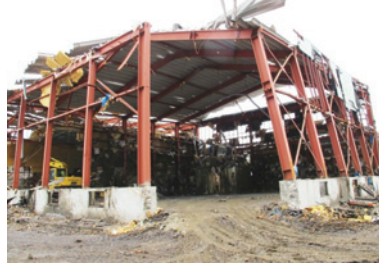
Photo 90 Factory E: cladding washed away.

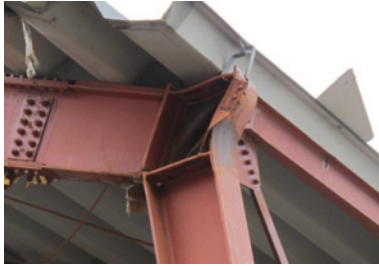
Photo 92 Factory E: large deformation of column panel zone.

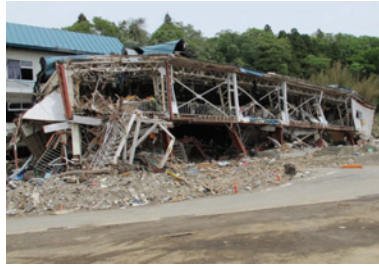
Photo 93 High-school gymnasium B: external view of collapsed building.

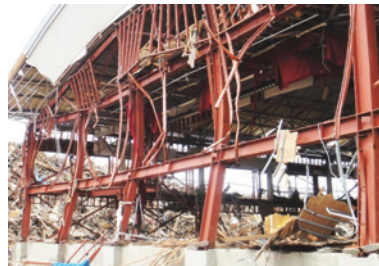
Photo 96 Gymnasium C: severely distorted columns.

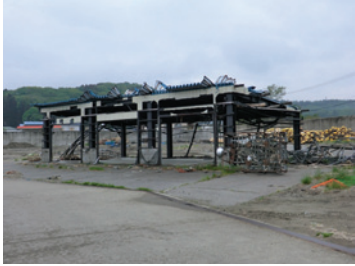
Observations: Internal and external finishes washed away. No residual drift.

Photo 98 Warehouse D: nonstructural elements washed away.

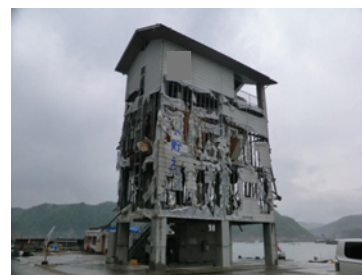
Photo 106 Ice making factory A: exterior view.

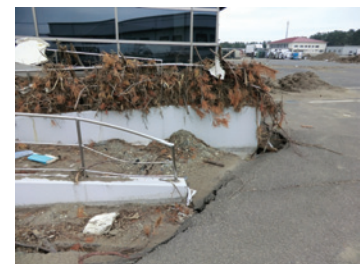
Photo 113 Subsided corner of same building shown in Photo 112 (Iwanuma)
