SEVERAL FEATURES OF LIQUEFACTION-INDUCED DAMAGE TO HOUSES AND BURIED LIFELINES DURING THE 2011 GREAT EAST JAPAN EARTHQUAKE

Susumu YASUDA¹ and Keisuke ISHIKAWA²

ABSTRACT: The 2011 Great East Japan earthquake caused severe liquefaction in Tohoku and Kanto districts. About 27,000 timber houses, a lot of buried sewage pipes and roads were damaged due to liquefaction. In Tokyo Bay area, the very long duration of the main shock and an aftershock 29 minutes later probably induced the severe liquefaction. Sidewalks and alleys buckled at several sites, probably due to a kind of sloshing of liquefied ground. Moreover, much sand boiled from the ground and the ground subsided significantly because the liquefied soils were very fine.

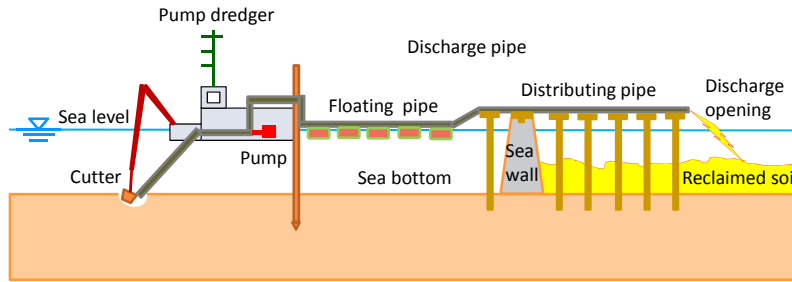
Figure 3 Process of dredging work

the pipe. As the dredged soils contain much water, coarse soil grains and fine soil grains are apt to deposit near the exit and far from the exit, respectively. Moreover the position of the exit moves to various positions, resulting in very non homogeneous strata. After filling with the dredged soils and covered by the hill sands, no soil improvement works were treated except several special areas where sand compaction piles or gravel drain piles and other methods were applied to prevent liquefaction.

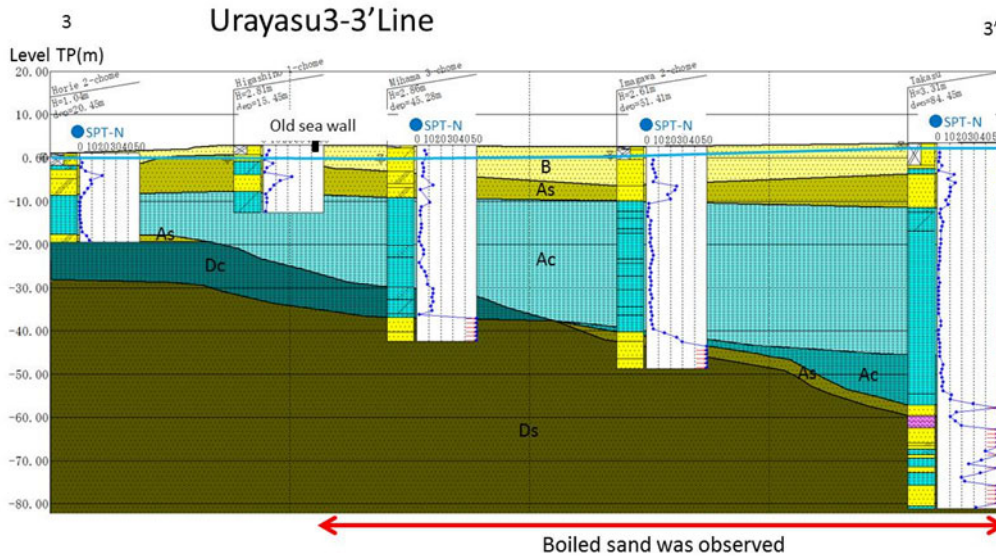
Figure 4 Estimated brief soil cross sections

As three sets of data base had been published by JGS, Chiba Prefecture and Tokyo Metropolitan in the liquefied area, the authors estimated brief soil cross sections along 11 lines which are perpendicular to the shore lines based on these data. Figure 4 illustrate the estimated soil cross sections along a line in Urayasu 3-3' together with the zones where sand boils were observed. The zones where sand boils were observed are exactly coincided with the area of reclaimed land which is the sea side from old sea wall. In the reclaimed zone, a filled layer with mainly hill sand (B) and a filled layer by dredged sandy soil (F) with low SPT *N*-values of 2 to 8 are deposited with a thickness of 6 to 9 m. An alluvial sand layer (A_s) with SPT *N*-values of 10 to 20 underlay with a thickness of 4 to 8 m. A very soft alluvial clay layer (Ac) is deposited under the A_s layer with a thickness of 10 to 40 m, by increasing the thickness towards sea. Diluvial dense sandy layer (Ds) with SPT *N*-value more than 50 underlay. Water table is shallow as GL -0.5 m to -3 m, by decreasing the depth towards sea. On the contrary, in the zone where sand boil was not observed, A_s layer deposited from ground surface. Therefore it can be estimated that the A_s layer basically did not liquefy by the 2011 Great East Japan earthquake though some loose part might liquefy in the reclaimed land, and that some part of the dredged sandy soil under water table might liquefied. Composition of soil layers is similar in other 10 soil cross sections, though thickness of each layer is different.

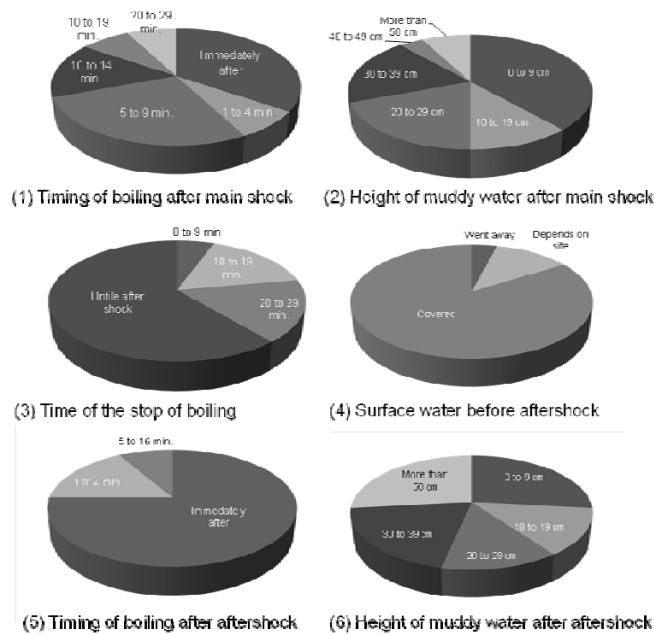
Figure 7 Questionnaires to inhabitants in Irifune

The authors sent out questionnaires to about 30 inhabitants in Irifune district which is also located in Urayasu City to ask the timing of boiling and height of boiled muddy water. Answers are summarized in Figure 7. About 1/3 persons observed the boiling of muddy water immediately after the main shock, however another 1/3 persons recognized the spout of muddy water 5 to 9 minutes after the main shock. Other persons found the muddy water at different timing. Height of the muddy water was not high as

mainly less than 9 cm after the main shock. About 2/3 persons mentioned that the boiling of muddy water continued up to the aftershock, and about 3/4 persons watched covered water until aftershock. On the contrary, about 3/4 persons observed spew out of muddy water just after the aftershock and the height of the water was apparently greater than the height after the main shock. This means the boiling accelerated due to the aftershock and more severe liquefaction occurred during aftershock at some sites. Question on the timing of the settlement of houses must be difficult to answer for inhabitants, however, a 1/3 persons and another 1/3 persons answered that the settlement of their houses was zero and 10 to 19 cm, respectively after the main shock. And, many inhabitants recognized the settlement on the next day. According to the hearing in Imagawa district some inhabitants testified boiling did not occur during main shock but occurred during aftershock.

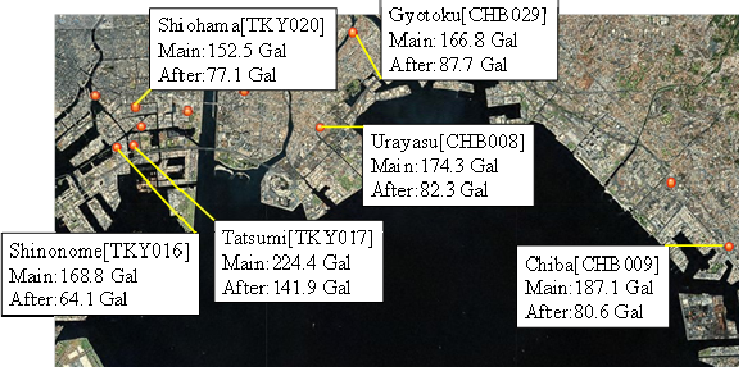
Figure 8 shows ground surface accelerations during the main shock and the aftershock. Surface accelerations were not high as around 160 cm/s² to 230 cm/s² though severe liquefaction occurred. The accelerograph recorded at K-NET Inage in Chiba where actually boiled sand was observed, is very important because liquefied time can be judged from the recorded waves. Figure 9 shows the accelerograph at Inage together with that at K-NET Urayasu which was recorded on the ground in where liquefaction did not occur. Both records started almost same time; 14:46:16 at Inage and 14:46:15 at Urayasu. In Urayasu’s wave frequency did not change drastically after the peak acceleration which induced at about 118 sec. (14:48:13). On the contrary frequency changed to low value after two peaks at 120 sec. (14:48:16) and 126 sec. (14:48:22). Therefore it can be judged liquefaction occurred at around

Figure 8 Comparison of accelerations during main and aftershocks by K-NET

One more impact to the ground must be the shaking during the aftershock. Peak accelerations during the aftershock were almost a half of those during the main shock in Tokyo Bay area as shown in Figure 8. Even though, as mentioned above, boiling occurred after the aftershock at some site. Therefore, major reason of the severe liquefaction must be the effect of long duration of shaking during main shock and an aftershock. The authors tried to conduct cyclic torsional shear tests and some simple analyses to evaluate the effect of the long shaking on the occurrence of liquefaction. Two types of shear wave were applied to specimen, sine wave of 20 cycles and the seismic wave recorded during main shock and after shock at Urayasu K-NET. In case of seismic wave, excess pore water pressure increased gradually with shear stress as illustrate in Figure 10. Then, relationships between stress ratio R (τ_d / σ') for sine wave or R_{max} (τ_{max} / σ') for seismic wave and residual excess pore water pressure u/σ_c' are plotted in Figure

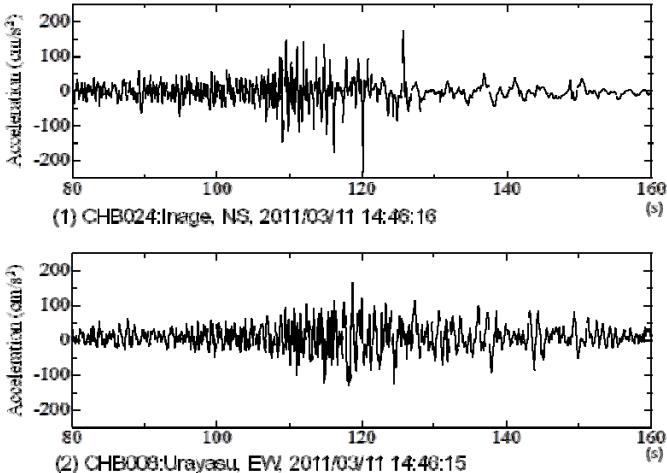
Figure 9 Comparison of accelerographs recorded at K-NET Inage and Urayasu

14:48:16 to 14:48:22 at K-NET Inage. This means many cycles of shear stress, say around 20 cycles from 110 sec. might cause liquefaction at K-NET Inage site. And it must be noted shaking still continued for long time after the occurrence of liquefaction. By referring to the accelerograph at K-NET Urayasu, shake of the ground at Inage continued for about 3 minutes after liquefied.

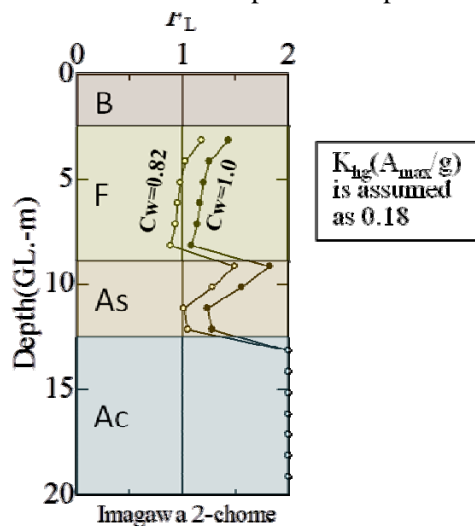
Figure 12 Analyzed F_L at Imagawa 2-chome Urayasu City

11. As $R=0.27$ for $u/\sigma'_c=1.0$ and $R_{max}=0.31$ for $u/\sigma'_c=1.0$, the correction factor C_w by JRA standard (2002) becomes 0.82. Then safety factor against liquefaction F_L and liquefaction potential P_L were evaluated for every boring data used for the estimation of 11 brief soil cross section, under the conditions of $C_w=0.82$ and 1.0. In the estimation, R_L was estimated from SPT N-values and F_c , by using the proposed formula by the technical committee of Urayasu City. Figure 12 shows evaluated F_L values for a boring data in Urayasu where liquefaction occurred. If the C_w is assumed as 1.0, all F_L are estimated greater than 1.0 whereas F_L are less than if C_w is assumed as 0.82. Figure 13 compares P_L for all boring data under the assumption of $C_w=0.82$ and $C_w=1.0$. If $C_w=0.82$, P_L for liquefied sites are calculated as greater than about 10 and severity of liquefaction can be demonstrated.

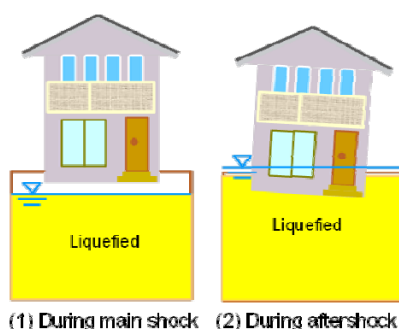
Figure 14 Possible effect of aftershock on the settlement of house

As mentioned above, occurrence of liquefaction must be affected by the aftershock. Not only the occurrence of liquefaction but also the settlement and inclination must be affected by the aftershock. Ground water table increased after the main shock and boiled muddy water covered the ground surface until the aftershock at many sites. Then, settlement of houses is excitable during the aftershock though shaking amplitude was less than that during the main shock as schematically shown in Figure 14.

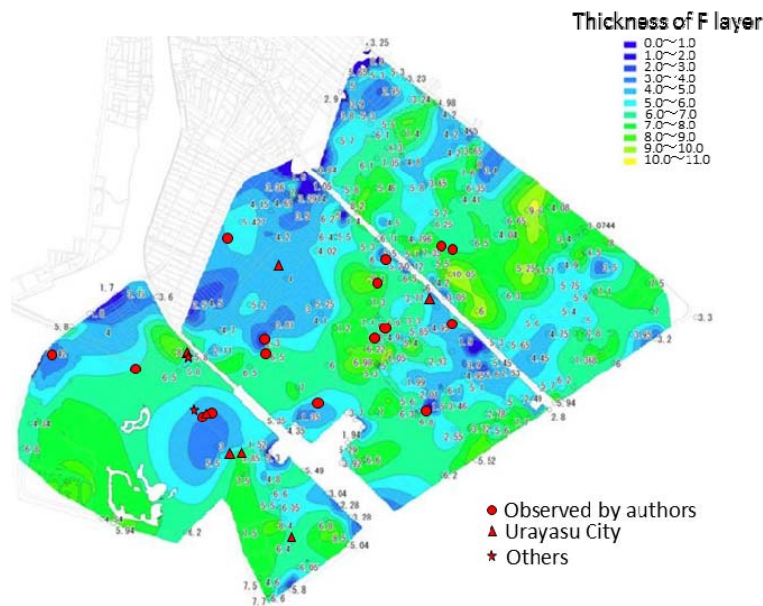
Miracle phenomena, heaving, buckling or thrust were observed at several footways and alleys as shown in Photo 3 at many sites in Tokyo Bay area. Some thrust might occur at the boundaries due to a kind of sloshing of liquefied ground as schematically shown in Figure 15 (1), because shaking continued for long time after the occurrence of liquefaction. Figure 16 shows heaved footways or alleys in Urayasu City together with contour lines of the thickness of the F layer under the ground water table. It may be said that the heaving occurred at the sites where the bottoms of the F layer, in other word liquefied layer,

Figure 16 Heaved footways or alleys in Urayasu City together with contour lines of the thickness of the F layer under the ground water table (Contour lines are quoted from research materials (2011))

are sloped. This implies that a kind of horizontal buckling of surface layer might occurred due to the concentration of horizontal compressive stress as schematically shown in Figure 15 (2). However, more studies are necessary on the mechanism of the buckling.

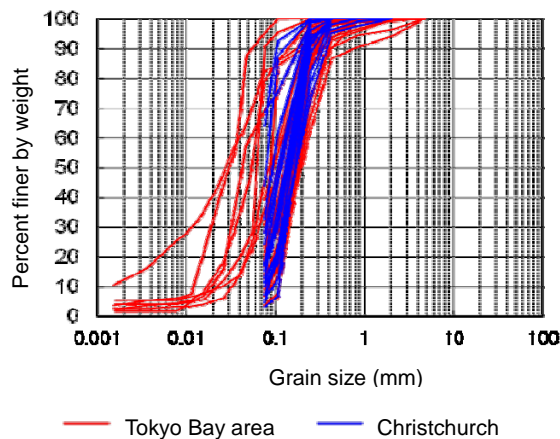
Figure 18 Comparison of grain size distribution curves of boiled sands in Tokyo and Christchurch

Much eruption of sands and large ground subsidence occurred in the liquefied area. The maximum thickness of the erupted sand and the maximum ground subsidence observed by the authors were about 30 cm and 50 cm, respectively. This is the first experience for the authors to see such thick deposited boiled sand in Japan. However, one of the authors had seen similar much eruption and large subsidence in Christchurch during the main shock on September 2010 and aftershock on February 2011. Figure 18 compares grain size distribution curves of erupted soils in Christchurch during the main shock with those in Tokyo Bay during this earthquake. Fines contents for Christchurch and Tokyo Bay are similar. Then it is estimated that in the very fine sands, ejection of water continues for long time because of low permeability of liquefied soils in both area. Moreover fine soil particles are easy to uplift above the ground surface by the ejecting water. And the removal of the deposited soils by inhabitants accelerated the settlement of the ground surface.
