THE DAMAGE OF SEWAGE TREATMENT SYSTEMS CAUSED BY THE GREAT EAST JAPAN EARTHQUAKE

Manabu MATSUHASHI¹, Wataru FUKATANI², Toshihiro YOKOTA³, Masaaki OZAKI⁴, and Nobuyuki HORIE⁵

¹Research Engineer, Department of Water Quality Control, National Institute for Land and Infrastructure Management, (NILIM), Ministry of Land, Infrastructure, Transport and Tourism (MLIT), Tsukuba, Japan, matsuhashi-m92ta@nilim.go.jp

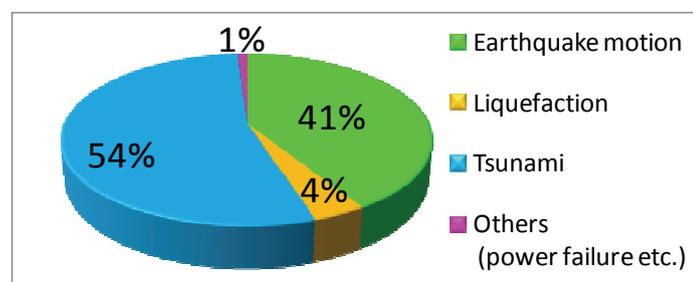
The percentages of damage by cause of damage at individual facilities inside sewage treatment plants (divided into 23 facilities) (Fig. 2), were 54% caused by tsunami, followed by 41% by earthquake motion, and 4% by liquefaction.

Figure 2. Causes of Damage to Sewage Treatment Plants

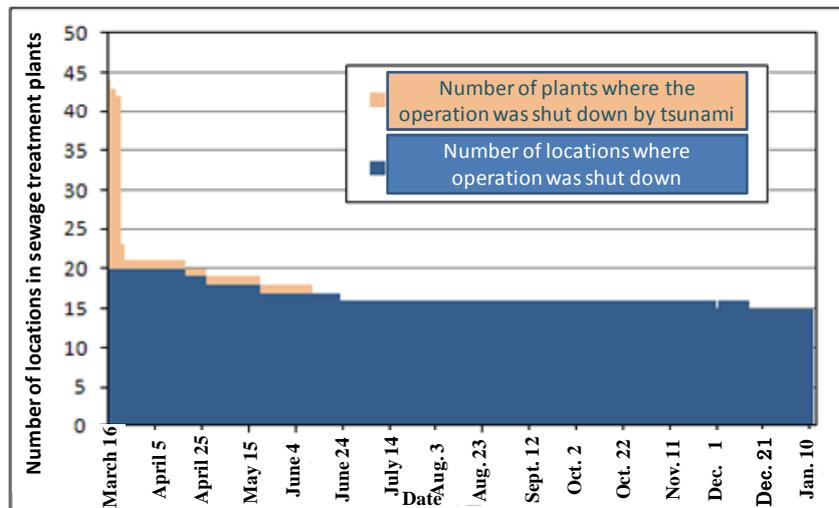
Figure 7 shows change over time of the number of sewage treatment plants which were shut down. At the time of the disaster, 48 sewage treatment plants were shut down (tsunami was the cause at 20 of these).

However, at 20 sewage treatment plants damaged by tsunami, while restoration activities were obstructed by fatal damage to entire facilities and by rubble etc., in order to prevent untreated water from flowing into city streets and conserve public waters, beginning about three and one-half months

after the earthquake, the plants began to perform simple treatment such as precipitation or sterilization, and on January 12 this year, emergency restoration work has been completed at all sewage treatment plants receiving inflowing polluted water. But it is predicted that it will take about two years to return these plants to normal operation, and it is believed necessary to take tsunami-resistance measures at sewage treatment facilities in the future.

Figure 7. Change Over Time of the State of Operation of Treatment Plants by Cause of Damage

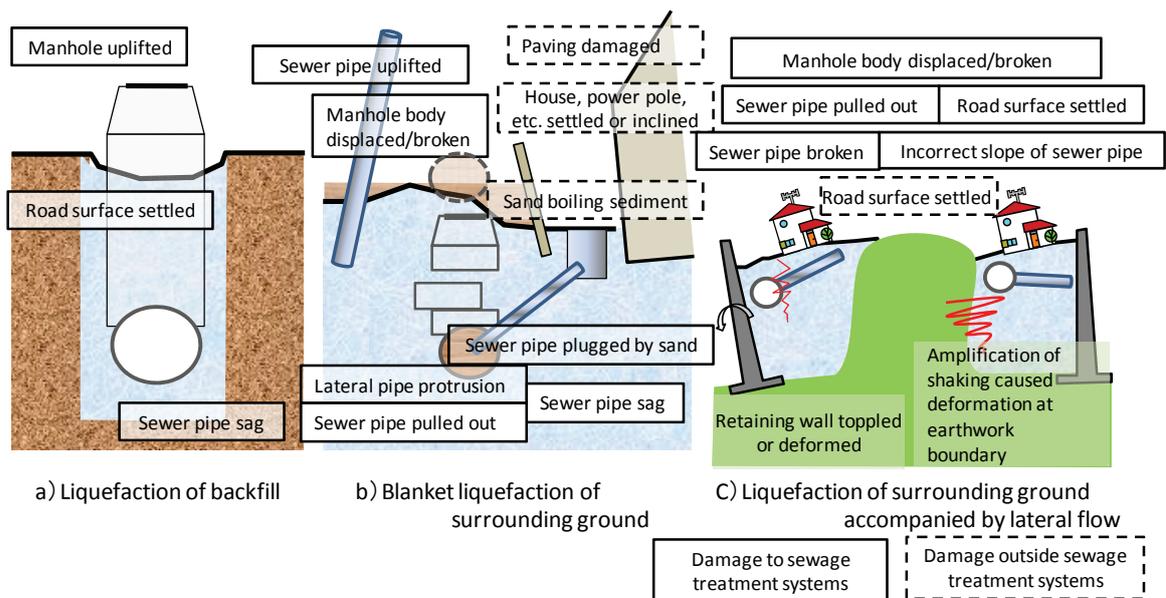
Figure 8. Categorization of Causes of Damage to Sewage Treatment Systems

Case where only the backfill of sewer pipe facilities liquefied (a in Fig. 8)

Case where the surrounding ground entirely including the backfill liquefied (b in Fig. 8)

Case where lateral flow was caused by liquefaction etc., including the surrounding ground (c in Fig. 8).
