EFFECTS OF LOCAL SITE CONDITIONS ON LIQUEFACTION DAMAGE IN MIHAMA WARD OF CHIBA CITY

Toru SEKIGUCHI¹ and Shoichi NAKAI²

ABSTRACT: The distribution of liquefaction damage in Mihama ward of Chiba city during the 2011 Great East Japan earthquake was investigated by conducting an exhaustive search for all the public roads and parks immediately after the earthquake. The effects of local site conditions on the damage distribution in the region were examined based on the research, microtremor measurements, the boring logs and the aerial photography.

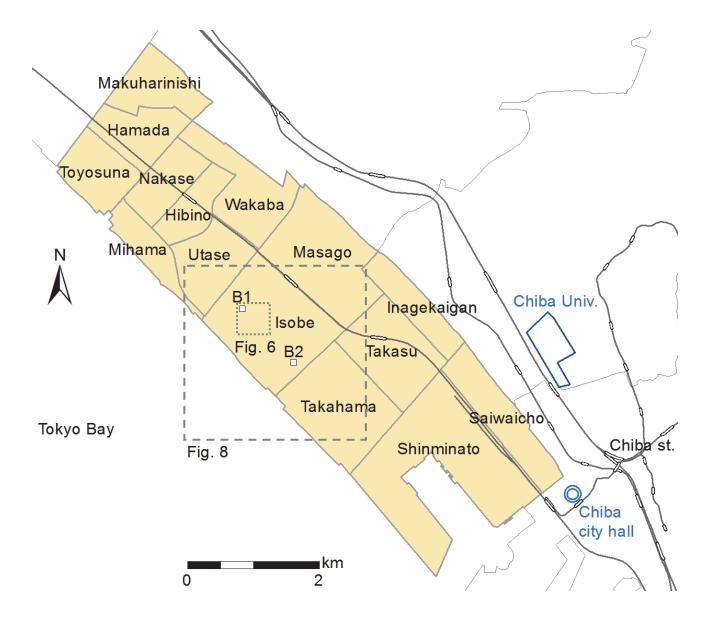
Fig. 1 Map of Mihama ward, Chiba city

Fig. 1 shows the map of Mihama ward with the districts. Mihama ward is located in the western part

At the districts of Nakase, Hibino, Takasu and Takahama where heavy sand boiling was found, the basement depth of alluvial deposit is deep and the districts are on the valley which is accumulated by thick alluvial deposit. The districts of the northern part of Isobe and the western part of Shinminato where heavy sand boiling was also found are, however, situated on the ridge in the old times presently covered with thin alluvial deposit.
