# INVESTIGATION OF NATURAL FREQUENCY REDUCTION MECHANISM OF A HISTORIC MASONRY BUILDING IN PATAN FOLLOWING THE 2015 GORKHA EARTHQUAKE IN NEPAL

**ABSTRACT:** On April 25, 2015, Gorkha earthquake occurred about 80 km northwest of Kathmandu. In Patan, masonry structures collapsed in Durbar Square. The two-story masonry building that is the subject of this study, is about a 5-minute walk from Durbar Square. Although the building did not collapse, cracks were confirmed in several places. Microtremor measurements performed before and after the earthquake revealed that the natural frequencies of the building decreased. This study examined the factors that decrease the natural frequencies of buildings by seismic response analysis using ground motion estimated by the H/V spectrum ratio as input.

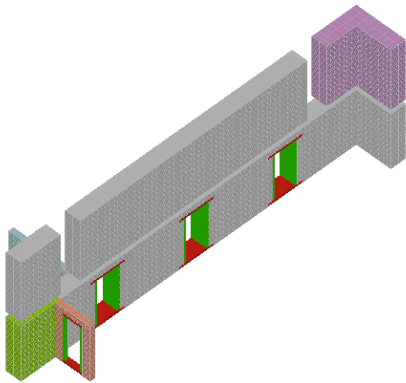
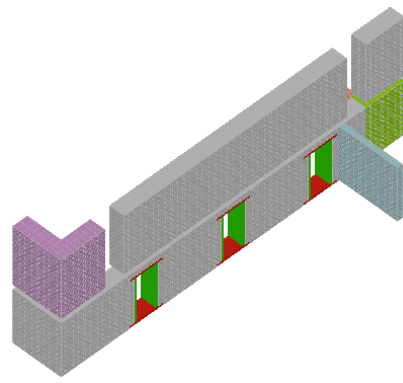
which is used as a warehouse. The thin wall was modeled as 20 cm thick. Cracks have been identified at both ends of this thin wall (D1 and D2 in Fig. 2(a)). In the north-west side of the first floor, there is a thin wall connecting the inner wall and the western wall, and the thin wall was modeled as 20 cm thick (The thin wall is modeled with pink brick elements and the door frame is modeled with green and red timber elements.). A crack (D3 in Fig. 2(a)) is observed at the joints between the thin wall (light purple) and the inner wall (gray) as described before. As described later, the gray and yellowish green elements are color-coded to represent the crack of D3 generated at the boundary between the gray and yellowish green elements.

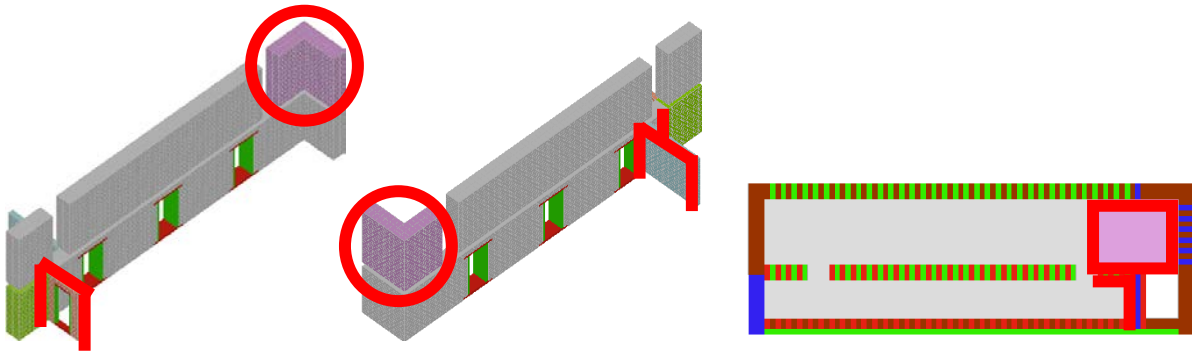
Fig. 12 The areas where failure occurrence is allowed for Analysis Model B (the area indicated by a thick red line and the area surrounded by thick red circles and a square)

- Both ends and the upper end of the first-floor pink inner wall shown in Fig. 12 (a) (both ends (shown by the green circle ●) and the upper end of the pink wall in Fig. 2)
