EMBANKMENT MATERIAL CHARACTERISTICS AT AGRICULTURAL RESERVOIR DAMAGED BY THE 1983 MIDDLE JAPAN SEA EARTHQUAKE IN AOMORI PREFECTURE

Hiroshi MORI¹ and Toshiki ASAKURA²

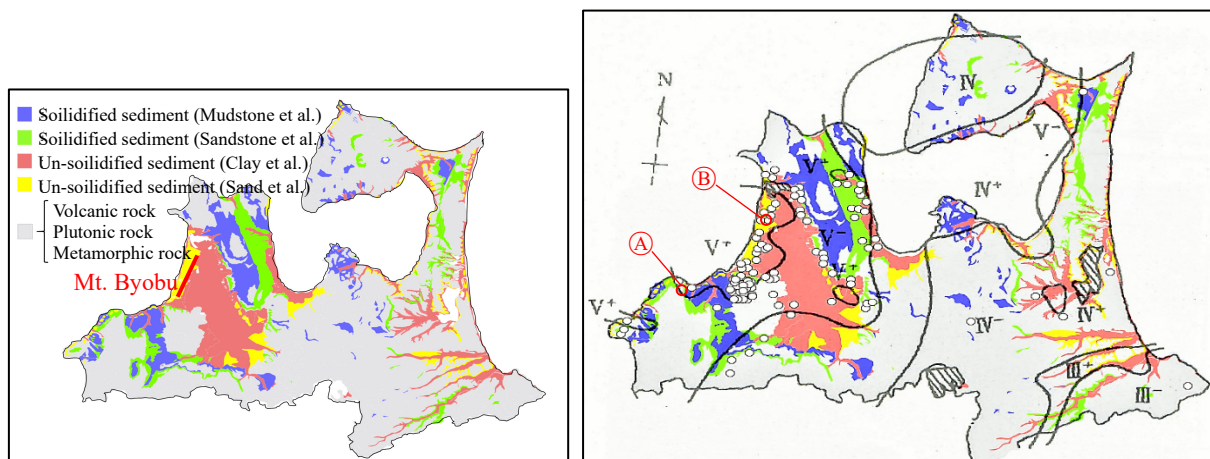
Fig. 2 Ground surface geological classification map [Reference 6) with partial revision]

Figure 2 shows a ground surface geological classification map in Aomori Prefecture. The un-solidified sediment of an alluvium in the northwestern region with Iwaki River flowing through the Tsugaru Plain, the sand-fill area between Mt. Byobu on the western side of the Tsugaru Plain and the Sea of Japan and the volcanic rock sediment including loam and pumice on the eastern side with many rivers flowing into the Pacific Ocean, are accumulated.

Figure 3 shows the presumed seismic intensity distribution⁷⁾ and damage distribution map of agricultural reservoirs⁸⁾ on a ground surface geological classification map shown in Fig. 2 in the 1983 Middle Japan Sea Earthquake. It indicates the seismic intensity $V^- - V^+$ at the Tsugaru Plain area stretch

and shows that about 70% of damaged agricultural reservoirs are distributed throughout the northwestern region. It particularly shows the seismic intensity V^+ at the sand-fill area between Mt. Byobu on the western side of the Tsugaru Plain and the Sea of Japan. The damaged agricultural reservoirs around the sand-hill area tended to be concentrated. Consequently, influences of the surrounding topography and geological condition including the strength of seismic intensity, might be related to the damage factor sustained by agricultural reservoirs.

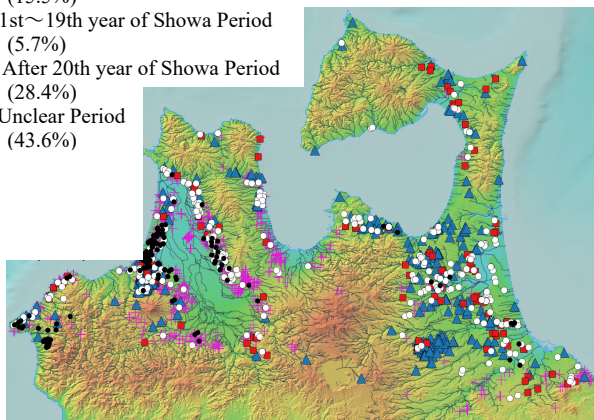
Fig. 6 Construction age distribution map [Reference 10) with partial revision]

Figure 6 shows a construction age distribution map of agricultural reservoirs as a percentage of the number of all reservoirs. Because approximately half of these data were unclear (+), we assumed these data to be old and that the reservoirs would not be in operation. In fact, agricultural reservoirs constructed before the Edo Period (●) including the Unclear Period (+) were numerous in the northwestern region of Tsugaru area. However, new agricultural reservoirs (○ • ■ • ▲) constructed after the Meiji Period are distributed widely throughout the eastern region facing the Pacific Ocean. After development of new paddy fields in the early stage started at an alluvial plain (Tsugaru Plain) with the Iwaki River, it might be inferred that the plowed-land development in the eastern region advanced with modern construction technology and widening influence of farm machinery to enter the Meiji Period. A change was apparent in the development of a new paddy field in Aomori Prefecture¹¹⁾.

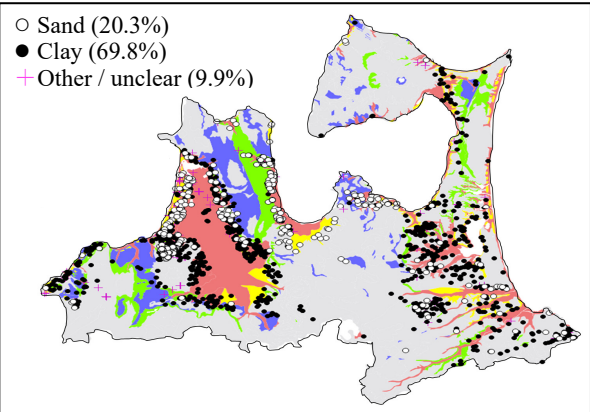
Fig. 8 Embankment material distribution map [Reference 6] with partial revision]

Figure 8 shows an embankment material distribution map of agricultural reservoirs as a percentage to the total number of reservoirs on the ground surface geological classification map indicated in Fig. 2. Agricultural reservoirs with clay embankment material (●) are distributed widely throughout all of Aomori Prefecture, but agricultural reservoirs with sand embankment material (○) are distributed widely throughout the northwestern region and done in the sand-fill area in the Sea of Japan side of the Tsugaru Plain and sandstone facing Mutsu Bay. Furthermore, agricultural reservoirs with sand embankment material account for about 20% of the whole. The possibility of damage exists at those places even when examined based on a seismic hazard of the past^{5),9)}.

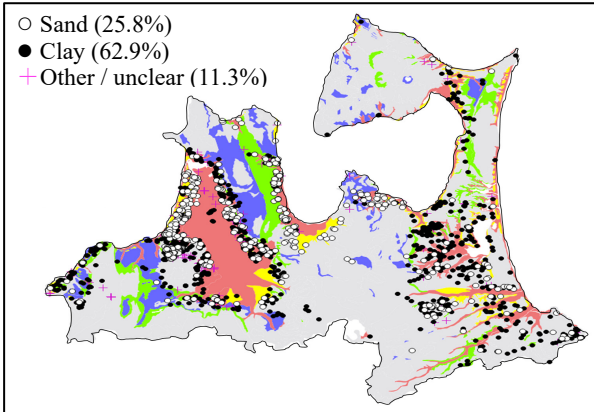
Fig. 9 Foundation ground material distribution map [Reference 6] with partial revision]

Figure 9 shows a foundation ground material distribution map of agricultural reservoirs by the percentage to the number of total reservoirs on the ground surface geological classification map indicated in Fig. 2. Although high-precision investigation is difficult to conduct according to the foundation ground material of agricultural reservoirs, it is often almost the same material as the embankment material in comparing with Fig. 8. Much of the embankment material had probably been used as foundation ground material around the agricultural reservoirs. Therefore, as foundation ground materials of agricultural reservoirs with sand embankment materials might consist of sandy sediment by a high probability, there would be fear of influence of liquefaction of foundation ground materials from now on.

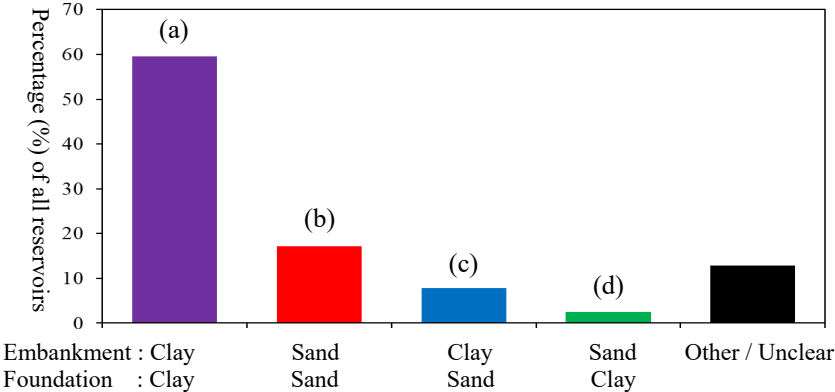
Fig. 10 Each material combination with the embankment and foundation ground

Figure 10 shows each material combination with the embankment material (sand or clay) and foundation ground material (sand or clay) as a percentage of all reservoirs. Although the material combination (a) by which both the embankment material and foundation ground material are clay is about 60%, the material combination (b) with sand–sand is also about 17%. Investigation of these combination percentages in other prefectures from basic documents must be done to elucidate the leakage damage occurrence attributable to embankment materials and to assess liquefaction damage exacerbated by the foundation ground material.

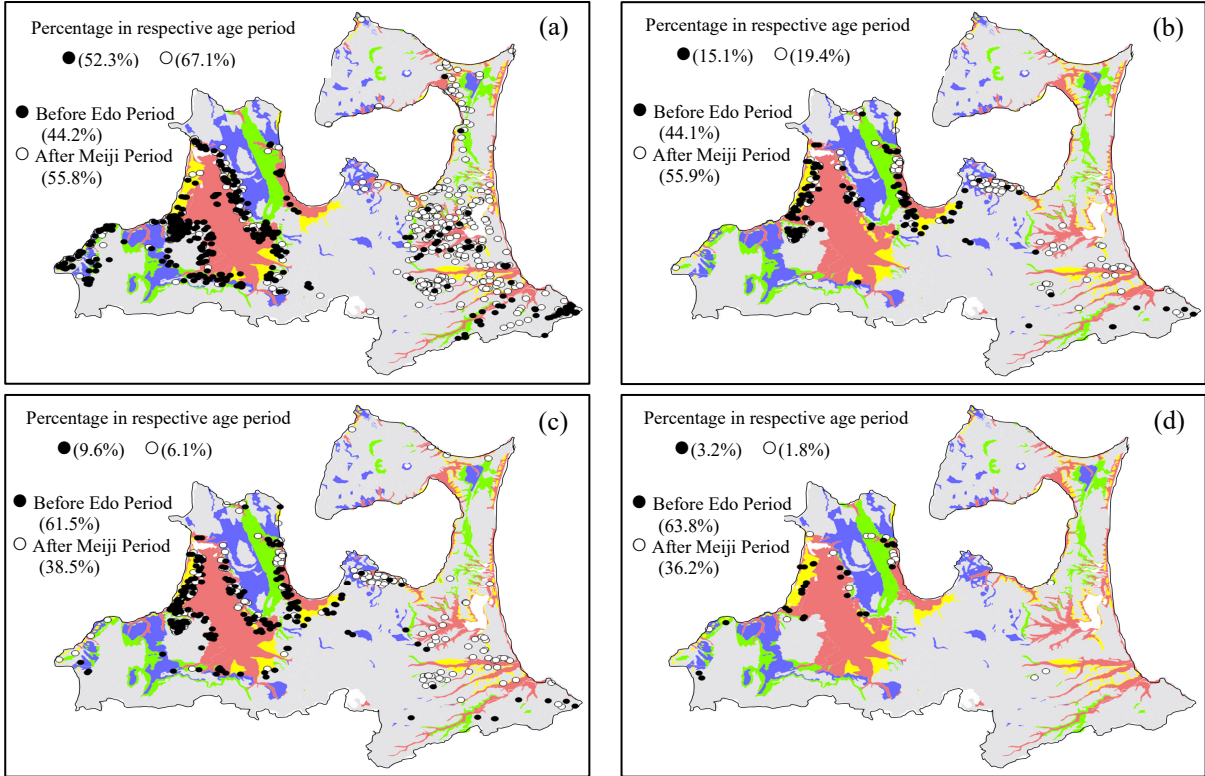
Fig. 11 Construction age distribution map of each material combination [Reference 6) with partial revision]

Figure 11 shows the construction age distribution maps of each material combination as a percentage of all agricultural reservoirs, and the percentages of the respective material combinations in respective age periods are also indicated in Fig. 11. In Fig. 11(a) indicating the clay–clay material combination of embankment material and foundation ground material, many agricultural reservoirs

constructed before the Edo Period (●) including the unclear period are situated in western regions, and reservoirs constructed after the Meiji Period (○) are widely distributed throughout the eastern region. In Fig. 11(b) indicating the sand–sand material combination of embankment material and foundation ground material, the agricultural reservoirs constructed both before the Edo Period and after the Meiji Period are situated around the Tsugaru Plain in the northwestern region, and the percentage (about 15%) of agricultural reservoirs constructed only in this age before the Edo Period was lower than that (about 19%) after the Meiji Period in this only age after the Meiji Period. In Fig. 11(c) indicating the clay–sand material combination of embankment material and foundation ground material, the percentage (about 10%) of reservoirs constructed only in this age before the Edo Period is large in being different from other cases except for Fig. 11(d) which the number of reservoirs is few, and these reservoirs are around the Tsugaru Plain in the western region. Because the foundation ground material was not actually investigated and recorded in the agricultural reservoir ledger, it was often judged from the surrounding topography and geotechnical conditions. The recognition of safety for leakage prevention to reservoirs constructed the embankment using the clay soil before the modern age, however, would be higher than we expected, even if the surrounding ground was the sandy soil material. The number of embankment materials in Fig. 11(d) constructed by sandy soil with a possibility of the leakage is usually small, although the foundation ground material is clay. Consequently, because it is generally easy for fill material to treat sandy soil, the percentage of reservoirs constructed before the Edo Period scarcely shows high technical capabilities of civil engineering works.
