Quick damage survey after the 2011 off the coast of  
Fukushima Earthquake (M 7.3)

Takashi KIYOTA, Masataka SHIGA  
Institute of Industrial Science, University of Tokyo

# Survey area (16<sup>th</sup> Feb., three days after the earthquake)

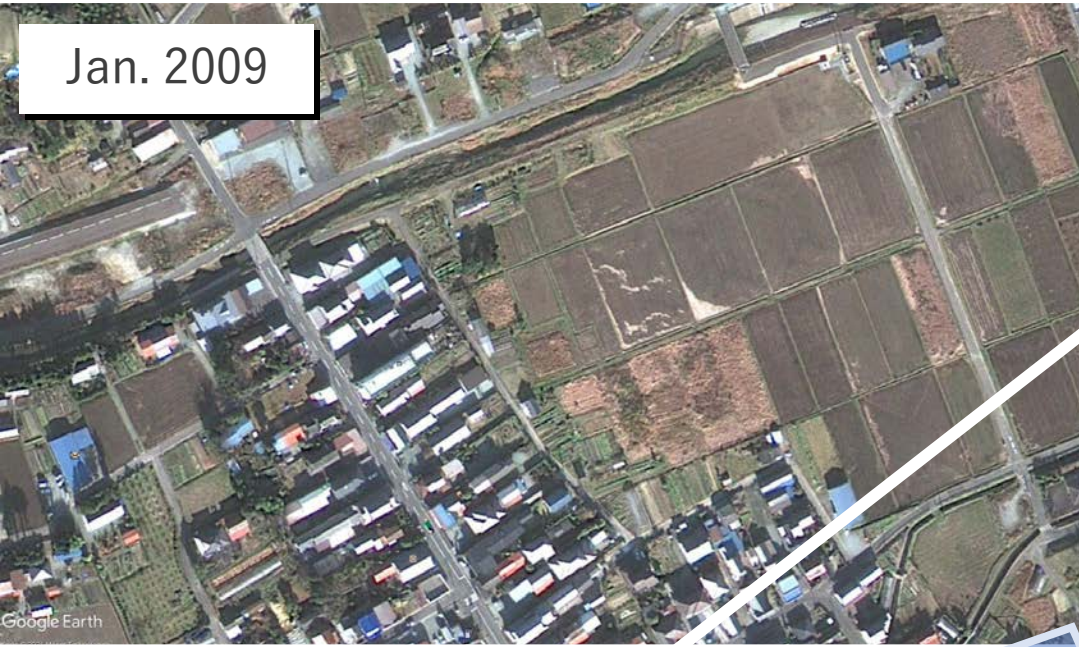
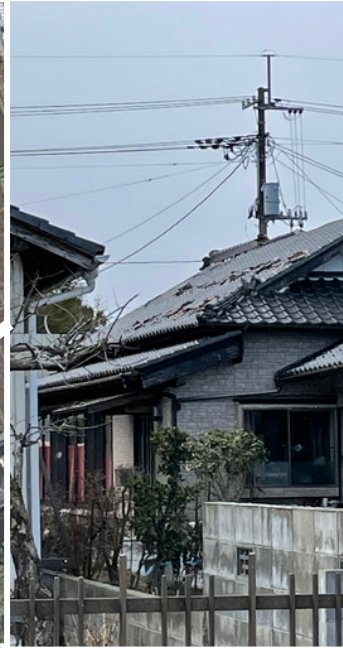
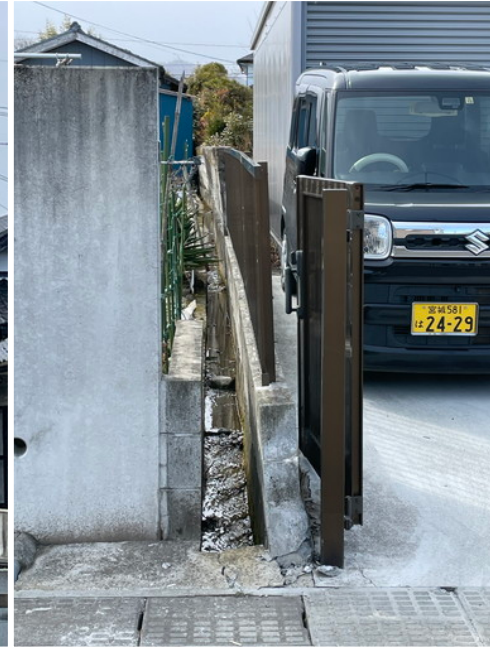
Jan. 2009

- The branch office opened in February 2015 and was built on reclaimed land that was once paddy field (see next page).
- Damage to block paving due to ground subsidence around the building. Liquefaction-induced sand ejecta was also confirmed.
- Cracks were found in the road and residential property in the reclaimed land.
