# LIDAR MEASUREMENT OF THE BREACHED EARTH-FILL DAM IN THE MARCH 11<sup>th</sup> GREAT EAST JAPAN EARTHQUAKE

**ABSTRACT:** Fujinuma dam, an earth-fill dam for irrigation located in Sukagawa City, Fukushima prefecture, was breached in the March 11<sup>th</sup> Great East Japan Earthquake. The debris mass from the breached dam flushed a village lying its downstream leaving 8 dead and 1 missing. The authors made a survey along the stream channel of the debris flow. During their survey, the breached dam body was LiDAR surveyed for its entire 3D image. With the findings from the survey, this paper discusses a possible mechanism of dam breaching.

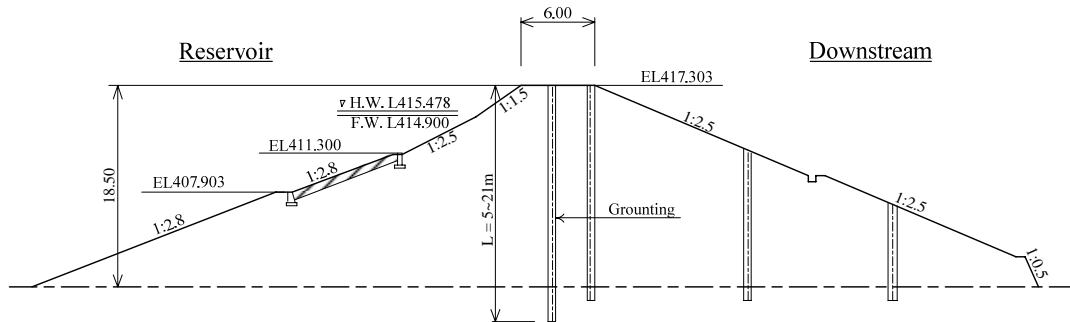
Fig. 3 Cross section of original large dam body

Fig. 3 shows the original cross section of the large dam. The large dam is 6 meters wide at its crest, 133 meters long with upstream surface concrete-block-faced. Photo 2 and 3 show the breached large dam body (Height 18.5m, Length 133m, Volume 99,000m<sup>3</sup>) from right and left abutments, respectively. The middle to right part of the dam body was scoured deep by the overtopped water. A clear laminar structure was seen on the exposed interior of the dam body. Dark-colored mudstone was exposed on the scoured abutment. 20 to 30 cm-thick Ignimbrite sand layers were also found bedding horizontally in the exposed dam body (See Photo 2) indicating that the dam body was constructed by compacting ignimbrite sand. The slide may have been followed by the subsidence of the entire dam body and thus water-overtopping.

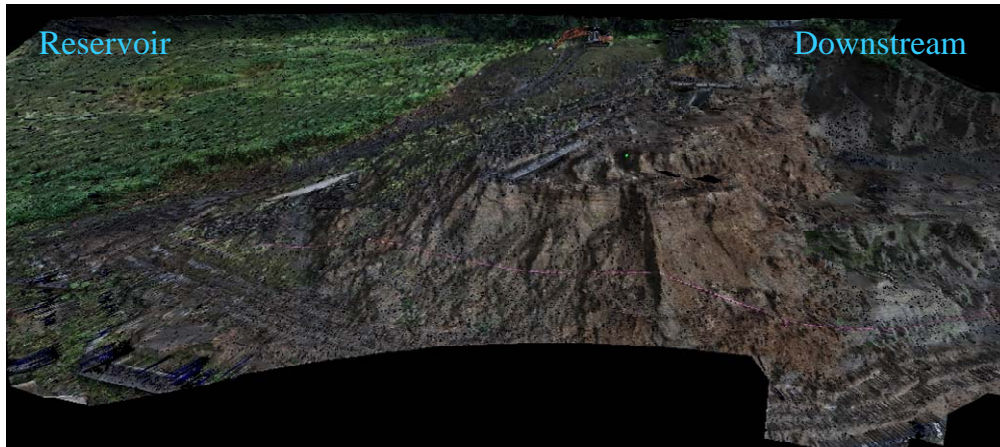
Fig. 4 3D image of the breached dam body using LPM-321

The breached dam body was LiDAR surveyed for its entire 3D image using the laser profile measuring system LPM-321 (See Photo 9). LPM-321 is based on the time-of-flight measurement of short laser pulse. It covers 6000m distance without reflector (@ Laser class 1M), with a wide view filed of 150° x 360°, an expected maximum error of 25mm and measurement rate of maximum 1000 points / sec. Using a high resolution digital camera along with it, a RGB color image can be obtained for all laser-shot points. The authors conducted a LiDAR survey on August 21<sup>th</sup>. The dam body was laser-scanned from three different locations: two are on the right abutment; then one on the left abutment. And then, 3D digital surface models were combined for the 3D LiDAR image of the entire dam body. Fig.4 shows the obtained 3D image of dam body from the right abutment.
