# DAMAGE SURVEY ON BUILDINGS AND THE LESSONS FROM THE 2011 EAST JAPAN EARTHQUAKE

## Toshimi KABEYASAWA

**ABSTRACT**: Damage survey on buildings is outlined, which was conducted as a part of reconnaissance activity of AIJ, Architectural Institute of Japan after the 2011 East Japan Earthquake. Typical types and levels of damages to building structures are classified, both by the ground motions and the tsunami waves, based on the field observation data on buildings in the affected regions. The damage rates in the selected area are analyzed and discussed based on the statistical data of the inventory damage rates, as well as in relation with calculated seismic performance indices.

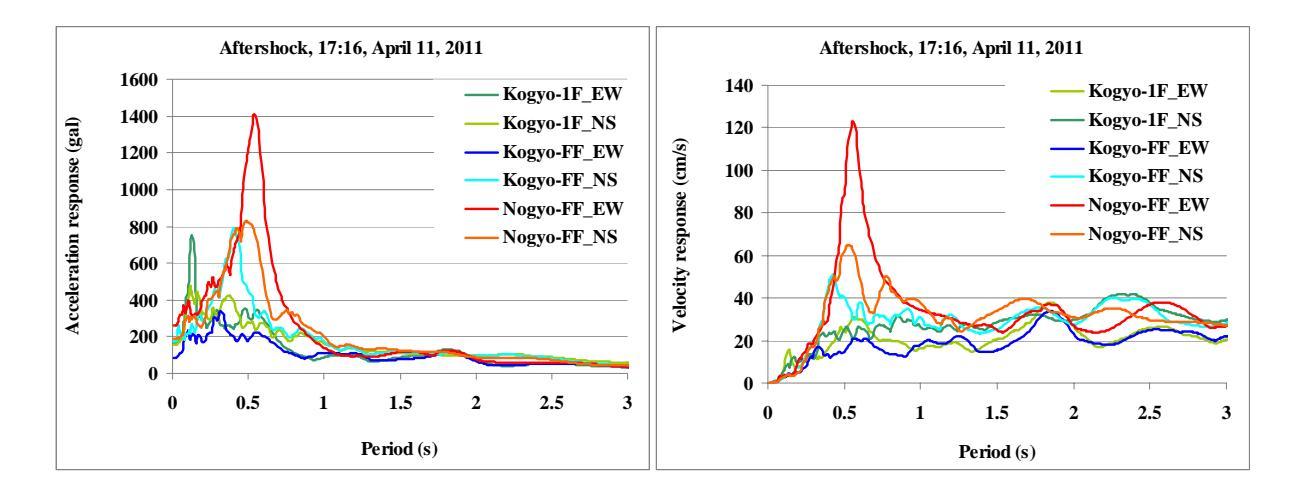
Fig. 6 Response spectra of aftershocks at the sites at the top and the bottom of the hill

The aftershock observations were also spread out at various sites after the 2011 earthquake in parallel with the damage survey with the same objectives. The detailed results will be reported elsewhere, while an example of the results is shown in Fig. 6 for the site of I-high school described as above, where the acceleration and velocity response spectrum of the aftershocks recorded at the top of the hill(Nogyo) and the bottom of the hill(Kogyo) on April 11 are compared in the figure. It was obvious that the response spectrum at around of the period of 0.6 second was much amplified at the hill top, especially in EW component by several times. Although the ratio of the main shock might have been smaller than in case of aftershock for due to the non-linear soil responses, it would be necessary to take the local site amplification into account, such as by 1.5 or 2.0 times, if the new buildings are to be designed and constructed in the rehabilitation procedure.

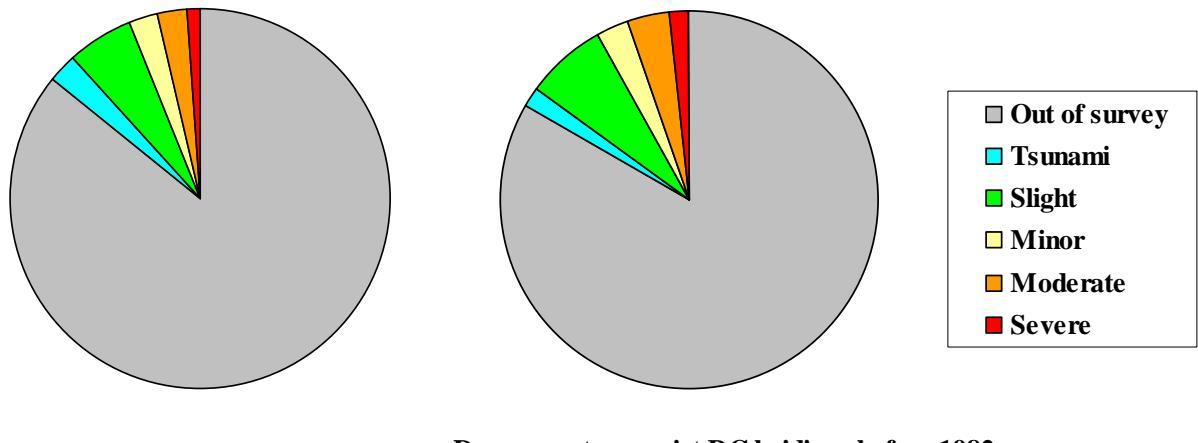
Fig. 7 Inventory damage rates for all prefecture school buildings

The ratio of minor to severe damages in total, where the buildings were basically not functional in use, was about 6% to total and 8% to the buildings before 1982. Because these are is based with a parameter including Aizu and Soso, therefore if the two regions are excluded from the parameter, then the ratios are 8% and 12% respectively. As for the buildings classified into the grade of severe, which were to be demolished and rebuilt rather than repaired, the ratios were 1.1% to total, 1.6% to pre-1982, 1.5% to those without Aizu and Soso, 2.2% to pre-1982 without Aizu and Soso. Considering the intensities of the ground motions were close to the very rare level of BSL, level 2, in most regions, it may be concluded that these damage rates were satisfactorily low. This was partially owing to the seismic strengthening of school buildings, although it had been behind in Fukushima prefecture, which will be discussed later in this paper. Other reasons also lie in discrepancy with the standard requirement of seismic evaluation and the actual response behavior.

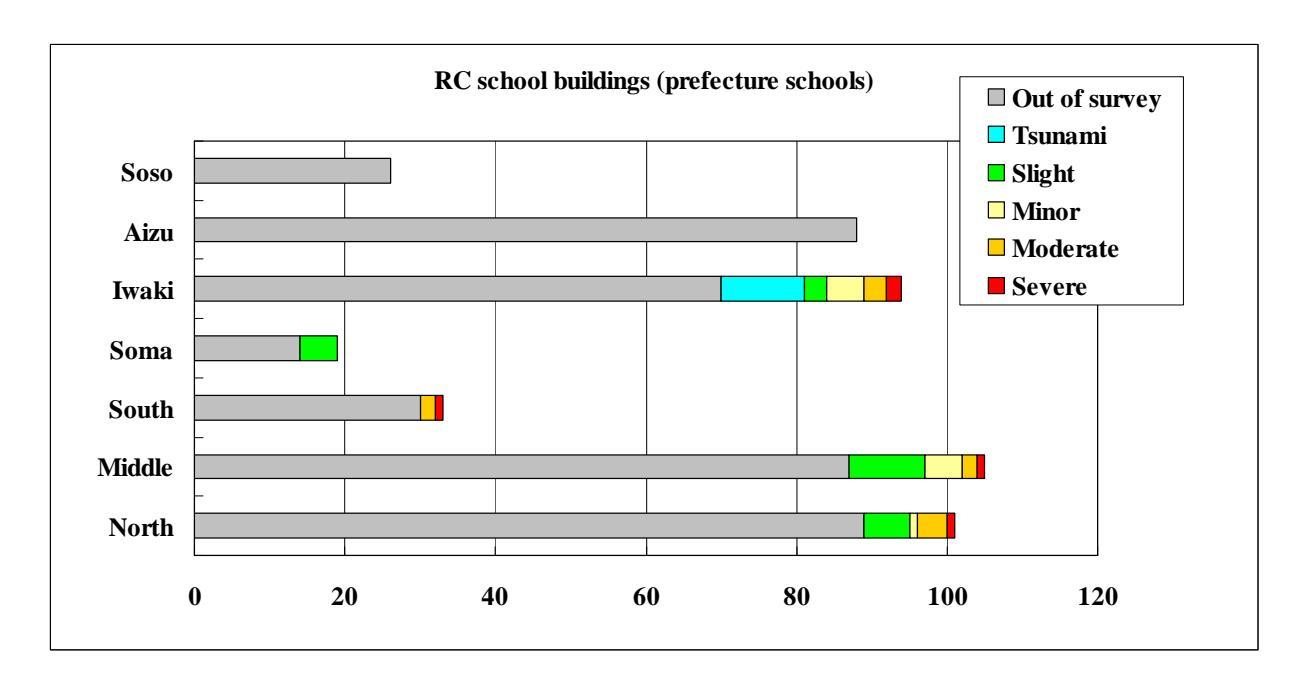
Fig. 8 Regional distribution of inventory damage rates for all prefecture school buildings

As for the regional distributions, the damage rate was obviously small in Aizu region while relatively higher in Iwaki region. These are partially because of the earthquake intensity including the site effects and distance to the sources, especially to the Off-Iwaki source, though these were not much clear by K-net motions shown in Figs 1 to 4. It is also presumed for another reason of lower damages in Aizu region that the design seismic force is relatively higher including the permanent snow loads in the region.

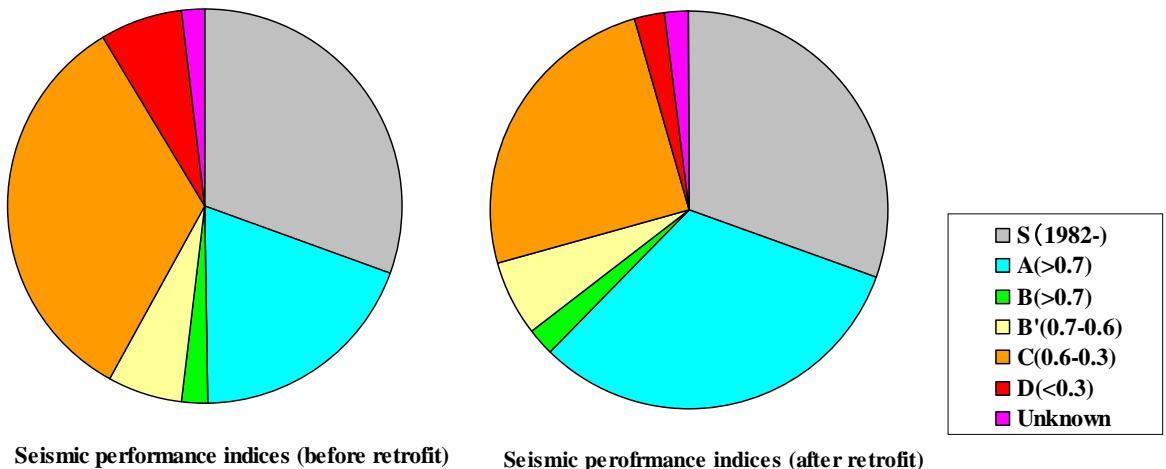
Fig. 10 Seismic performance indices before and after retrofit

If the seismic safety ratio of the RC school buildings were defined as the sum of the ranks S and A, then the ratio was around 50% before the strengthening started and had been upgraded up to 62% by the retrofit at the time of earthquake, as shown in Fig. 10. The regional distributions of these seismic performance ranks are shown in Figs. 11 and 12, also before and after retrofit. It might be concluded that the safety ratios are relatively higher in Aizu, Soma and South regions with few rank D, where the damage ratios in Figs. 8 and 9 were generally smaller.

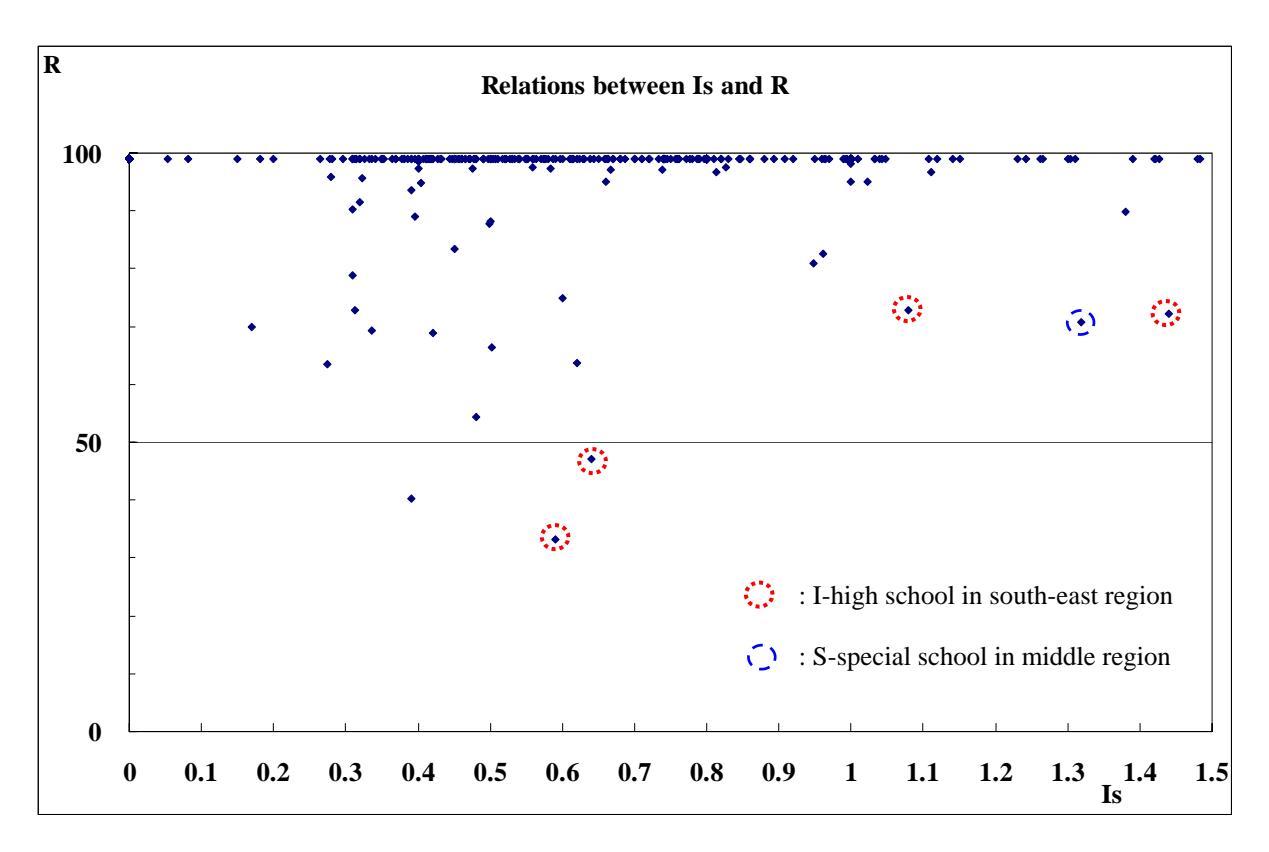
Fig. 13 Relations between the seismic performance indices **Is** and the damage rates in terms of the residual capacity **R** (%)

The direct relations are plotted in Fig. 12 between the observed damage level in terms of the residual capacity R and the calculated seismic performance level in terms of the structural seismic index Is-value. The unknown R is assumed as 99%, which might not be different much, even if evaluated, while the unknown Is is assumed as zero, which is to be disregarded. Positive correlations are observed between Is and R generally. It should be noted, however, in cases of the marks with dotted circles, that R is lower than 80% even if the Is is much higher or around 0.6. Four of these are the buildings of I-high school on the hill in Iwaki described above, and a building in S-special school in middle region, where the ground motions might have been higher there due to some local site effects. Detailed model and analysis are needed to simulate the damage level in relation with the estimated input motions.
