EARTHQUAKE DAMAGE INVESTIGATION OF GRAVITY-TYPE QUAY WALLS IN IBARAKI PORT

ABSTRACT: One of the most common used types of quay walls in Japan is gravity type with concrete caissons. A number of gravity-type quay walls have been constructed in Ibaraki Prefecture where huge ground motion occurred in the Great East Japan Earthquake of March 11, 2011. This paper reports on damage to gravity-type quay walls in the Port of Hitachinaka, which serves as a freight transport hub for the northern Kanto region.

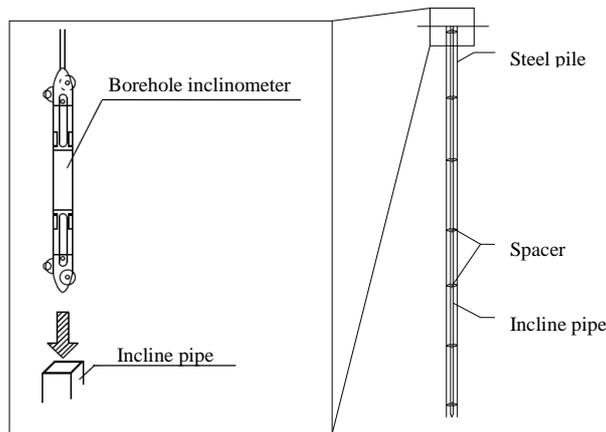
Fig. 10 Method for measuring horizontal displacement of steel pile foundation

There is currently no established method for measuring the displacement of an inclined or bent steel pile. In this study, steel pile displacement was measured using the method shown in Fig. 10. First, an inclined pipe with relatively low stiffness was fitted into the steel pile with the aid of spacers. Then, a borehole inclinometer was inserted into the inclined pipe to measure its inclination. Finally, the horizontal displacement of the inclined pipe was calculated from the angle of integration. Its displacement was considered to be almost the same as that of the steel pile.

The horizontal displacements of two representative steel piles are shown in Fig. 11, which indicates that the seaward displacements of the pile tops were 0.52 m and 0.63 m, and that the piles bent seaward from deep to shallow parts. The radius of the curvature calculated from the displacements shows that these piles reached their yield condition, indicating the need for replacement.
