# DAMAGE OF BRIDGES DUE TO THE 2011 GREAT EAST JAPAN EARTHQUAKE

Kazuhiko KAWASHIMA

**ABSTRACT:** This paper presents damage of bridges during the 2011 Great East Japan earthquake. Since the bridges in the north Miyagi-ken and south Iwate-ken suffered extensive damage during the 1978 Miyagi-ken-oki earthquake, damage of bridges during the 2011 Great East Japan earthquake is evaluated in comparison with the damage due to the 1978 Miyagi-ken-oki earthquake so that the effect of recent progress of seismic design can be evaluated. Tsunami-induced damage was extensive for bridges along the Pacific Coast. Typical feature of tsunami-induced damage is presented based on video movies.

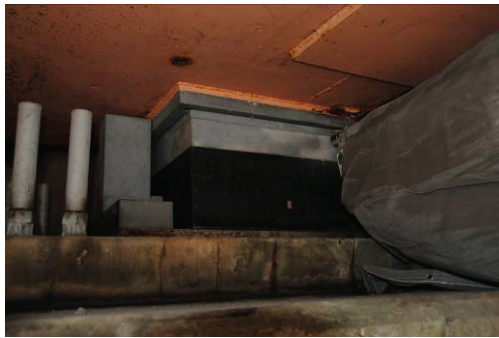
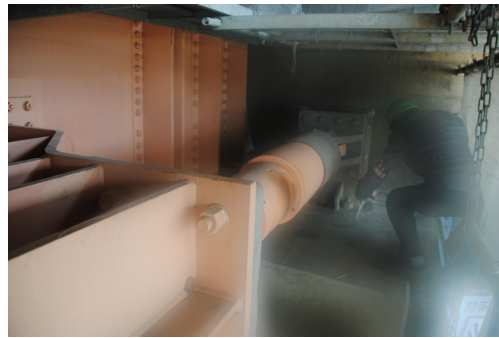
Photo 10 Elastomeric bearings and viscous dampers which were set for seismic retrofit did not suffer damage during the 2011 Great East Japan earthquake

Shin-Iino-gawa Bridge suffered extensive damage at steel pin and roller bearings as shown in Photo 9 during the 1978 Miyagi-ken-oki earthquake. It was retrofitted prior to the 2011 Great East Japan earthquake: 1) some reinforced concrete piers were retrofitted using steel jacketing, 2) nonlinear viscous dampers were installed, and 3) steel bearings were replaced with elastomeric bearings as shown in Photo 10. As a result, the bridge suffered no damage during the 2011 Great East Japan earthquake.

(a) An elastomeric bearing without damage

(b) A damper for seismic retrofit

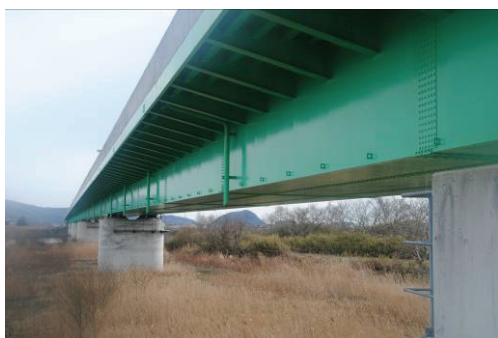
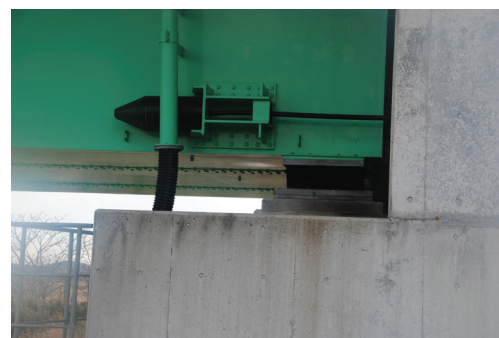
Photo 11 Shin-Tennoh Bridge

Bridges which were designed in accordance with the post-1990 codes suffered essentially no damage during the Great East Japan earthquake. For example, Photo 11 shows Shin-Tenno Bridge constructed in 2002 suffered no damage. Elastomeric bearings and new cable restrainers which satisfy the requirements of the post-1990 design code were set. This bridge was located only 200m upstream of Tenno Bridge which suffered extensive damage during the Great East Japan earthquake (refer to Photos 5 and 6).

(a) Bridge after Great East Japan Earthquake

(b) Elastomeric bearing without damage

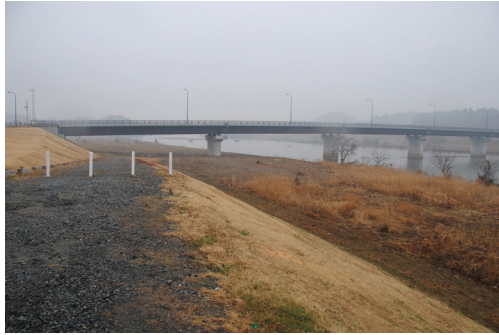
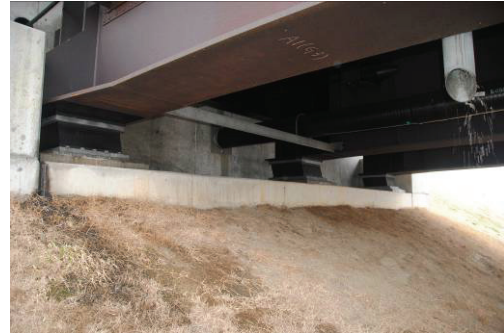
Photo 12 Higashi-Matsushima Bridge

Photo 12 shows Higashi-Matsushima Bridge which was constructed in 2007. No damage occurred in this bridge.

(a) General view

(b) Deck end supported by three elastomeric bearings

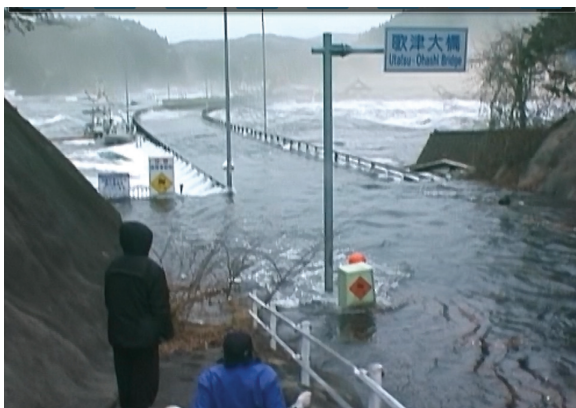
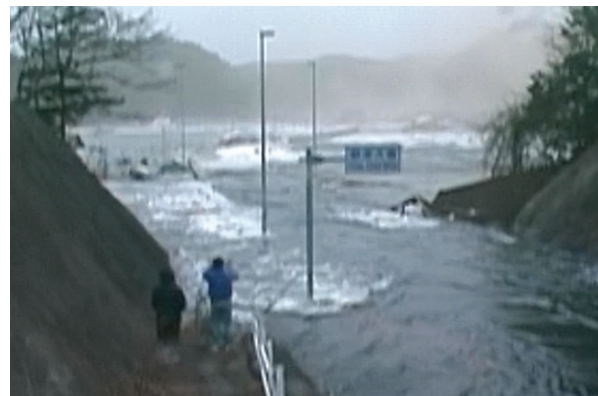
Photo 19 Video taken by a local resident near A2

A video was taken from A2 by a local resident. This video shows a whole process of rising tsunami water level until the bridges was completely covered by tsunami as shown in Photo 19. Since the bridge failed after it was completely covered by tsunami, it is not known when the decks were uplifted and floated. Since tsunami flow was not fast at both sides of the bay, this saved D1-D2 and D11-D12 from collapse. Tsunami flow velocity was about 6m/s.

(a) Tsunami reached the bottom of decks

(b) The bridge was completely covered by tsunami

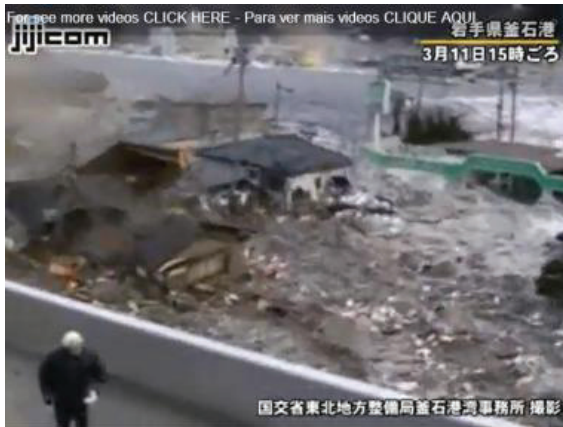
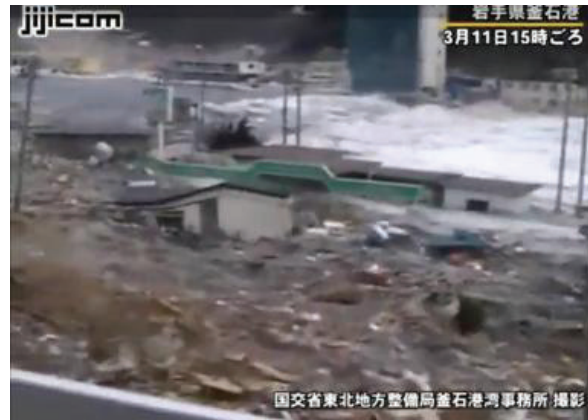
Photo 22 Tsunami attack to Yanoura Bridge

At about 15:00, the first tsunami attacked the bridge as shown in Photo 22. Tsunami reached nearly the top of an entrance gate of Toyota rent-a-car office. Since the tsunami reached mid-height of the second story of Ozawa Building, it is evaluated that the maximum covering depth of tsunami above the bridge surface was about 5m. It is noted from the video that few debris was included in tsunami which hit the bridge because this bridge was located at the mouth of Koshi River.

(a) Tsunami almost covered Yanoura Bridge

(b) Yanoura Bridge completely covered by tsunami
