LIQUEFACTION-INDUCED DAMAGE TO BUILDINGS IN URAYASU CITY DURING THE 2011 TOHOKU PACIFIC EARTHQUAKE

Kohji TOKIMATSU¹, Kota KATSUMATA²

ABSTRACT: An overview of the liquefaction-induced damage to buildings in Urayasu city during the 2011 Tohoku Pacific earthquake is presented, based on field reconnaissance made after the quake. It is shown that extensive soil liquefaction occurred in most of the areas reclaimed after 1968, accompanied by numerous sand boils and large ground settlement up to 60 cm as well as settlement/tilting of wooden and reinforced concrete buildings supported on spread foundations. The extent and distribution of the damage were significantly affected by local soil conditions including the thickness of reclaimed fills, the depth to the bedrock or natural site period, and whether remedial measures were taken against soil liquefaction, as well as structure soil structure interaction effects.

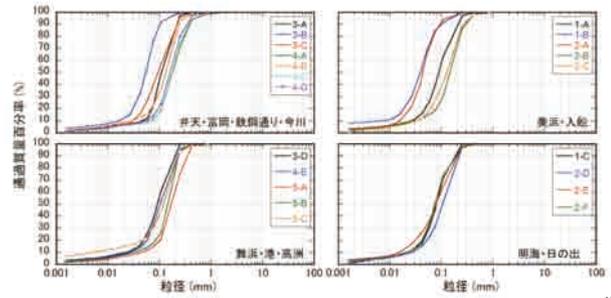
Figure 19 shows grain size distribution of boiled sand samples collected at several locations in Urayasu. The samples each have high fine-grain content ratios, at 15 to 70 percent. Those fine grains are believed to be non-plastic fine sand or silty sand, which correspond to the composition of the sand layer in reclaimed land up to 10 meters below the sea level. This suggests that the reclaimed sand layer liquefied during the earthquake.

Fig. 19 Grain size distribution curves of boiled sands⁴⁾

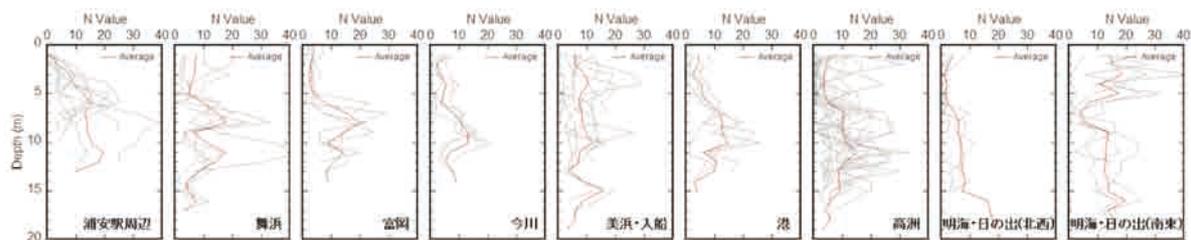
Figure 20 shows depth distributions of the N-value of earth filling or sand layers at each area of Urayasu in gray. The average is shown in red. The data was obtained from the Chiba prefectural

government²⁾ and the authors' own survey. For the Akemi-Hinode area, separate graphs were given for the northwestern and southeastern districts, because the extent of the damage was distinctively different between them. It can be seen in the figure that the N-value in the sand layer was extremely small in Tomioka, Imagawa and Akemi-Hinode (northwest), but large in the neighborhood of Urayasu Station, which is not reclaimed land, and in Akemi-Hinode (southeast), which is reclaimed land but which is the highest in altitude. The thickness of earth filling and sand layers was different from place to place, with Maihama, Mihama-Irifune, Takasu and Akemi-Hinode marking high figures.

Fig. 20 Distribution of SPT-Value with depth at selected districts⁴⁾

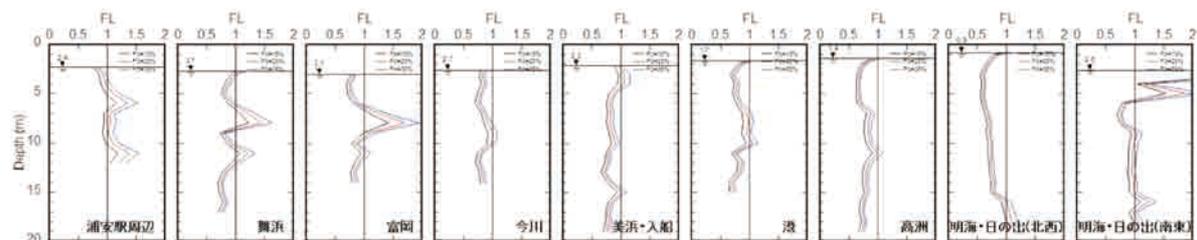
Figure 21 are the results of liquefaction evaluation made with a method specified in the Architectural Institute of Japan's guidelines for basic structural design (2001), using the average N-value for each area (Figure 20), a peak ground acceleration of 2.0m/s² and at magnitude 9.0. The ground water level is set at the average for each area, and the fines content was set at three different levels—15%, 25% and 35%.

Fig. 21 Result of SPT-based liquefaction evaluation at selected districts⁴⁾

The FL-value (safety factor against liquefaction) came to 1 or more at most depths in the neighborhood of Urayasu Station, where no liquefaction damage was observed, and in the Akemi-Hinode (southeast) area, where only minor damage was seen. But in other places, the FL-value turned out to be lower than 1. Especially in Mihama-Irifune, Takasu and Akemi-Hinode (northwest), there are a sequence of layers with the FL-value of lower than 1 until the depth of nearly 20 meters. These results agree with the actual damage situation.
