TSUNAMI DAMAGE TO BRIDGE STRUCTURES IN RIKUZEN-TAKADA CITY AND THE EMERGENCY ROAD NETWORK RECOVERY ACTIONS

Shigeki UNJOH¹

¹ Research Coordinator for Earthquake Disaster Prevention, National Institute for Land and Infrastructure Management, MLIT, Tsukuba, Japan, unjoh-s92ta@nilim.go.jp

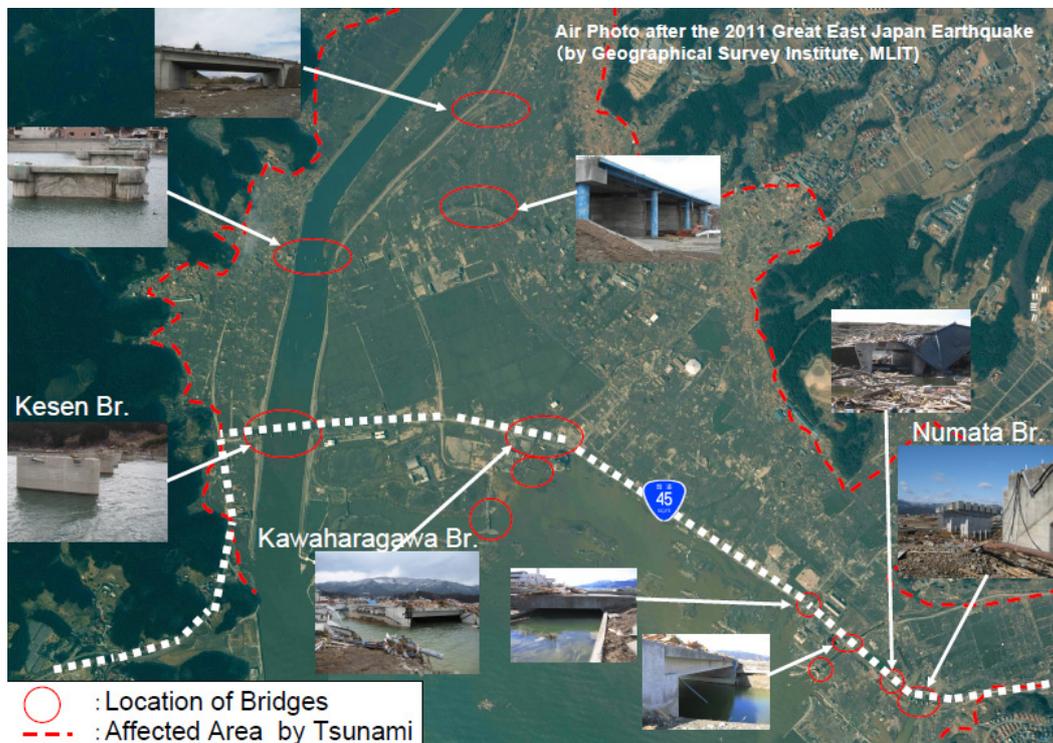
National highway route 45 was along the coast line and 4 sections were completely disrupted by the damage of bridges. In the Rikuzen-Takada city, there were 4 bridges and 2 culverts on national highway route 45 and 6 bridges on local highways. Photo 4 shows the aerial photo of Rikuzen-Takada city, in which red circles and red dotted lines show the locations of 12 bridges and the affected area by tsunami, respectively. Three bridges out of 12 were heavily damaged by the tsunami, which were on national highway route 45 as shown in Fig. 2. Superstructures of two bridges were completely washed out and the backfill soils of the abutments were heavily scoured. The details of damage and the repair of the bridges will be discussed later. Furthermore, the peeling-off of road pavement and the scouring of soil sections due to the tsunami were also observed at several locations as shown in Photo 5.

Photo 4 Rikuzen-Takada City and Inundated Area by Tsunami
