DAMAGE TO REINFORCED CONCRETE BOXED WALL-BUILDINGS IN THE 2011 GREAT EAST JAPAN EARTHQUAKE

ABSTRACT: Post-earthquake damage evaluation for 634 public apartment buildings having boxed wall type structure (WRC, WPCa PS and ribbed panel) was conducted within the city of Sendai by AIJ Committee on boxed wall structures. Of the 496 buildings having a reinforced concrete boxed wall (WRC) structure, 97.4% were found to be undamaged or to have only slight damage. Among the remaining 2.6%, only one building had moderate damage and no buildings had severe damage. The others had minor damage. All of the 47 buildings having a precast prestressed reinforced concrete boxed wall (WPCa PS) structure in Sendai were found to have suffered no or slight damage. Of the 91 buildings having a boxed wall of thin ribbed concrete panel (ribbed panel) structure, 72.5% were found to have suffered no or slight damage. Among the remaining 27.5%, 11 buildings were moderately damaged and 1 building was severely damaged. The ribbed panel buildings suffered relatively higher damage. This is because 71 out of the 91 ribbed panel buildings were constructed before the new earthquake-resistance standards 1981.

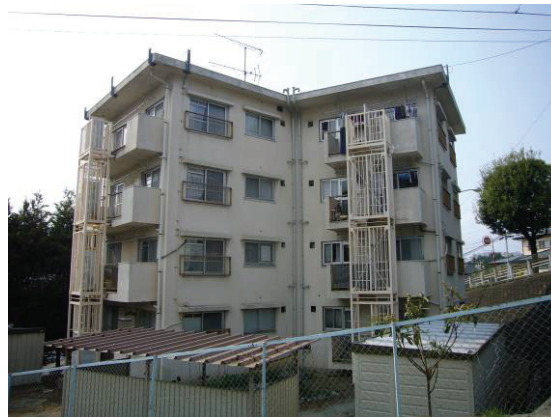
Photo 1 Overview of the star-house apartment

The complex is located on a slope. Six four-story buildings (buildings 1 through 6 referred to as “star houses” because of the Y-shape in plan) and an apartment building (building 7) with an ordinary rectangular plan exist in the complex. The complex was subjected to vibration of seismic intensity less than 6. The superstructure of building 7 was not damaged. Of the star houses, three buildings were slightly damaged, two suffered minor damage and one was moderately damaged. Photograph 1 gives an overview of a star-house apartment building.

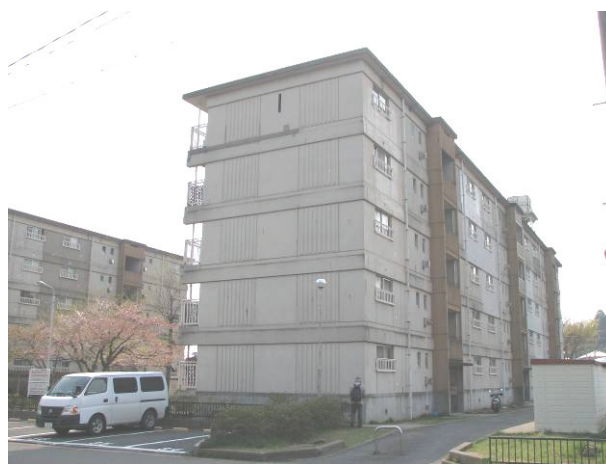
Photo 5 Overview of d-apartment in Natori city

Apartment complex *F* accommodates two buildings, building *d* in the north and building *e* in the south. Both are of WPCa PS structure. Building *d* accommodates 30 five-story buildings and building *e* 20 five-story buildings. The construction of buildings *d* and *e* was started in October 1981 and completed in March 1982. Photograph 5 gives an overview of building *d* in apartment complex *F*.

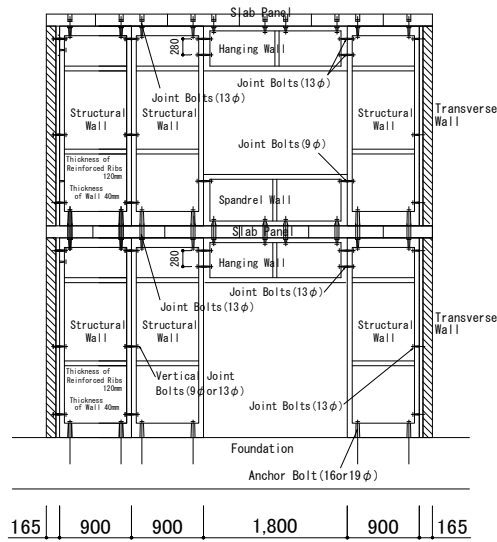
Fig. 2 Outline of ribbed panels structural system

Figure 2 outlines a ribbed panel structure. Column forms were installed at intersections of longitudinal bearing wall and transverse wall. Damage to the ribbed panel structure was observed at the positions listed below.

- (i) Vertical crack at the vertical joint between the bearing and hanging walls (Photograph 9)
- (ii) Vertical crack at the vertical joint between the bearing and spandrel walls
- (iii) Flexural crack at the foot of the bearing wall where the wall thickness changes (boundary between a 120-mm-thick rib around the bearing wall and a 40-mm-thick area other than the rib)
- (iv) Shear crack in the bearing wall (Photograph 10)
- (v) Horizontal crack in the bearing wall at the height of the hanging wall
- (vi) Vertical crack at the vertical joint between bearing walls or at the vertical joint between the transverse bearing wall and column form
- (vii) Vertical crack in the foundation and failure of foundation beam due to ground settlement or fissure

Damage (i) and (ii) were confirmed most frequently. The results are the same as the damage to mass-produced public apartment buildings in the past earthquakes. In the buildings constructed after the enforcement of the new code, improvements have been made in detail and damage is incurred less frequently.
