LIQUEFACTION IN TOKYO BAY AND KANTO REGIONS IN THE 2011 GREAT EAST JAPAN EARTHQUAKE

Kenji ISHIHARA

Key Words: Mega earthquake, Liquefaction, Lateral flow, Settlements

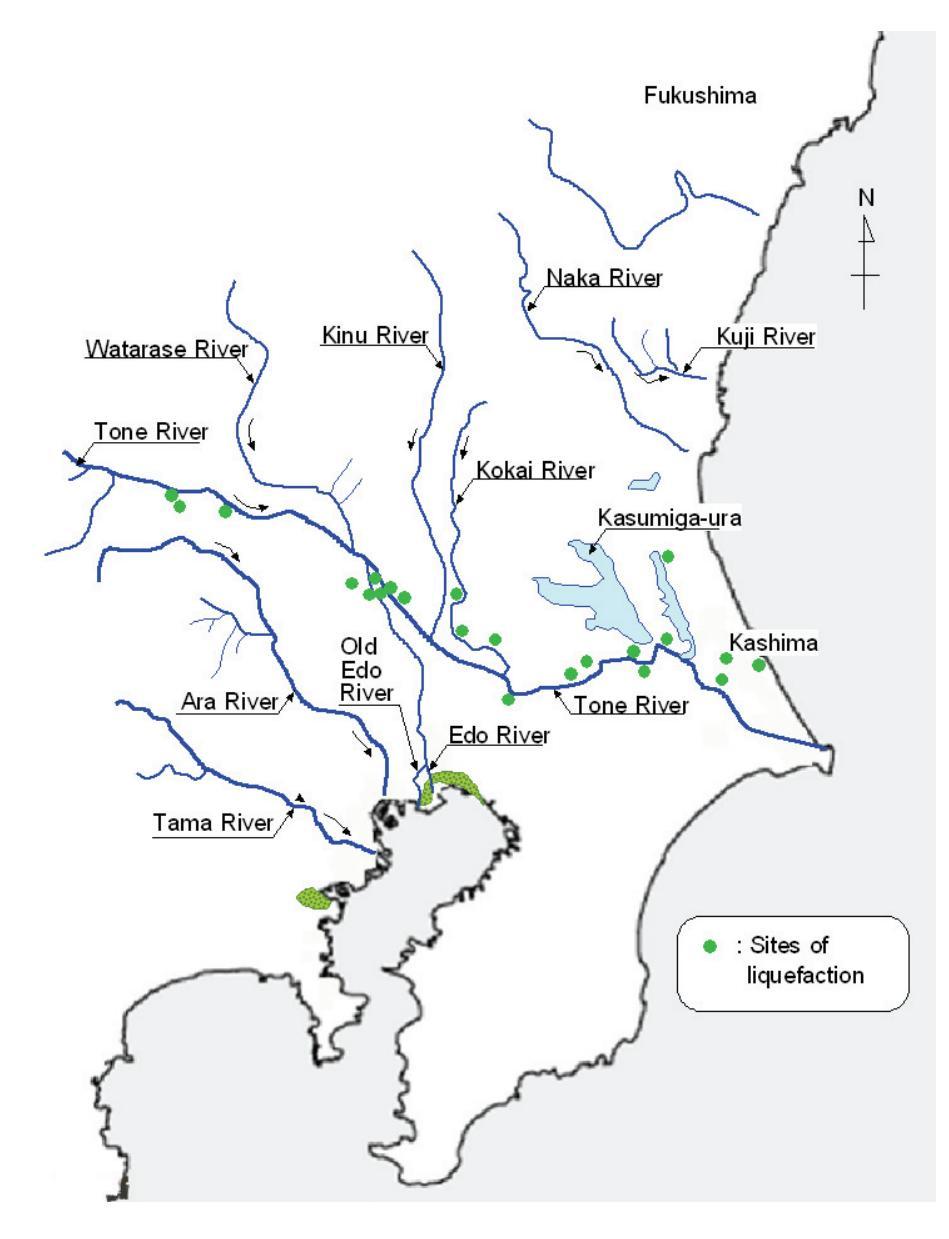
Fig. 4 Liquefaction - affected area in Kanto Region (S. Yasuda, 2011)

liquefaction were observed is purported to have been of the order of 70km². In terms of the long distance from the epicentre and also in terms of the large expanse net area, the liquefaction in the Kanto region by the 2011 earthquake was unprecedented and truly record-breaking. Shown in Fig. 4 is the distribution of places where apparent signs of liquefaction were observed such as sand oozing, boiling, ground cracking and associated ground settlements. These may be classified as (1) those which developed in the reclaimed waterfront area along the Tokyo Bay, (2) the liquefaction in the lakeshore district south of Kasumiga-ura in the lower reach of Tone River, and (3) the spotwise occurrence of liquefaction at many locales along the Tone River and its tributaries where landfills had been conducted in originally marshy flat lands.

The areas of liquefaction along the Tokyo Bay are roughly displayed in Fig. 4 where it is noted that its effects extended south to the city of Kanazawa-bunko in Yokohama and also that the low-land areas west of the lower reach of the Edo River in Tokyo suffered the damage due to liquefaction. Several cities in Chiba Prefecture east of Urayasu were also affected seriously by the liquefaction. These cities are shown in a enlarged map in Fig. 5.

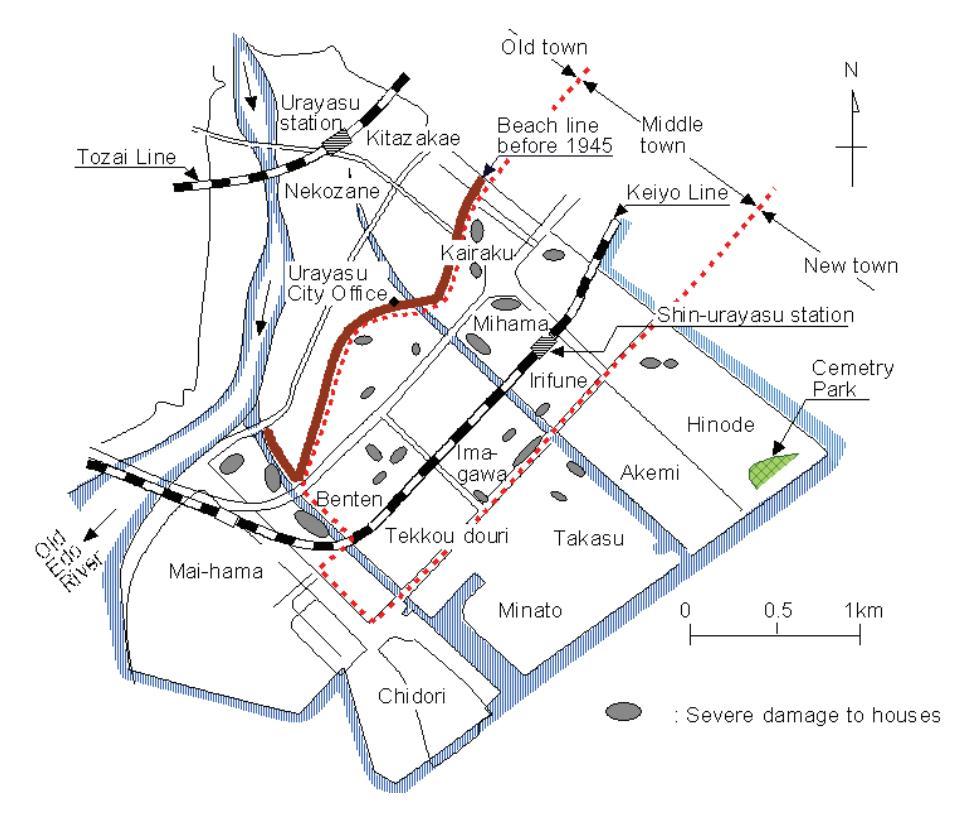
Fig. 6 Places of serious damage to private houses in Urayasu

Amongst the cities in Chiba Prefecture, Urayasu was the one most seriously affected by liquefaction. The major areas in Urayasu are indicated in Fig. 6 where apparent signs of liquefaction were observed at the time of the first strongest shaking on March 11, 2011 as well as in the aftershocks. Most of the areas affected were those reclaimed over the period of 1960~1980 and developed to provide landspaces for residential houses, parks, schools and warehouses for industries. There was a sharp contrast between the areas of liquefaction or no liquefaction which is divided by the old shore-line before the reclamation started early in 1960's. This boundary line is indicated on the map in Fig. 6.

The old town part of Urayasu was practically free from any distress by the quake due probably to relatively stiff nature of the alluvium. The middle town area which is residential and commercial zone suffered serious damage due to liquefaction, because of the newly filled loose sandy soil deposit existing near the ground surface and also because of the high ground water table shallower than 1.0m. In the new town area, the ground had been raised to an elevation of 4~5m above the sea level by placing additional fills transported on land. Thus, the ground water table was rather lower. The majority of structures in the new town were hotels, office building etc. which were constructed on

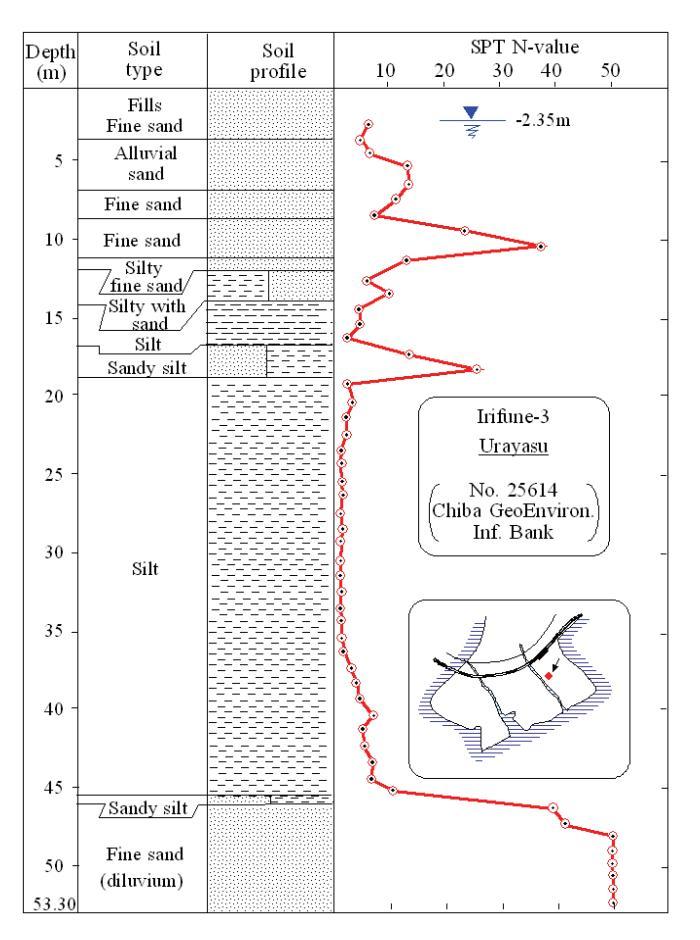
Fig. 9 Soil profile at Irifune 3-chome

A typical soil profile in the middle town at a site at Irifune 3-chome is shown in Fig. 9, with the exact location indicated in the inset. It can be seen that a soft clayey silt deposit of alluvial origin exists to a depth of 45m at this site overlaid by alternate layers of silty and sandy soils of alluvial era. The loose sandy layer near the surface to a depth of 5m having a SPT N-value of 3~10 is the one placed newly by the reclamation. A series of boring data obtained along the alignment D-D' in Fig. 10 are arranged in a form of a side view shown in Fig. 11.

It is of interest to notice that, although the SPT N-value of 5-15 for the alluvial sand is slightly larger as compared to $N=5\sim10$ for reclaimed sand, the new sand deposit was more vulnerable to liquefaction, as evidenced by the clear manifestation on the ground in the reclaimed area in contrast to no liquefaction in the old town area in the north. This fact seems to indicate that effects of solidification of fines due to aging might have contributed for strengthening of sandy soils, although it is not clearly reflected in the penetration resistance of the SPT. Upon compilation of many other boring data, the bottom of the old alluvium was established and shown in Fig. 10 as contour lines of buried valleys.

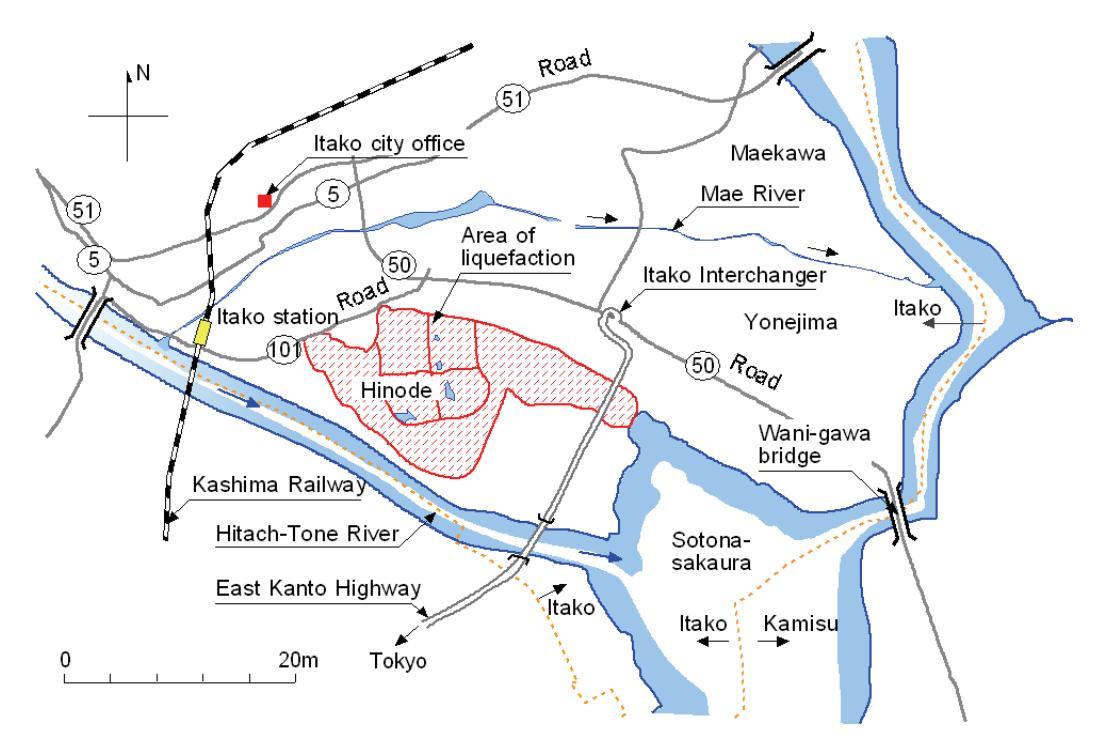
Fig. 15 Places of liquefaction, Hinode, in Itako city

While places of liquefaction were scattered widely over Itako city, severe damage was concentrated predominantly in the district of Hinode about 25km long and 15km wide as indicated in Fig. 15. This area is a land which was in an early period created by draining off the lagoon called Uchina-Sakara. The lagoon area as of 1893 prior to the drain-off is shown in Fig. 16. The drain-off

As a result of strong shaking lasting for 1-2 minutes, liquefaction did develop extensively over the area of Hinode. The accelerations recorded at the nearby Edozaki K-NET station showed the peak acceleration as much as 400gals. Particularly notable was the tilting and settlements of private houses, uplifting building and sinking of road surface, and uplifting box-type water-draining channels buried beneath the sideway, accompanied by sand boiling and some lateral displacements. Fig. 19(a) shows a settlement of about 50cm with 1° tilt of a 3-storey house located in Hinode-5 in Fig. 18. The damage to the road in Hinode-5 is displayed in Fig. 19(b) where the central part is seen being lifted about 20-30cm relative to the sideway. This appears to have resulted from floating of old water channels used for draining water out of the lagoon at the time of the drain-off.

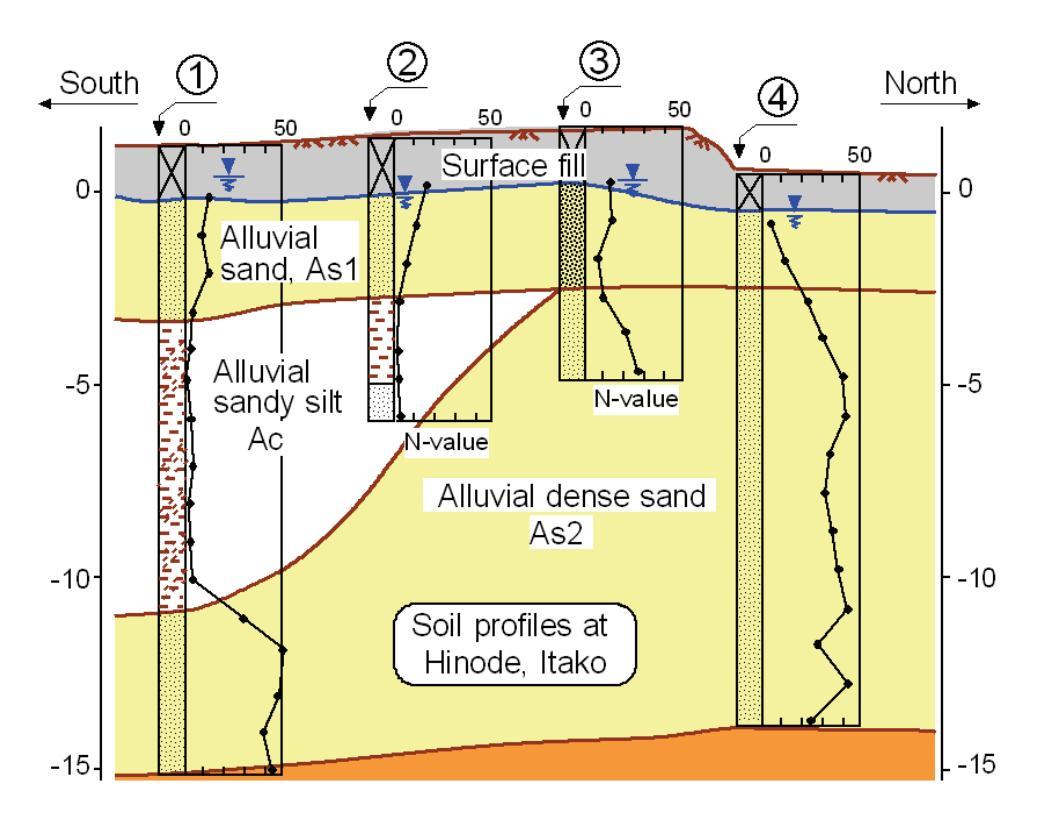
Fig. 20 Soil profile in N-S direction at the center of Hinode, Itako (from Itako city office)

Soil conditions in Hinode district at Itako were investigated, prior to and after the earthquake, by in-situ boring combined with the Standard penetration test (SPT). The soil profiles along the N-S line, (1,2,3,4) indicated in Fig. 18, is demonstrated in Fig. 20 where it can be seen that below the surface fills there exists a loose deposit of sandy soil having a low SPT N-value of the order of 5-15. Saturated with a high ground water table of 1~2m below the ground surface, the near-surface sand fill is deemed to be a new sand deposit which was placed hydraulically at the time of the recent reclamation in 1965-1981. It is obvious that this deposit had developed liquefaction during the earthquake. It is also likely that the loose alluvial sand deposit below the fills have induced liquefaction as well.

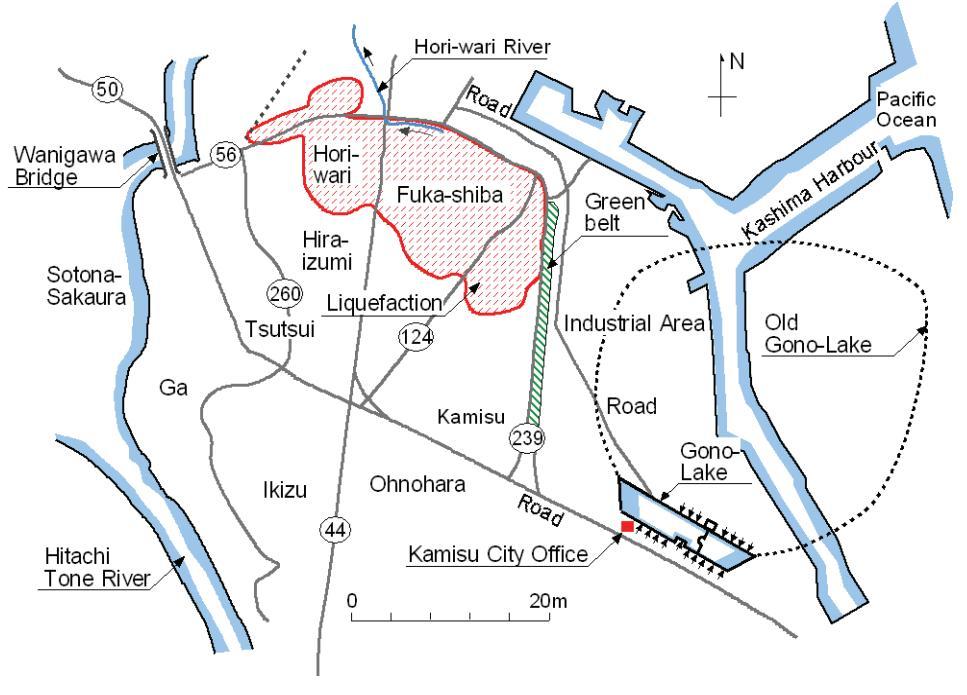
Fig. 21 Areas of liquefaction-induced damage

The city is located in the downstream plain area of the Tone River as shown in the map of Fig. 14. An enlarged map in Fig. 21 indicates that the Kamisu city is about 7km east of Itako city and about 5km from the coast of the Pacific Ocean. The district of severe liquefaction in Kamisu is at Horiwari and Fukashiba and sporadically distributed spots in their vicinity.

According to an old map, there existed a fairly large lake with triangular shape in the north of the Gono Lake. Its location is also shown in Fig. 21 with a dashed line. This lake was buried around 1960 when the near shore industrial complex was developed, but the belt zone about 1km wide and 200m wide was left and reshaped as the new Gono Lake as accordingly indicated in Fig. 21. The shore line of this lake was also damaged by the lateral flow of liquefied materials.

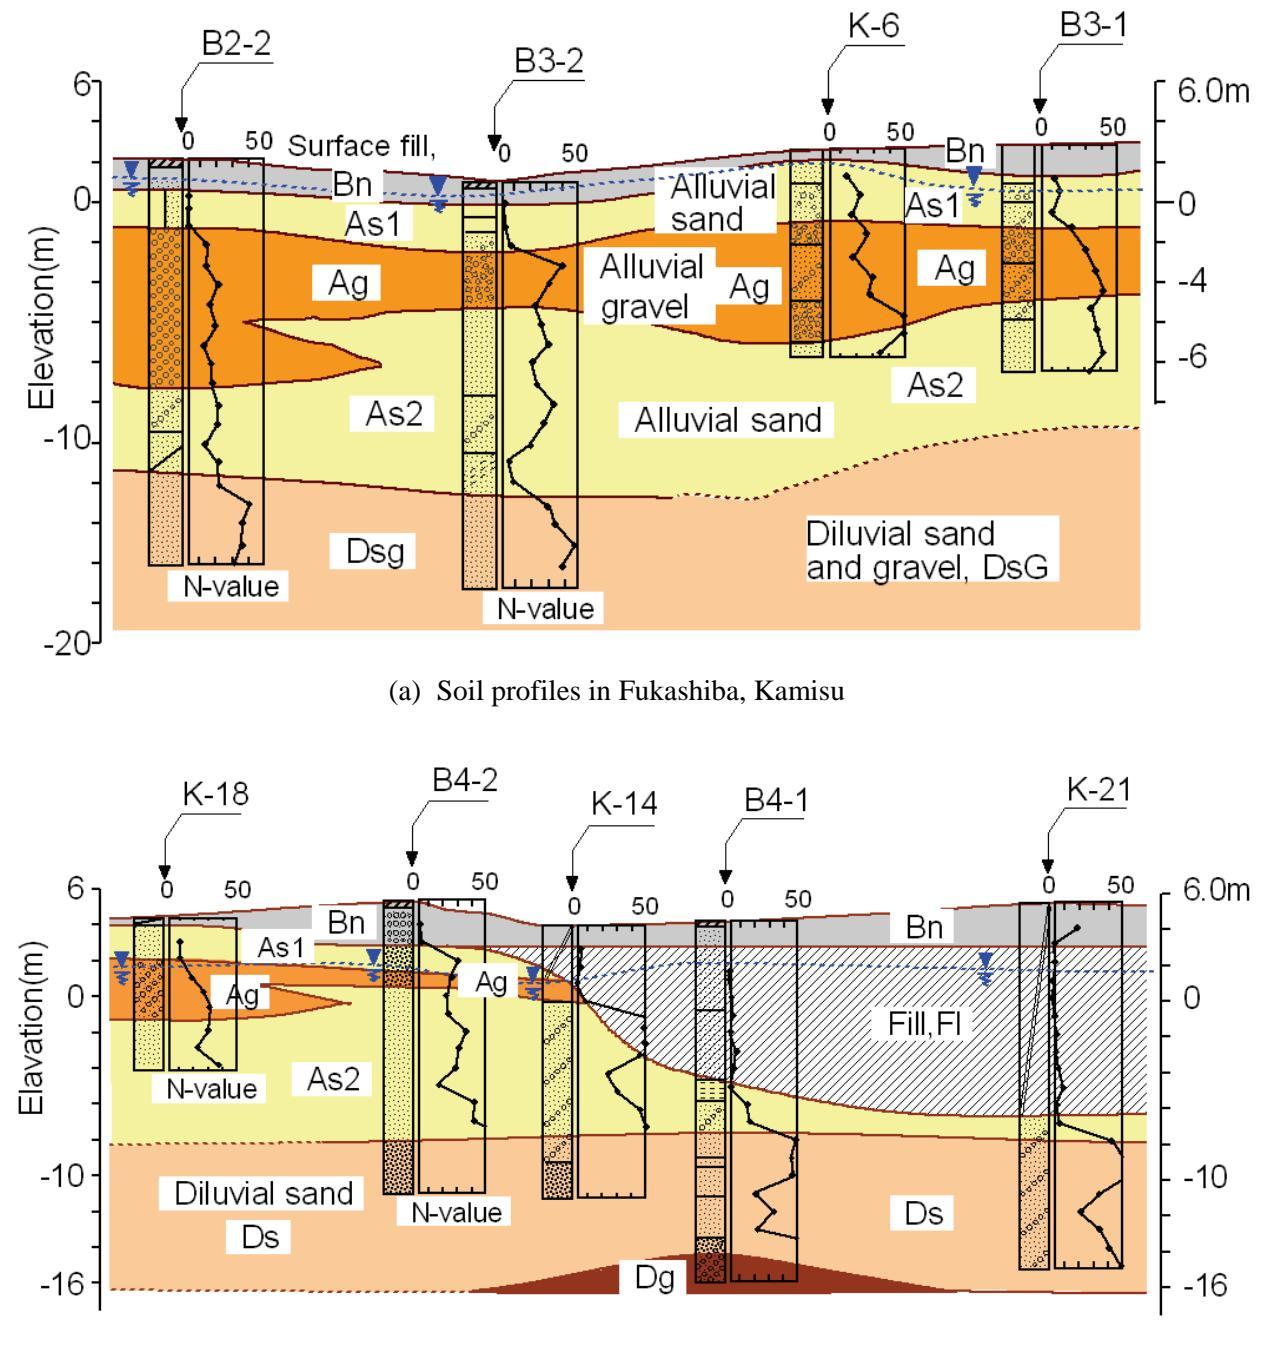
Fig. 24 Side views of soil profiles at Fukashiba, Kamisu (from Kamisu city)

The soil conditions in this district were investigated by means of the SPT combined with Swedish cone. The results of the investigations are reported in papers by Tsukamoto et al. (2012a, 2012b). Soil investigations were performed at numerous other sites at Fukashiba as shown in Fig. 23. Some of the results of these borings are displayed in Fig. 24 in the form of sideviews where it is apparently seen that the sand fills (Bn, Fl) or alluvial sand (As1) developed liquefaction. Particularly to be noticed is the existence of the thick deposit of man-made fill, Fl, towards the north-east, as demonstrated by the boring B4-1 and K-21 in Fig. 24. This is the typical deposit formed by backfilling the open pits in recent years.
