# STUDY OF LOW-RISE RC BUILDINGS WITH RELATIVELY HIGH SEISMIC CAPACITY DAMAGED BY GREAT EAST JAPAN EARTHQUAKE 2011

**ABSTRACT:** This paper investigates the damage of several low-rise RC buildings caused by the Great East Japan earthquake in Sendai city. The selected building are evaluated to have high seismic capacity, index  $I_s > 0.7$ , using Japanese Standard for Seismic Evaluation of Existing RC Buildings. Causes of the damage are discussed. Moreover, pushover analysis was carried out to those buildings. In general, pushover analysis predicted well the damage level, but there were some differences in plastic hinge locations when compared to the actual damage.

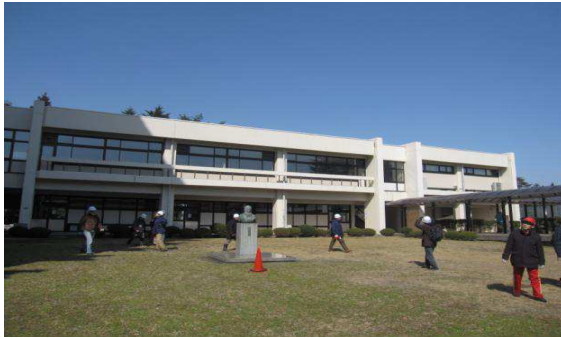
Fig. 1 N Lecture building

This paper is divided into two main sections. First the study of lecture-room RC building of 2-stories constructed in 1966 located in Tohoku University engineering campus which was severely damaged is presented. This building will be referred to as N Lecture (Fig.1). N Lecture is compared to another lecture-room building similar in its structural system and standing next to it but the latter was slightly damaged. This building will be referred to as S Lecture.

The N Lecture building had a severe shear failure in many of its columns in the 1<sup>st</sup> story in the longitudinal direction (see Fig.6). The damage to columns progressed much due to the 7<sup>th</sup> of April aftershock earthquake (see Fig.7). Less damage in the 2<sup>nd</sup> story but shear cracks were also noticed. First floor plan with damage classes of columns in the longitudinal direction are classified based on the “Post-earthquake damage evaluation standards of Japan” (JBDPA 2001a) and shown in Fig 8. Two columns were damaged by previous earthquake and strengthened by FRB sheets jacketing are marked as (未 unknown) in Fig. 8. It is marked unknown because damage to concrete was invisible by the FRP jacket. The details of this repair were unavailable. However, the transverse direction was slightly damaged.

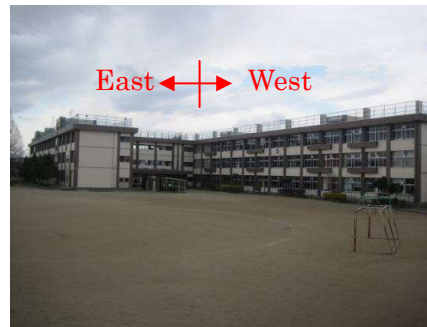
Fig. 2 North view of H school building

Secondly, the study of 3 storied RC building of an elementary school in Sendai city constructed in 1974 is presented (Fig.2). The building is divided by expansion joint into west side and east side. Seismic evaluation was carried out to both sides. According to the seismic evaluation, the East side building needed to be retrofitted and the West side was evaluated to have enough seismic capacity and no retrofiting was needed. The East side building, which had already seismically retrofitted suffered only minor damage in its structural members. On the other hand, the West side building was heavily damaged.

The longitudinal direction of building (B) had shear failure in many of its columns (see Fig.18) and shear cracks in some wing walls (see Fig.19). Cracks in slab and beams were also observed. The transverse direction had slight damage. Damage was concentrated in the 1<sup>st</sup> floor of building (B).

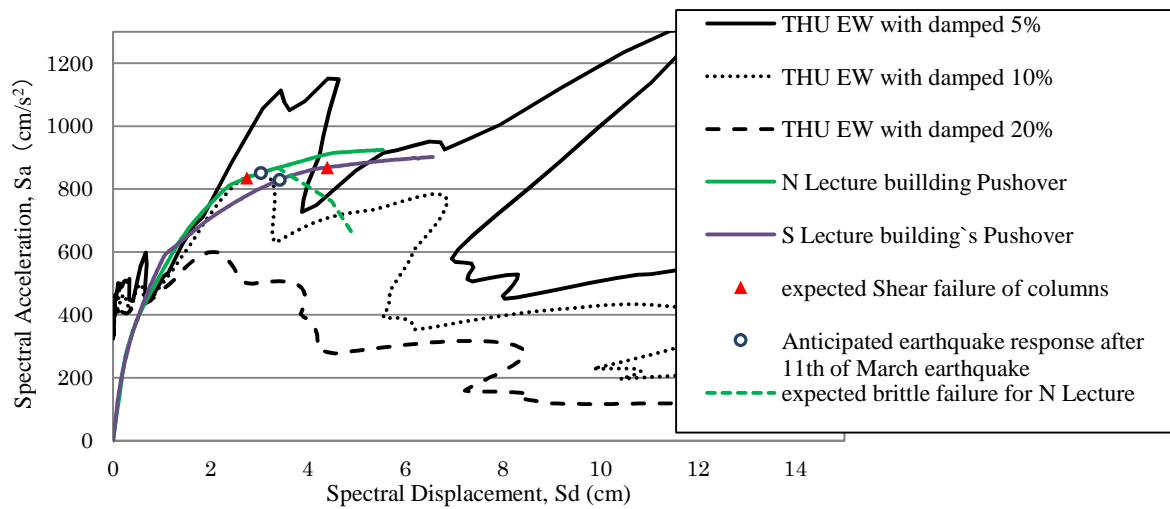
The response spectra curve of THU EW has low values and sharp peaks at short periods as shown in Fig.10 and intersects the capacity curve of both buildings at low  $S_a$  values. If the capacity method is used, the seismic response for both buildings was expected in the elastic region and that contradicts the actual damage observed in the buildings. Therefore anticipated seismic response was chosen at the point where the actual damage observed matched the damage calculated by pushover analysis which was at relative story drift angle of about  $1/200\text{rad}$  in the 1<sup>st</sup> story for both buildings. Due to large spacing between stirrups, 300mm, brittle failure and rapid degradation of shear resistance is estimated and shown as the green dotted line in Fig.8.

Fig.10 THU EW response spectrum

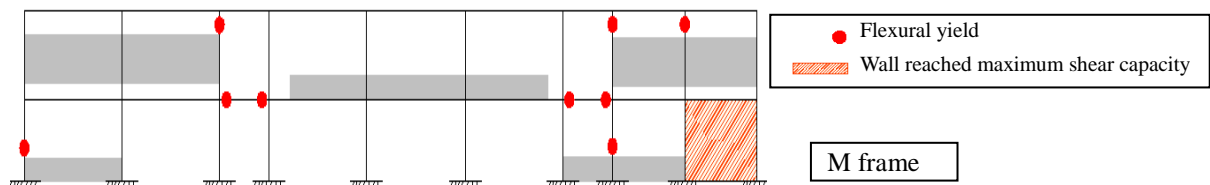
Fig. 11 shows yielded hinge locations in frame in longitudinal direction of S lecture building at story drift of  $1/200\text{rad}$ . The Shear wall has yielded and hinges are formed in two beams and two columns. However, as for the actual damage for S Lecture building, only shear cracks was noticed at the shear wall, no cracks was observed in other members. In the other hand, at the same story drift angle, three columns of the N Lecture building had failed in shear (see Fig 12) and many columns were about to fail in shear and had plastic hinges.

Plastic hinges were expected in some beams as shown in the Fig. 11 and Fig. 12 which were not noticed in the actual damage investigation. This could be due to the contribution of slab which was not considered in the calculations of the beams strength capacity.

Fig.11: Damage predicted using pushover analysis for S lecture at 1<sup>st</sup> story drift angle of  $1/200\text{rad}$

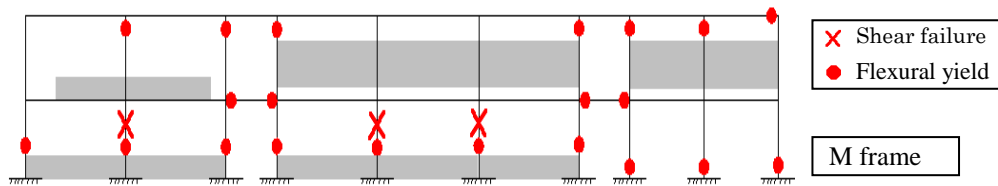
Fig.12 Damage predicted using pushover analysis for N lecture at 1<sup>st</sup> story drift angle of 1/200rad

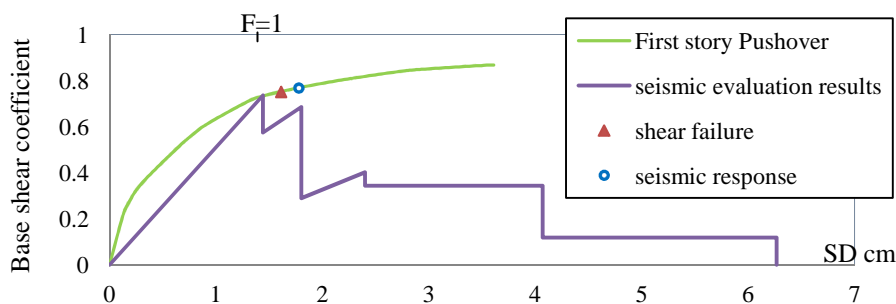
Comparison of base shear-displacement curve in the first story for both buildings between pushover analysis results and seismic evaluation results is shown in Fig.13 and Fig.14. The F index is converted to lateral displacement as follows: F=0.8 is equivalent to Inter-story drift of 1/500, F=1 is equivalent to Inter-story drift of 1/250, F=1.27 is equivalent to Inter-story drift of 1/150 and for F>1.27 the Eq.3 is used.

Fig.13. 1<sup>st</sup> story pushover and seismic evaluation results of N Lecture Building

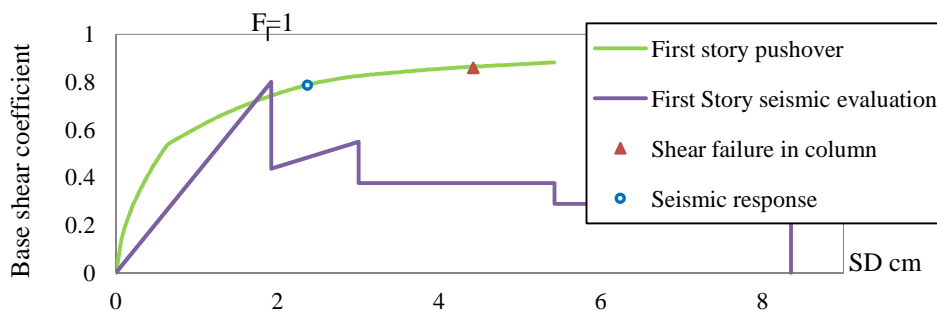
Fig.14. 1<sup>st</sup> story pushover and seismic evaluation results of S Lecture Building

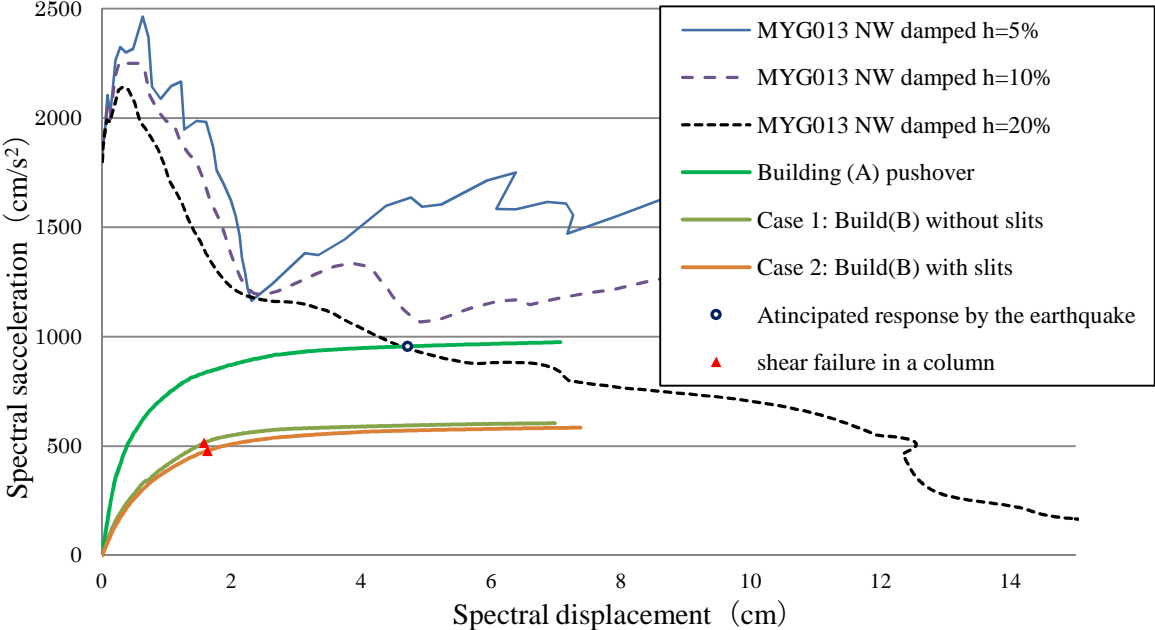
The building is oriented at an angle of 45° from North (see Fig.17). The response acceleration at an angle of 45° from north will be referred as NW in this paper. Response spectra for NW of K-net MYG013 (NIED) and NW of JMA Sendai (JMA) are plotted against pushover curve in Fig.23 and Fig.24 respectively.

Fig.23 MYG013 NW response spectrum and pushover curves

Two Response spectra, MYG013 KNET and JMA Sendai, are used for analysis. Using MYG013 response spectra, Fig. 21, it is demonstrated that more significant structural damage would occur in building (A) and a higher probability of collapse for building (B). In the other hand, the damage expected using JMA Sendai Spectra, Fig. 22, relatively matches the actual damage.

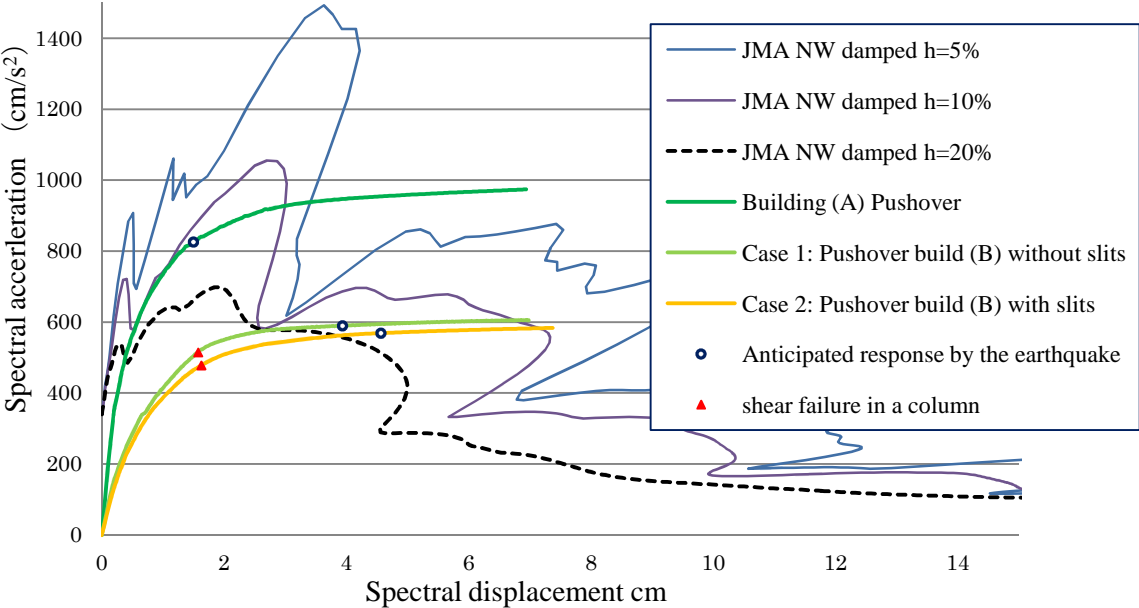
Fig. 24 JMA Sendai NW response spectrum and pushover curves

$I_s$  index for both buildings are chosen at a ductility greater than  $F=0.8$ , which means that the failure of extremely short columns was allowed in the seismic evaluation, since axial loads could be redistributed to other columns and the building will not collapse. However, short column failed only in building (B) and didn't in building (A). This is due to several reasons; The CT.SD for 1<sup>st</sup> story at ductility index  $F = 0.8$  for building (A) is about twice of building (B), Table 5. It is thought that building (A) had a story drift just less than  $F=0.8$ . This is shown in Fig. 23 using anticipated seismic response of JMA NW spectrum. Therefore short columns didn't reach their maximum allowable ductility and thus shear failure didn't occur. In the other hand, The  $I_s$  value for building (B) depends on ductility ( $F=1.75$ ) to reach the criteria of  $I_s > 0.7$ . The anticipated seismic response using either JMA NW or MYG013NW spectrum are greater than  $F=1$  (see Fig.24). Therefore all short and shear columns have collapsed.

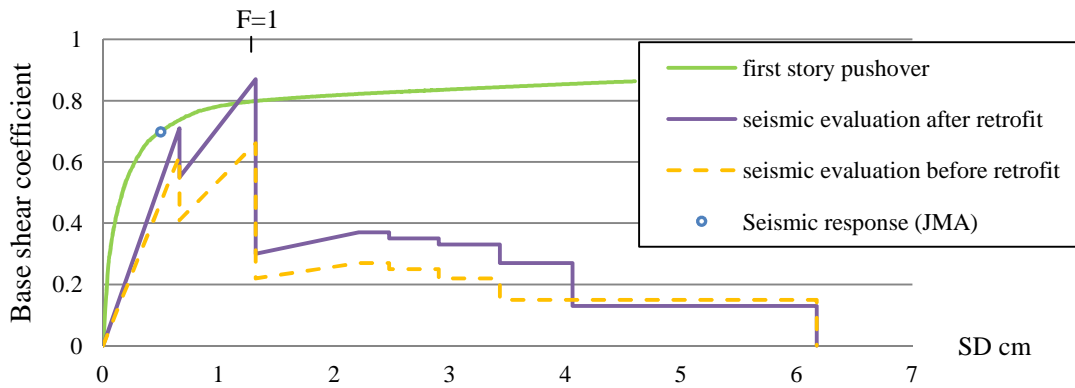
Comparison between pushover analysis results for first story for both buildings and seismic evaluation results is shown in Fig.25 and Fig.26

Fig. 25 1<sup>st</sup> story pushover and seismic evaluation results building A

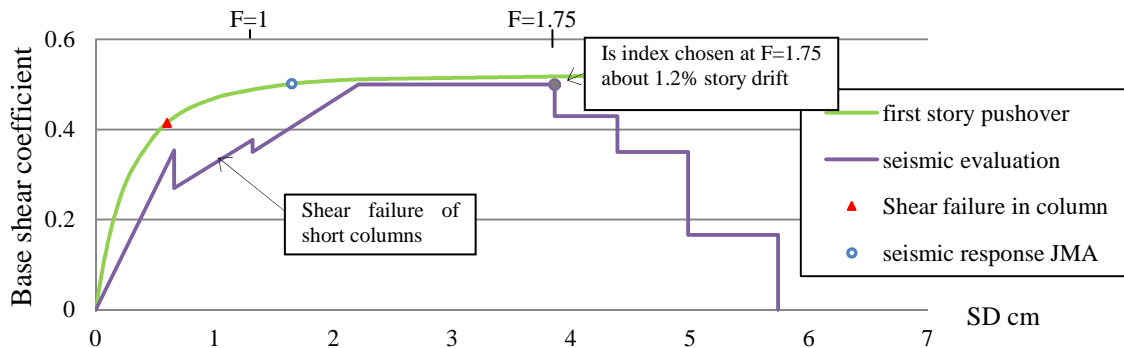
Fig. 26 1<sup>st</sup> story pushover and seismic evaluation results building B

The actual damage for building B matches the pushover analysis results in some columns and doesn't in others columns. Some columns which actually failed in shear didn't in the pushover analysis. This is because plastic hinges were expected to occur in beams and not in columns, but this wasn't the case of the actual damage. This could be due to the contribution of the slab and the contribution of hanging concrete walls to the beam's strength.
