# TOHOKU TSUNAMI-INDUCED BUILDING DAMAGE ANALYSIS INCLUDING THE CONTRIBUTION OF EARTHQUAKE RESISTANT DESIGN TO TSUNAMI RESILIENCE OF MULTI-STORY BUILDINGS

Gary CHOCK<sup>1</sup>, Ian ROBERTSON<sup>2</sup>, Lyle CARDEN<sup>3</sup>, and Guangren YU<sup>4</sup>

**ABSTRACT**: The structural details of numerous buildings in the Tohoku region were documented by the American Society of Civil Engineers. Tsunami flow depths and velocities were determined based on analysis of video records and the effects on simple benchmark structures in the flow. Failure analysis of several buildings was then used to evaluate design equations for hydrodynamic loading conditions. These findings will influence the design objectives of the forthcoming chapter on Tsunami Loads and Effects in the ASCE 7 Standard, Minimum Design Loads for Buildings and Other Structures.

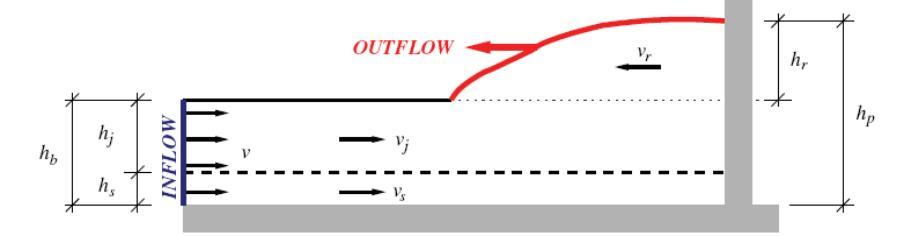
Using inundation depth estimates by the Joint Survey Group and video footage, the resulting pressure distribution was applied to a nonlinear finite element model (FEM) of the reinforced concrete wall. A tsunami bore travelling over standing water and striking a wall is addressed by the method of Robertson, Paczkowski, and Riggs (2011) for structural walls oriented perpendicular to the flow direction with a width greater than  $3h_b$  or  $3h_j$ , whichever is smaller, as shown in Figure 8. The transient lateral load per unit width of wall is given by Eq. (1).

Fig. 8 (a) Parameters for a tsunami bore travelling over standing water and striking a wall
