MICROTREMOR MEASUREMENTS OF THE HIGH-RISE BUILDINGS LEANED BY THE 2011 OFF THE PACIFIC COAST OF TOHOKU EARTHQUAKE

Kazuya MITSUJI¹, Zhiwei LIU², Susumu OHNO² and Masato MOTOSAKA³

Key Words: The 2011 off the pacific coast of Tohoku earthquake, microtremor measurement, damage investigation, high-rise building, dynamic characteristics

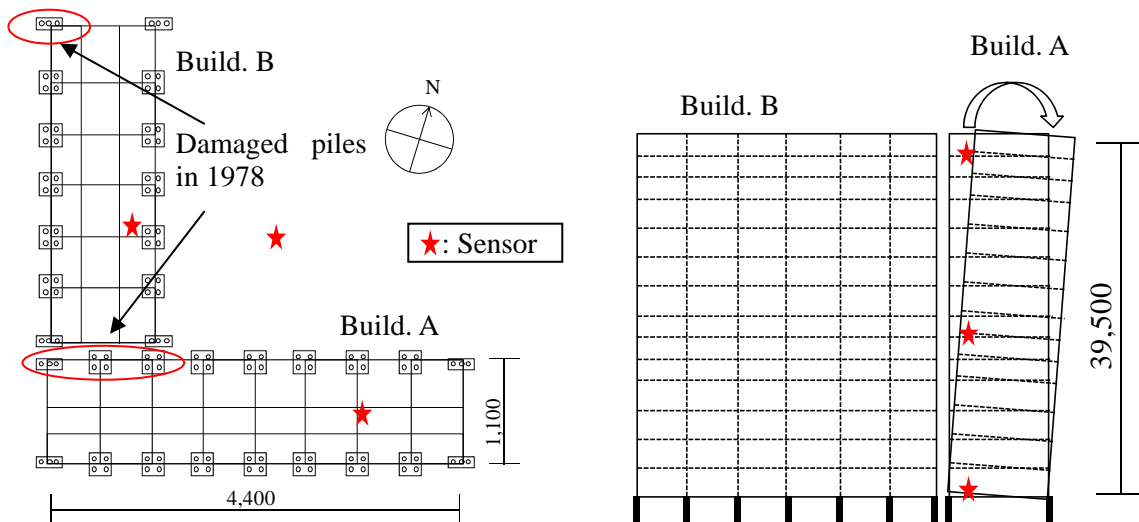
Fig. 6 Schematic plan and façade of the housing complex of STM

Schematic plan and façade of the housing complex of STM are illustrated in Fig. 6. Photos of the exterior appearance of the buildings are shown in Photo 1. Housing complex STM consists of the two buildings. Both of them are SRC 14-storey buildings supported by pile foundations. Height of both buildings is about 40m. Construction of the buildings have completed in 1976. After the completion, the buildings suffered severe shaking and were heavily damaged by 1978 Miyagi off shore earthquake ($M_j=7.4$).

The buildings had been also damaged by the 1978 Miyagi off shore earthquake, then some group piles that are marked by red circles in the left figure of Fig. 6 were heavily damaged (Shiga 1980, Sugimura and Oh-oka 1981). According to the damage investigation report of the 1978 Miyagi off shore earthquake, concrete body of pile were crushed, some steel bars indicated buckling and shear cracks were observed at the pile head in some group piles. Those buildings were restored after the 1978 Miyagi earthquake, and residents have kept living in those buildings before the earthquake of March 11 occurred.

After the main shock of 2011/03/11, the buildings have been heavily damaged by strong shaking again. Building A and B were connected by expansion joint that were demolished by dynamic behavior of the buildings. Building A and B forms L-shape plan shown in Fig. 6. Dynamic behavior of each building is completely different, because strong axes cross each other. Most characteristic damage is that building A indicates remarkable inclination in NS direction as shown in the photo in
