Mechanism of Slope Failures in Residential Land on Fill during Great East Japan Earthquake

ABSTRACT: As a result of the Great East Japan Earthquake, five slope failures occurred in a residential area on artificial valley fills in Taiyo New Town, Yamamoto, Miyagi Prefecture. The fill material is sandy, derived from the weathering of tuffaceous sandstone which formed the natural ground. Cyclic triaxial tests showed that the fill, which has about $F_c=20\%$, has very low liquefaction resistance, which decreased with application of initial shear stress. Thus, the slope failure in Taiyo New Town can be attributed to the liquefaction of the fill material induced by the intense shaking.

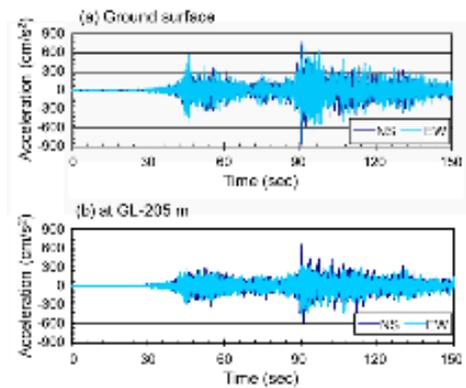
Figure 2. Acceleration time histories obtained from Yamamoto KiKNet Seismic station: (a) at ground surface; (b) at GL-205m (data from KiK-Net website)

About 2km to the south of Taiyo New Town, the National Research Institute for Earth Science and Disaster Prevention (NIED) operates a KiK-Net seismic station (MYGH10: Yamamoto Station) with digital strong-motion seismometers installed at the ground surface and at a depth of GL-205m. The 2011 Tohoku earthquake triggered many seismic stations in the area, including the one in Yamamoto, and recorded strong motions. Figure 2 shows the acceleration time histories recorded at the station, both on the surface and at depth, while Figure 3 illustrates the corresponding Fourier spectra of the acceleration records. The peak accelerations recorded at depth were in the range of 150~220 cm/sec^2 with predominant frequency of 0.35 Hz. On the ground surface, on the other hand, the peak values were much higher, 850~870 cm/sec^2 , with the predominant frequency shifting to 4-6 Hz.

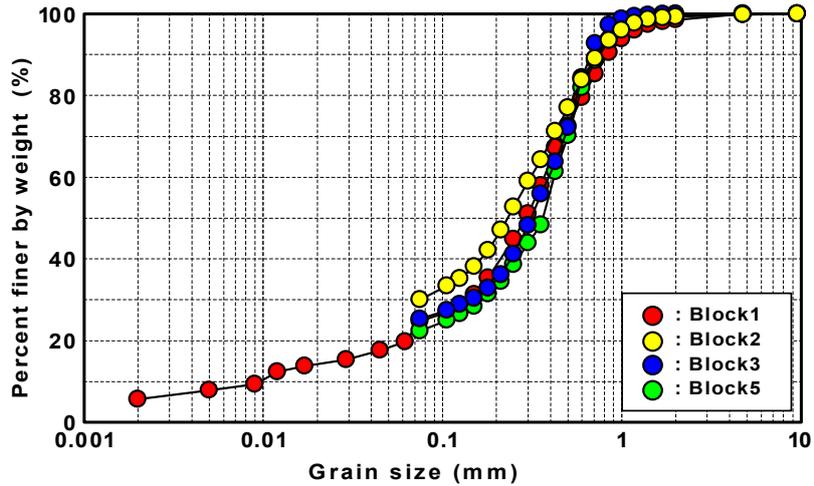
Figure 6. Grain size distribution curves of samples obtained from four sites

Soils samples were obtained near failed Blocks 1, 2, 3 and 5 in order to investigate the geotechnical properties of the soil used as fill. Figure 6 shows the grain size distribution curves for samples from the four sites. It can be seen that the curves were fairly similar at all three locations, indicating that the fill materials were uniform throughout the housing site. The soil has a fairly uniform distribution with fines content, $F_c=20\%$.

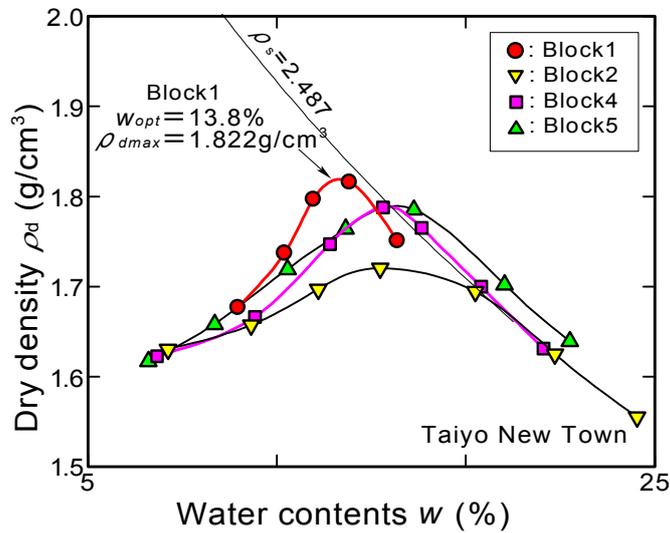
Figure 7. Compaction curve

Samples obtained from Block 1 site were quite abundant and these were used in most of the geotechnical tests. Index property tests, based on Japanese Geotechnical Society standards (JGS, 2001) showed that the density of the particles was 2.478 g/cm^3 , while the maximum and minimum densities were 1.319 and 1.079 g/cm^3 , respectively. The compaction curve is shown in Figure 8 where it is seen that the optimum water content is $w_{opt}=13.8\%$ corresponding to maximum dry density, $\rho_{dmax}=1.822 \text{ g/cm}^3$.

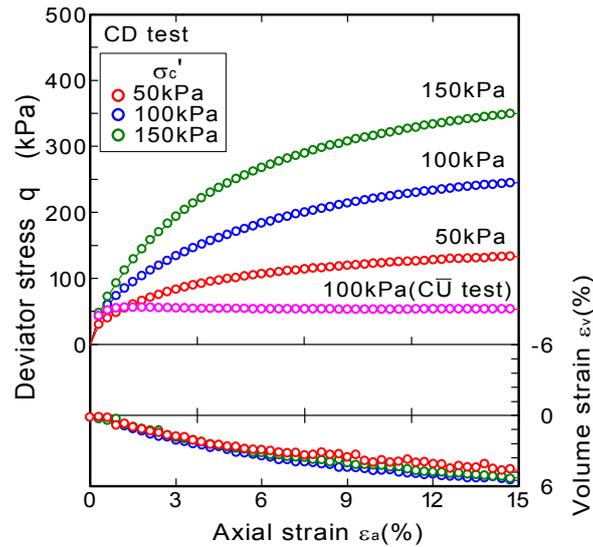
Figure 8. Results of consolidated drained triaxial tests

Next, monotonic drained and cyclic undrained triaxial tests were conducted on the soil samples. In these tests, the reconstituted samples were prepared such that they have dry density equal to 90% of the maximum dry density, i.e., degree of compaction $D_c=90\%$. Using the obtained maximum and minimum dry densities, this corresponds to a relative density $D_r=188\%$. The results of the monotonic drained tests for confining pressure of $\sigma_c'=50, 100$ and 150 kPa are shown in Figure 8. The undrained shear test was also performed for confining pressure of $\sigma_c'=100$ kPa and presented in the figure. The soil shows contractive behavior at all levels of applied pressure. This may be due to the collapsible behavior of weathered tuffaceous sandstone. From the stress-strain relations, Mohr circles of stress were drawn at residual state as shown in Figure 10, and the strength parameters were obtained. The results indicate the following values: cohesion, $c=9$ kPa, and angle of internal friction $\phi=31.7^\circ$. Such internal friction angle is quite low for sandy soils.

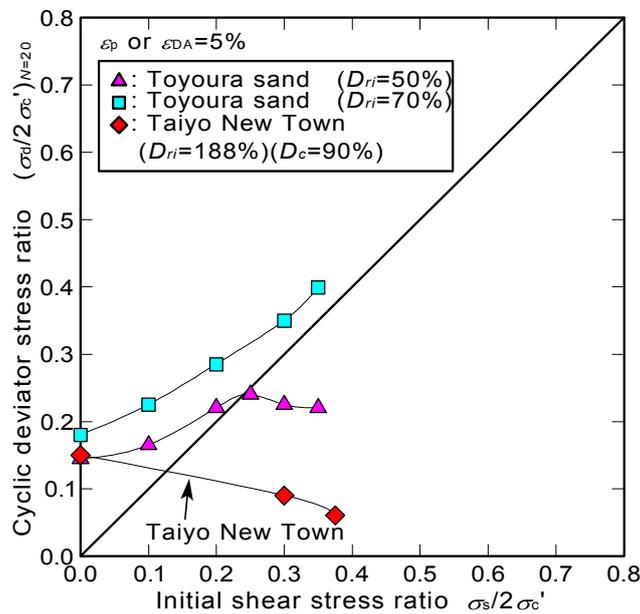
Figure 11. Variation of cyclic strength at $N=20$ cycles with initial shear stress ratio

materials (Vaid, 1983; Hyodo et al., 1991, 1994; Hosono and Yoshimine, 2004). This confirms that the fill material is indeed weak and susceptible to large deformation under earthquake loading. Figure 11 shows the cyclic deviator stress ratio to cause failure after 20 cycles. The results for Toyoura sand with $D_r=50\%$ and $D_r=70\%$ are also shown in the figure for comparison. In the case of Toyoura sand, the cyclic strength increases with initial shear stress ratio as expected for medium to dense material. However, in the case of the sampled soil, the cyclic strength decreased with increasing initial shear stress ratio, although it should be noted that the definition of failure changed from $\varepsilon_{DA}=5\%$ to $\varepsilon_p=5\%$. Further it should be noted that failure occurred for stress non-reversal condition at the material while stress reversal was necessary to cause failure at dense Toyoura sand.

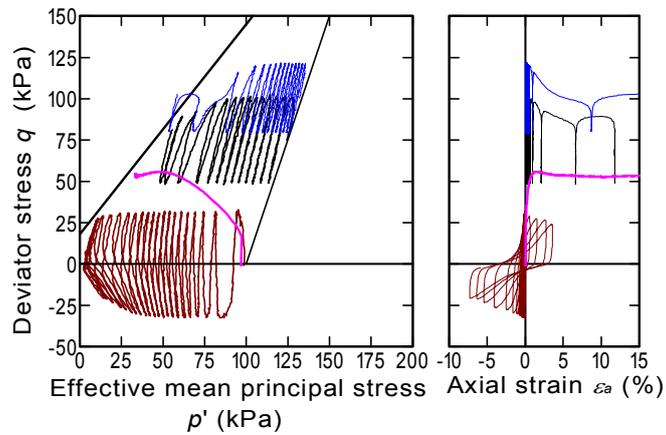
Figure 12. Cyclic stress paths and cyclic stress strain curves for isotropically and anisotropically consolidated samples

Figure 12 shows the stress paths and corresponding relationship between cyclic deviator stress and axial strain for both isotropically and anisotropically consolidated samples. Examination of the cyclic stress paths for isotropically consolidated sample shows liquefaction occurring as the stress path cycles through zero effective confining pressure. The development of cyclic strains occurs in both compression and extension. The cyclic failure was defined as a strain double amplitude of 5% ($\varepsilon_{DA}=5\%$). On the other hand, the cyclic stress paths for anisotropically consolidated samples shows cyclic failure occurring as the stress path reaches to the failure envelope developed by monotonic shear tests. The corresponding cyclic stress strain plots are shown taken to peak axial strain of approximately 15%. It should be noted that cyclic strain amplitude becomes larger as the stress path approaches to failure envelope. The cyclic strength for anisotropic samples was defined as the number of cycles to reach peak axial strain $\varepsilon_p=5\%$.

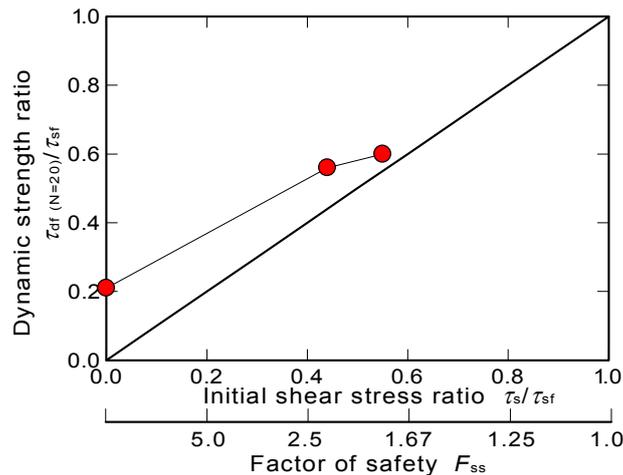
Figure 14. Relation between dynamic strength and initial stress obtained from triaxial test results

In addition to the analyses using conventional strength parameters, a supplementary analysis was performed using the results of cyclic triaxial tests instead. In such analysis, two stages were considered: static analysis prior to the application of the seismic load, and dynamic analysis using pseudo-static approach. In the static analysis, the strength parameters (cohesion c and frictional angle ϕ) obtained from conventional tests were used. Since the calculated factor of safety, F_s , indicates the ratio of the shear resistance, τ_{sf} , and shear stress, τ_s , along the slip surface (i.e., $F_s = \tau_{sf} / \tau_s$), it is possible to estimate the average static shear stress along the slip plane from the known values of F_s and τ_{sf} . From Figure 11, the cyclic shear resistance ratios corresponding to $N=20$ cycles were read from the curves, and the data were used to plot the dynamic strength ratio, τ_d / τ_{sf} , as a function of the initial shear stress ratio, τ_s / τ_{sf} , as illustrated in Figure 14. Thus, knowing the average static shear stress along a slip plane, the corresponding cyclic resistance (or dynamic strength) can be estimated. The cyclic resistance is added to the initial static shear stresses and then used as strength parameters in performing the pseudo-static analysis to compute the F_s for the specified earthquake load. Note that in this procedure, it is tacitly assumed that the earthquake loading is applied for $N=20$ cycles.
