DAMAGE TO EIGHT-STORY RC BUILDING RETROFITTED TO HAVE BASE SHEAR COEFFICIENT OF 0.65

ABSTRACT: An eight-story reinforced concrete building retrofitted according to the 1990 Japanese Standard was severely damaged during the 2011 Tohoku earthquake. The building was constructed in 1966 at Tohoku University. In 1996 the building was retrofitted using structural walls and carbon fiber. The base shear coefficients of the building in the longitudinal and transverse directions after the retrofit were estimated to be 0.67 and 0.65, respectively. This paper discusses the reasons for the severe damage that took place despite the retrofit.

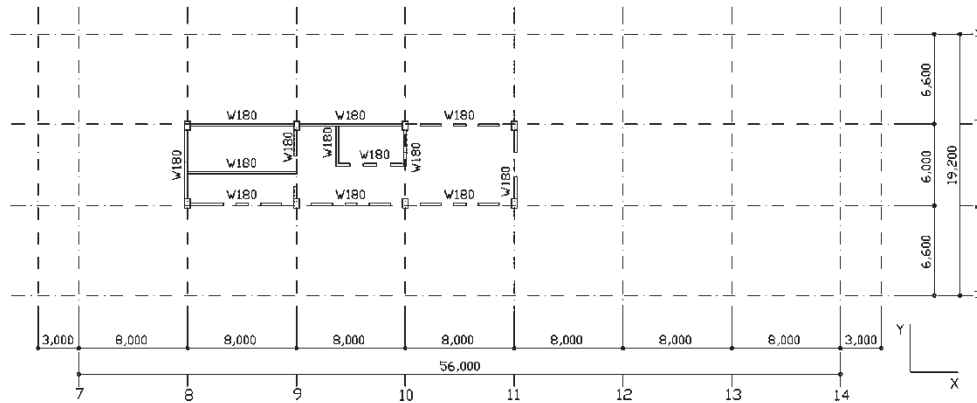
Fig. 2 First story of the penthouse plan

In the penthouse, the reinforcement bars used are 9 mm @200 double in 200 mm thickness walls and single in 120 mm thickness walls (Fig. 2). According to the pictures the used bars are all plain in the penthouse walls. In the columns the reinforcement bars are 14-D25 for the first story and 10-D25 for the second story and their stirrups are 9 Ø @150. It is also noteworthy that the penthouse of this building is quite slender. Its geometric slenderness is 1.40 and it may have affected the damaged inflicted to the walls and columns of the penthouse.

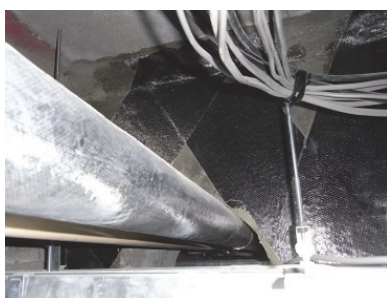
Photo 2 Stuck tape-shaped carbon fiber

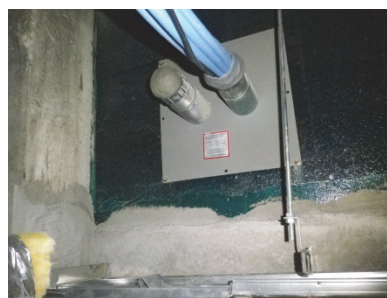
Photo 3 Stuck carbon fiber without anchors

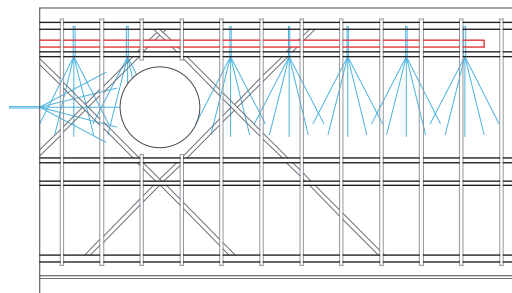
Fig. 9 Bars and anchors

Figures 8, 9 and 10 show the reinforcement detail of the 400 mm x 1000 mm beam in Photos 10 and 11. It is between a column on the left side and a wall in the right one. Its longitudinal reinforcement is 25 Ø, the diagonal reinforcement is 16 Ø and the stirrups are 13Ø. The only data obtained about the anchorage is that, according to photo measurement, it is around 12 Ø.

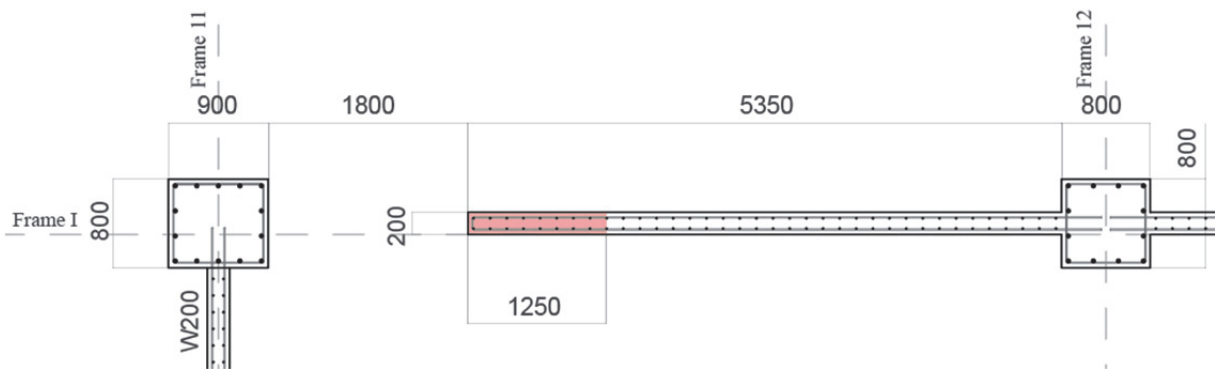
Fig. 11 Detail of the wall at 6th story, between frames 11-12 of the frame I

Compressive failure associated with flexural failure was observed in walls without boundary column as shown in Photo 13. The detail of the wall is provided in Fig. 11. The wall has double 9 \varnothing 150@ reinforcement. Some bars were not found in the plans but were visible at the place (Photo 14), the one on the left side may be a reinforcement at the end of the wall. According to the recent study (Takahashi et al, in press), the flexural drift capacity of RC wall can be computed as sum of elastic and plastic drifts and plastic, where the plastic drift is estimated by using the neutral axis depth, plastic hinge length and ultimate compressive strain of concrete. The calculated neutral axis depth is 1250 mm from the border of the wall and is shown in Fig. 11. The height of the observed compressive failure zone was almost 2.5 times of the wall thickness (Photo 13) as predicted by Takahashi et al (in press). From Photo 13, it is supposed that the compressive strain of concrete was very large. If we assume that the compressive strain was from 1% to 2%, the flexural drift is estimated from 0.6% to 1% by the methodology proposed by Takahashi et al. Therefore, actual lateral drift of this building is assumed to be comparable to these values.

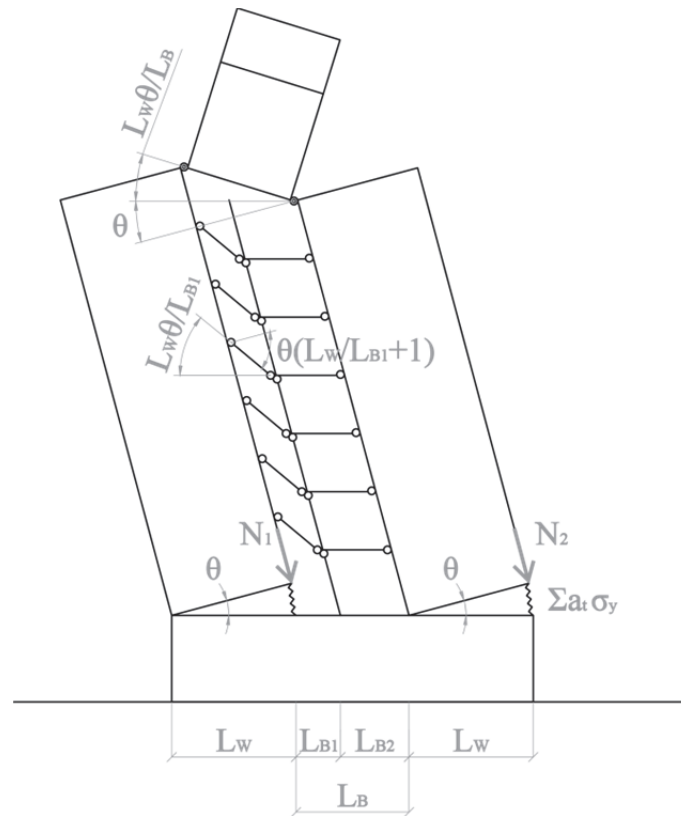
Fig. 18 Model of calculation for the frame number 11

Due to the damages seen in frame 11 (Fig. 5) the short beams between frames I-J failed in shear. Therefore, the failure mode as shown in Fig. 18 is assumed to estimate the lateral capacity of this frame. In this model the walls of frames H-I and J-K are strong enough while the coupling beams fail. For the analysis the first story is considered as rigid, because it does not have significant damages. These walls rotate as shown in Fig. 18 and vertical reinforcement bars are assumed to be yielded at the bottom of the second story, where a_t is the cross section area of the longitudinal reinforcement on boundary column and σ_y is the yield strength of the steel. The values N_1 and N_2 are the long term loading axial forces through the boundary columns of the walls. The double circle in this figure represents the plastic hinge of the joint and its plastic moment is computed as sum of the plastic moment of the column and that of the beam.

During the analysis, two models have been proposed. In the first one the short beams of the span L_{B1} of the model are completely destroyed, and in the second one the beams yield in flexure at both ends. According to the documents of the seismic evaluation, the lateral capacity of the frame number 11 is 10.7 MN; considering the walls from the second, third and fourth story as flexural walls and the rest as shear walls. According to the model of the analysis, all the walls have been considered as flexural walls because of the hinge in the base of the walls of the model. This assumption is admissible since the small width of the cracks found in the walls of the building indicates that almost every wall yield in flexure rather than fail in shear. As to the results of the analysis, the flexural capacity of the frame number 11 is 8.7 MN, in the case of considering the contribution of the coupling beams. In the case of neglecting those beams the flexural capacity is 6.5 MN. Thus, the real value is between these two results and is a fact that the beams make an important contribution to the capacity of the frame, being around the 25% of the total capacity.
