SEISMIC PERFORMANCE OF REINFORCED CONCRETE SCHOOL BUILDING IN FUKUSHIMA UNDER THE GREAT EAST JAPAN EARTHQUAKE

Kazuya KAMATAKI¹, Akira TASAI², and Koichi KUSUNOKI³

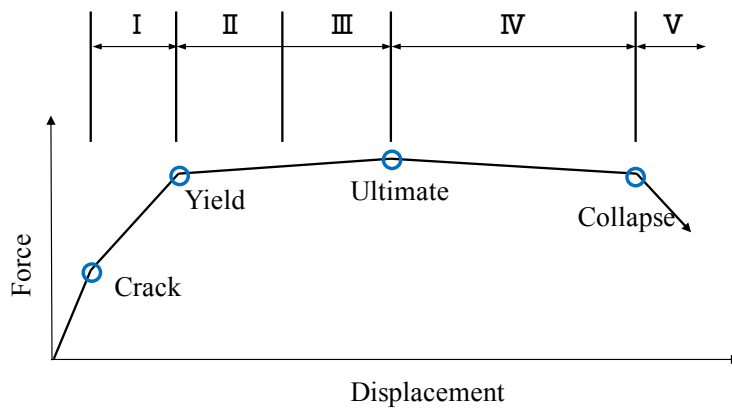
Fig. 11 Seismic performance level

Fig. 15 shows the shear damage pattern in the Building A by observation after the Great East Japan Earthquake, which is described in Fig. 11.

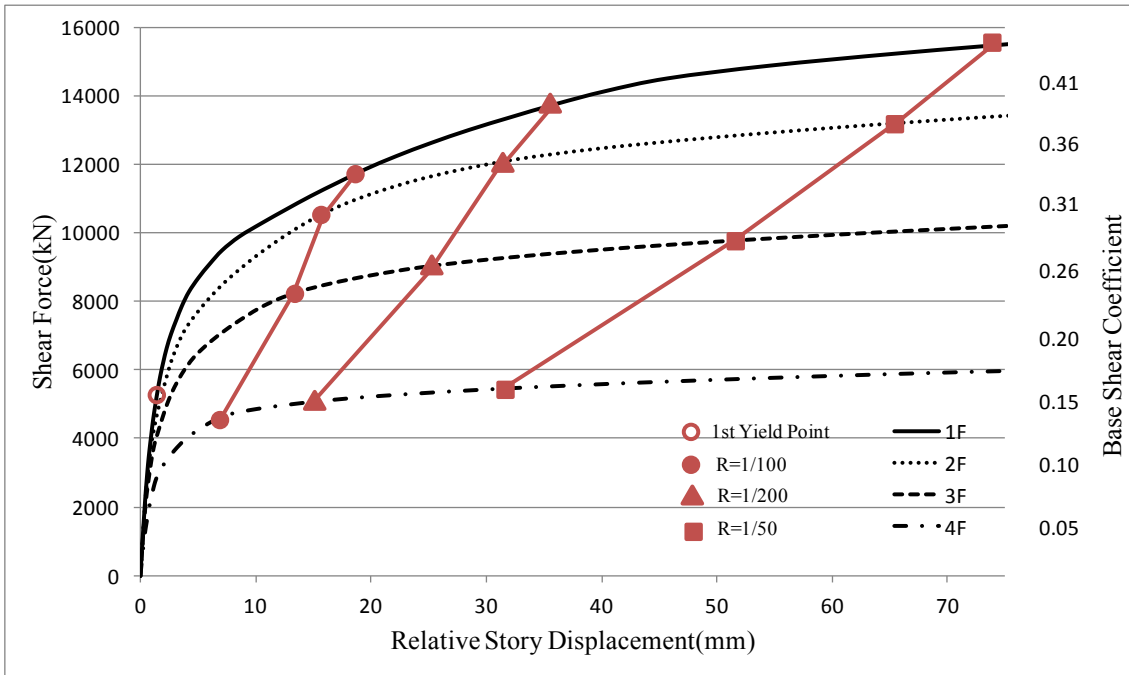
Fig. 12 Capacity curve of the Building A

The inverted triangular external force distribution along the building height conducts the nonlinear static analysis of the structure. The purpose of this study is to analyze the most affected structure (Building A) in the weakest direction (X axis). The shear force and relative story displacement of the Building A is show in Fig, 12.
