BUILDING DAMAGE IN NARITA, SAKURA AND THE TONE RIVER BASIN IN CHIBA PREFECTURE

ABSTRACT: The 2011 Tohoku-chiho Taiheiyo-oki Earthquake that occurred on March 11 caused severe damage to buildings. In Chiba Prefecture, a Japanese Meteorological Agency (JMA) seismic intensity scale (I_{JMA}) of six-minor was recorded at Narita, Inzai-sasagami and Inzai-ohmori. Tsunami damage on the Pacific side and liquefaction damage on the Tokyo Bay side and along the Tone River of Chiba were severe. In addition to this damage, there was building damage by liquefaction. We report here on the building damage in Chiba Prefecture.

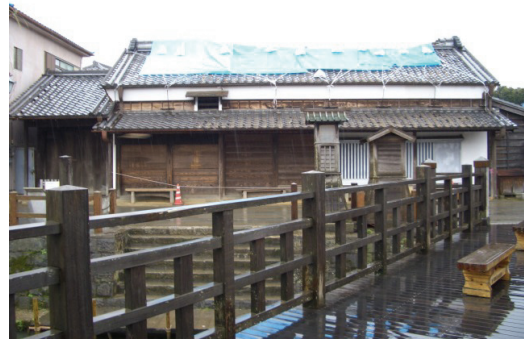
Figure 9 Old Ino Tadataka residence

In the important traditional building preservation area of Sawara, the roof tiles and plaster walls of traditional buildings were dislodged and collapsed (Figures 7 and 8). The government-designated excavation of the ruins of the old Ino Tadataka residence was closed and its roof was covered with blue tarpaulins (Figures 9 and 10). Mitsubishi-kan, which is a significant cultural property of Chiba, had no structural damage (Figure 11).

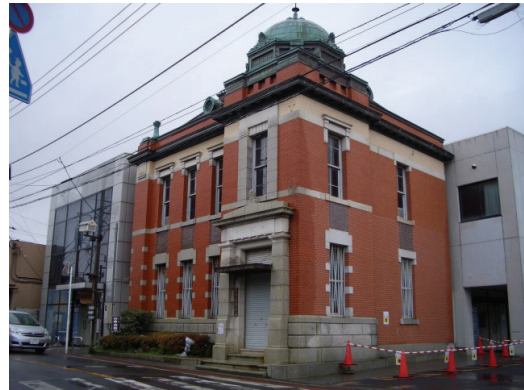
Figure 11 Mitsubishi-kan (no damage)

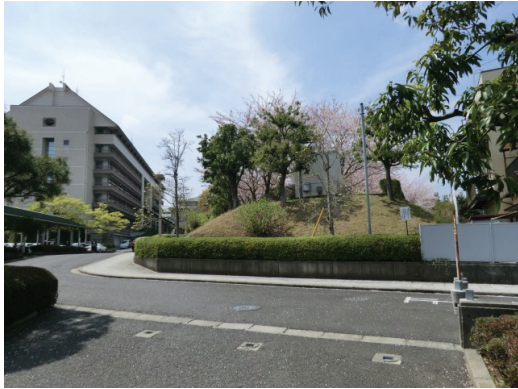
Figure 26 JMA Narita station and Narita city hall.

A JMA seismic intensity scale (I_{JMA}) six-minor earthquake was recorded at JMA Narita. The level six-minor was the maximum I_{JMA} recorded in Chiba Prefecture. The JMA Narita station was set up on higher ground than the neighboring area. Figure 26 shows the JMA Narita station and Narita city hall. Damage to exterior walls was observed in a steel structure near the JR Narita station (Figure 27). No other damage was observed apart from fallen roof tiles. Damage to housing was mainly uneven settling over a limited area caused by land failure. A collapsed ceiling in a public building was also reported.

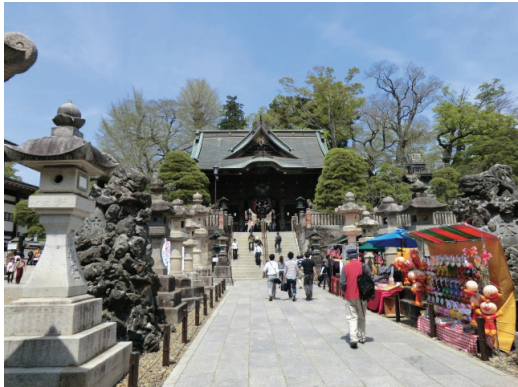
Figure 28 Naritasan Shinsho-ji Temple

Timber buildings in the Naritasan Shinsho-ji Temple had no structural damage but many stone structures, such as a stone lantern, had fallen.

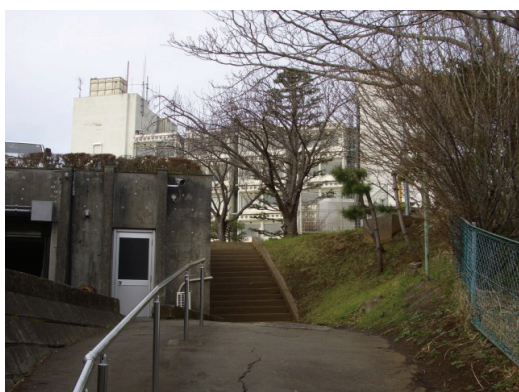
Figure 30 K-NET station and Sakura city hall on the hill.

A peak ground acceleration of 1,053 cm/s/s was recorded at the K-NET Sakura station (NIED). The station is set on a slope above the city hall. Figure 30 shows the K-NET Sakura station and city hall. Figure 31 shows the cityscape from Sakura city hall. The damaged roof tiles were covered in blue plastic tarpaulins. There were cracks in the stairs of a building near Keisei-Sakura station located in the low-lying area.

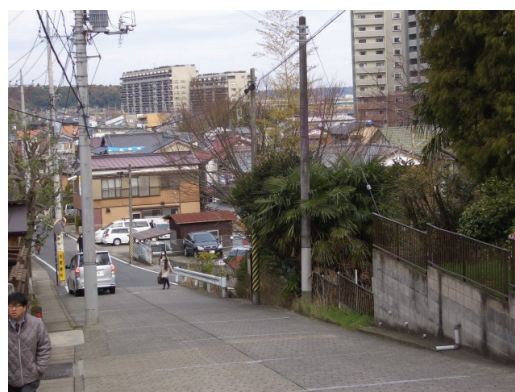
Figure 31 Cityscape from Sakura city hall
