# **BUILDING DAMAGE BY THE 2011 TOHOKU JAPAN EARTHQUAKE AND COPING ACTIVITIES BY NILIM AND BRI COLLABORATED WITH THE ADMINISTRATION**

**ABSTRACT:** This paper presents the outlines of the strong motions recorded in and around the buildings by the BRI Strong Motion Network, the motion induced building and residential land damage and the tsunami induced building damage by the 2011 Tohoku Japan earthquake. On-going coping activities in order to establish necessary technical standards collaborated with the administration are also introduced.

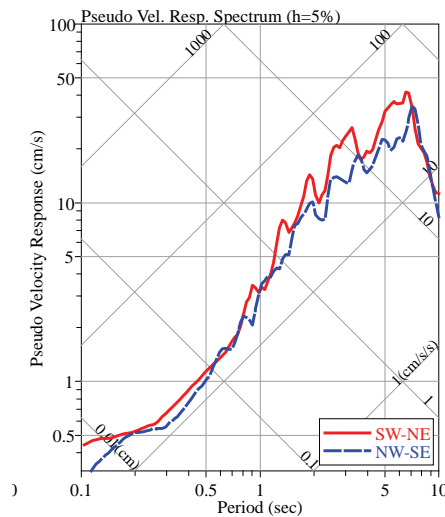
Fig. 2 Records of strong motion

During the earthquake, long-period earthquake ground motions were observed in Tokyo, Osaka and other large cities. One example is the 55-story steel office building on the coast of Osaka Bay that is 770 km away from the hypocenter. Photo 2 and Fig. 2 show the appearance of the building and the records of the absolute displacement waveforms. The absolute displacements in the SW-NE and in the NW-SE directions on the 1<sup>st</sup> floor was less than 10 cm, but the 52<sup>nd</sup> floor in the building suffered a large motion with a zero-to-peak amplitude of more than 130 cm. The pseudo velocity response spectra for the 1<sup>st</sup> floor records (Fig. 3) show clear peak at about 7 second period resulted in large earthquake responses at the top due to a resonance phenomenon.

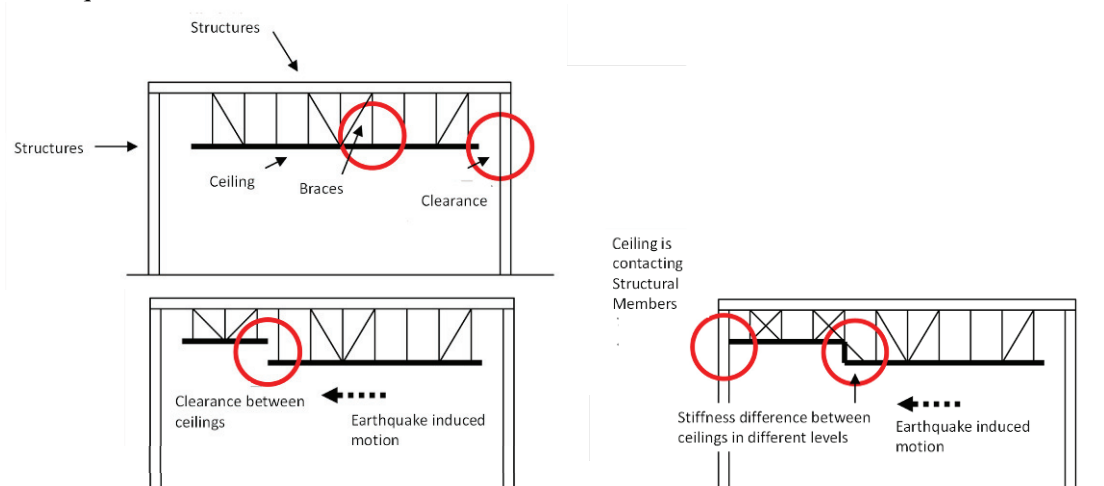
Fig. 33 Schematic explanation of current technical advice on details of ceilings

The problem of fallen down of the ceilings which cover large space such as gymnasiums and so on has been indicated by NILIM and BRI since 2001 Geiyo earthquake, and technical advice to keep appropriate clearance between ceiling and surrounding structure and to install appropriate amount of diagonal braces on hanging bolts as shown in Fig. 33 with the collaboration of the administration.

In the earthquake, huge number of large space ceilings fell down and even casualties occurred. Therefore, extensive detailed survey on fallen down ceilings in the earthquake was initiated, where 151 damaged ceilings are collected and 11 of them were studied in detail. Based on this study with the

previous knowledge, the current qualitative technical advice is under the study to be modified into much quantitative one.

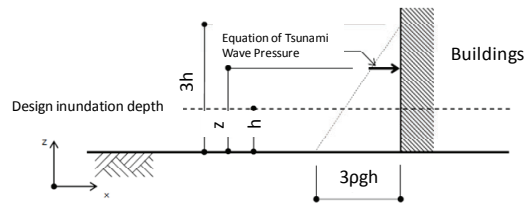
Fig. 34 Design tsunami force in the guidelines by the Cabinet Office

As for the design of buildings against tsunami force, the guidelines for tsunami evacuation buildings (Cabinet Office 2005) are the unique technical information at present. These guidelines are established as part of the countermeasures for Tonankai-Nankai earthquake provided by the Central Disaster Management Council. In the guidelines, the tsunami force is considered to be equivalent static water pressure as shown in Fig. 34 where the static water pressure of 3 times of the inundation depth is considered including the tsunami dynamic force. Here, 3 is the coefficient of water depth proposed by the waterway model test (Asakura, et al. 2000).

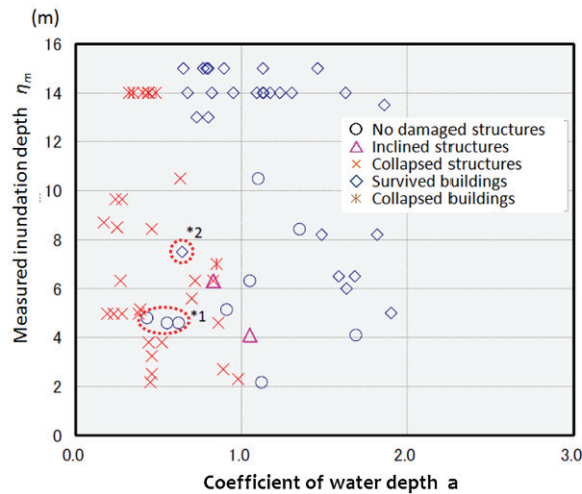
Fig. 35 Estimated coefficient of water depth of detailed studied buildings

About 100 buildings were carefully selected and studied in detail as explained above. First, the horizontal resistant strength of each building is evaluated whether damaged or not from the surveyed dimensions. Next, the coefficient of water depth is calculated so that the tsunami horizontal force estimated considering the observed inundation depth at or around the building as a function of the coefficient agrees with the calculated building strength. Figure 35 shows the relation of tsunami inundation depth and the estimated coefficient for the studied buildings. It can be seen that the coefficient of water depth is about 1.0 and it reduces as the inundation depth increases.

In the tentative guidelines announced from the administration in December 2011, the coefficient of water depth was relaxed as 2.0 in case the building was blessed by the shading effect from front building and/or embankment and further relaxed as 1.5 in case the building located at 500 m or larger from the coastline and river in addition to shading effect. The effect of the openings of the building is also taking into account in the tentative guidelines.
