FRAGILITY ENHANCEMENT IN SEISMIC-TSUNAMI RISK REDUCTION FOR NUCLEAR POWER PLANTS

Naotaka TAKAMATSU¹、Hiroyuki KAMEDA² and Katsumi EBISAWA³

³ Associate Vice President, JNES, Tokyo, Japan ebisawa-katsumi@jnes.go.jp
(JNES: Japan Nuclear Energy Safety Organization)

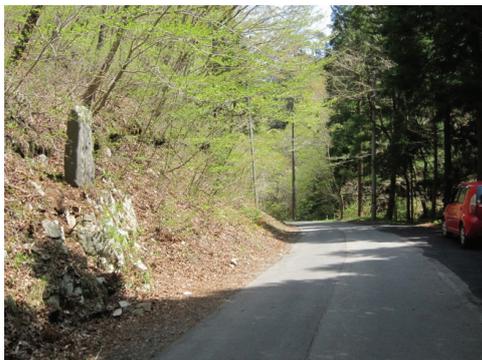
(1) A photo from the village’s point of view
(Average height of district: about 60 m)

The stone monument stands at the Aneyoshi district in Miyako city as shown in **Fig.9(1)**. As lessons learnt from past experience of the tsunami disaster, the inscription reads as “Do not build any house below this stone”. Run-up height of 38.9 m by Tohoku earthquake was observed as shown in **Fig.9(2)**. Thanks to having followed this ancient instruction, Tohoku earthquake did not claim a single casualty in this district. It is seen that the fate depended on whether this kind of previous tsunami lessons had been reflected in tsunami design or not (Japanese government 2011).

Fig.9(1)-(2) Ancient instruction and observance in Miyako city

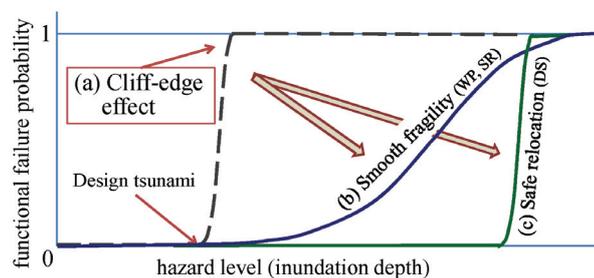
Fig.13 Enhancement of fragility under tsunami threat (Kameda 2011, Kameda 2012)

Vulnerability of electric devices to water intrusion (like switch boards, motors for seawater pumps, cables, etc.) should be drastically improved. This is a very specific feature of tsunami protection, compared to ground motion protections. We have seen the cliff-edge effects drastically as shown in Fig.13. If the tsunamis exceeded the design, then we suddenly get 100% malfunction. This is extreme dangerous, so eliminating the cliff-edge effect through making smooth fragility or relocating to a safe location. We need to do this kind of enhancement.
