DAMAGES TO REINFORCED CONCRETE BUILDINGS OBSERVED IN FUKUSHIMA AFTER THE 2011 EAST JAPAN EARTHQUAKE

Toshimi KABEYASAWA¹, Koichi KUSUNOKI², Daisuke KATO³,
Toshikatsu ICHINOSE⁴, and Akira TASAI⁵

ABSTRACT: This paper reports on structural damages to reinforced concrete buildings observed in Fukushima prefecture after the 2011 East Japan Earthquake. The survey was conducted as part of reconnaissance activity of AIJ, Architectural Institute of Japan. Typical severe damages to reinforced concrete school buildings are outlined, both by the ground motions and the tsunami waves, based on the detailed field observation and with ground motions recorded at K-net stations nearby. The causes of the damages are discussed with problems peculiar to the buildings.

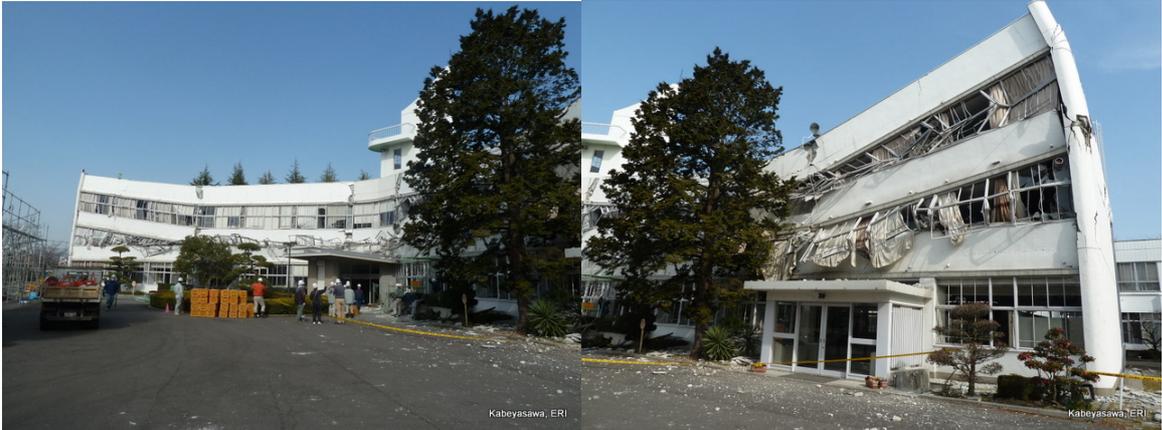
Photo 1 South overviews of west wing and east wing

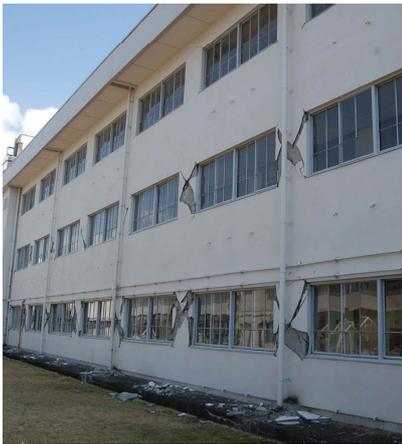
Photo 5 An overview

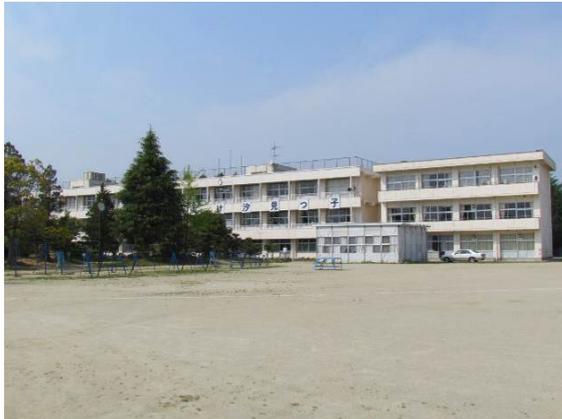
The first floor plan with the damage grade of structural members is shown in Figure 6.2.19. The longitudinal direction of the building is composed of moment resisting frames including secondary walls. In this direction, minor cracks of damage level I or II were observed in many columns and their wing walls. The transversal direction of the building is rigid-frame structure with seismic walls of 100-120 mm in thickness. Diagonal cracks whose maximum damage level was level III were observed in the seismic walls at the first floor.

(a) South side view of the building

Photo 7 An overview and damage of S-elementary school

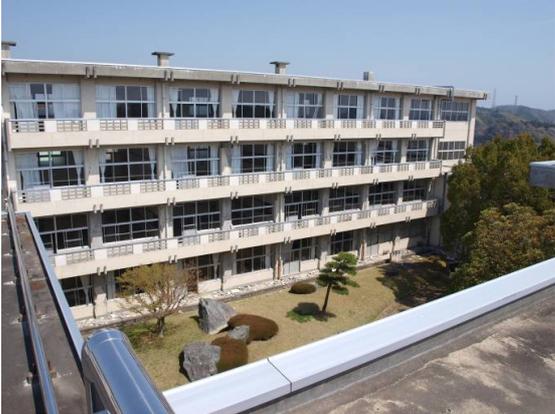
An overview of the Building A is shown in Photo 8. The north frame of the building was severely damaged, and the columns of the special classroom at the west end of the building in the first floor failed in shear up to the damage index of V. The vertical shortening of the columns was estimated obviously from the deformation of the window frames between them as shown in Photo 9. On the other hand, the shear wall at the west end of the building suffered no serious damages as shown in Photo 10. Some girders with standing wall in the north frame failed in shear. The floor level of Building A was 15cm lower than that of Building C. The residual seismic capacity index was calculated as $R=33.3\%$ for the longitudinal direction in the first story, by which the damage was classified into the severe damage.

Photo 8 An overview of the building A

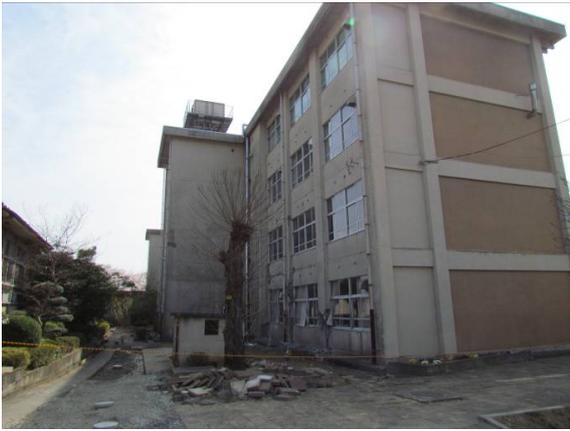
Photo 10 West side view of the building A
