# LESSONS AND VIEWS ON HARDWARE COUNTERMEASURES WITH EARTH BANKS AGAINST TSUNAMI ESTIMATED IN 2011 GREAT EAST JAPAN EARTHQUAKE

Ken-ichi TOKIDA<sup>1</sup> and Ryusuke TANIMOTO<sup>2</sup>

**ABSTRACT:** Through the field survey after the 2011 Great East Japan Earthquake, 13 damaged and/or non-damaged earth banks and 10 eroded dug pools related to the tsunami flood stream are investigated to focus on the effects of earth banks against the tsunami. Based on the investigations, important lessons on the hardware countermeasures against the tsunami with the earth banks are learned, and the performance-based design concepts for the reconstruction in this earthquake and the future tsunami disaster can be proposed.

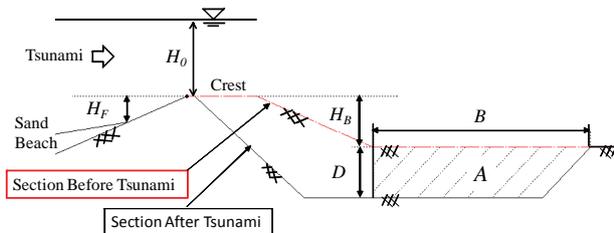
Fig.4 Identification of dug pool

where  $A$ : area of eroded section of sea wall or bank identified in Fig. 4 ( $m^2$ ).

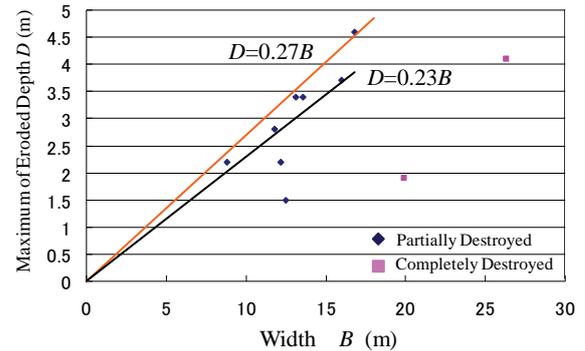
Fig.5 Relation between  $D$  and  $B$

The relation between  $D$  and  $B$  can be drawn in Fig. 5 and the average relation and the upper limit can be estimated, respectively as

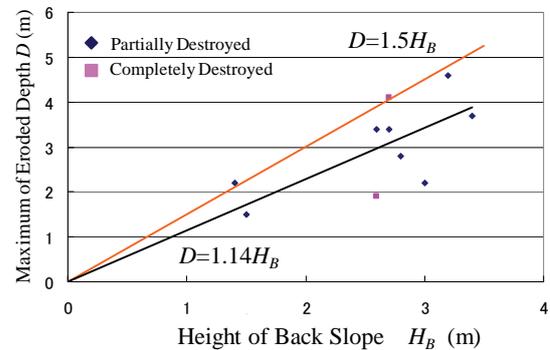
Fig.6 Relation between  $D$  and  $H_B$

The relation between  $D$  and  $H_B$  can be drawn in Fig. 6 and the average relation and the upper limit can be estimated, respectively as

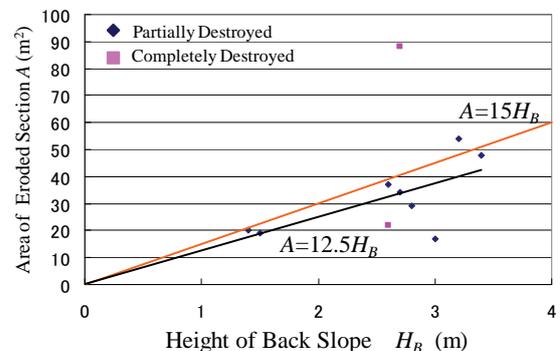
Fig.7 Relation between  $A$  and  $H_B$

The relation between  $A$  and  $H_B$  can be drawn in Fig. 7 and the average relation and the upper limit can be estimated, respectively as

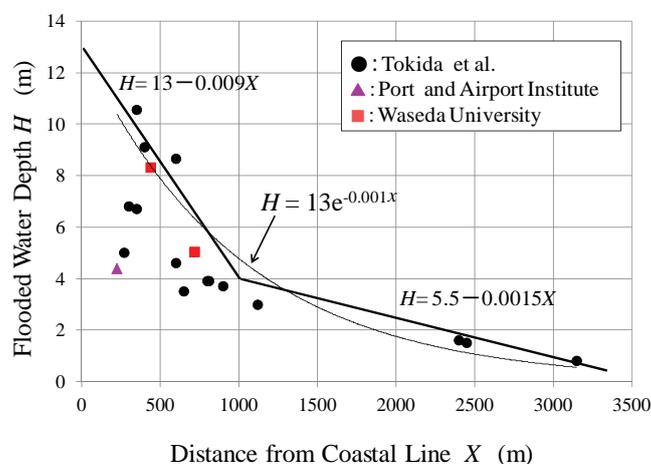
Fig. 10 Relation between flooded depth and distance from coastal line at Sendai Plane

The relations between the flooded depth and the distance from the coastal line can be drawn as in Fig. 10 where the relation is shown as
