SOME CONSIDERATIONS BASED ON OBSERVATIONS OF DISASTER-STRICKEN AREAS IN MIYAGI, IWATE AND AOMORI PREFECTURES AFTER THE GREAT EARTHQUAKE AND THE ISLAND OF OKUSHIRI

Kiyoshi SHINGU¹

ABSTRACT: The author visited disaster-stricken areas in Miyagi, Iwate, and Aomori prefectures after the 2011 great east Japan earthquake, and after that, visited the disaster-stricken areas in the island of Okushiri in Hokkaido. This paper reports on damage conditions of houses, buildings, breakwaters, tide embankments, and so on in those areas, and presents considerations of what can be learned from observations of Okushiri island, which was damaged about 19 years ago.

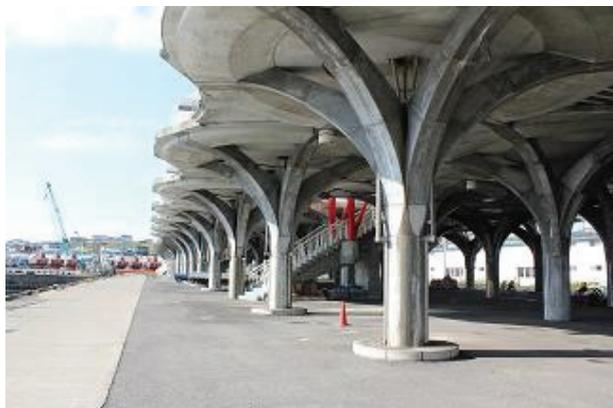
I made observations from a full circuit of the island. In the Aonae area, most heavily damaged in the 1993 earthquake, significant investment was made in building the Boukai-bashi refuge facility, shown in photo 23. Additionally, evacuation routes to high ground, both covered and open, have been established (photo 24).

Photo 23: Seaside refuge facility, Boukai-bashi. (Aonae area)

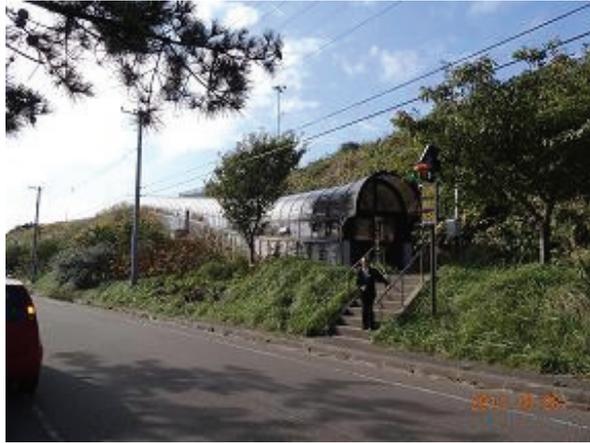
Photo 24: Covered evacuation route to high ground. (Aonae area)
