Damage of Buildings

Hitoshi Shiohara

Associate Professor, University of Tokyo, PhD, FACI Secretary, Disaster Committee, Architectural Institute of Japan (AIJ) Leader, Reconnaissance Group, Kanto Branch of AIJ

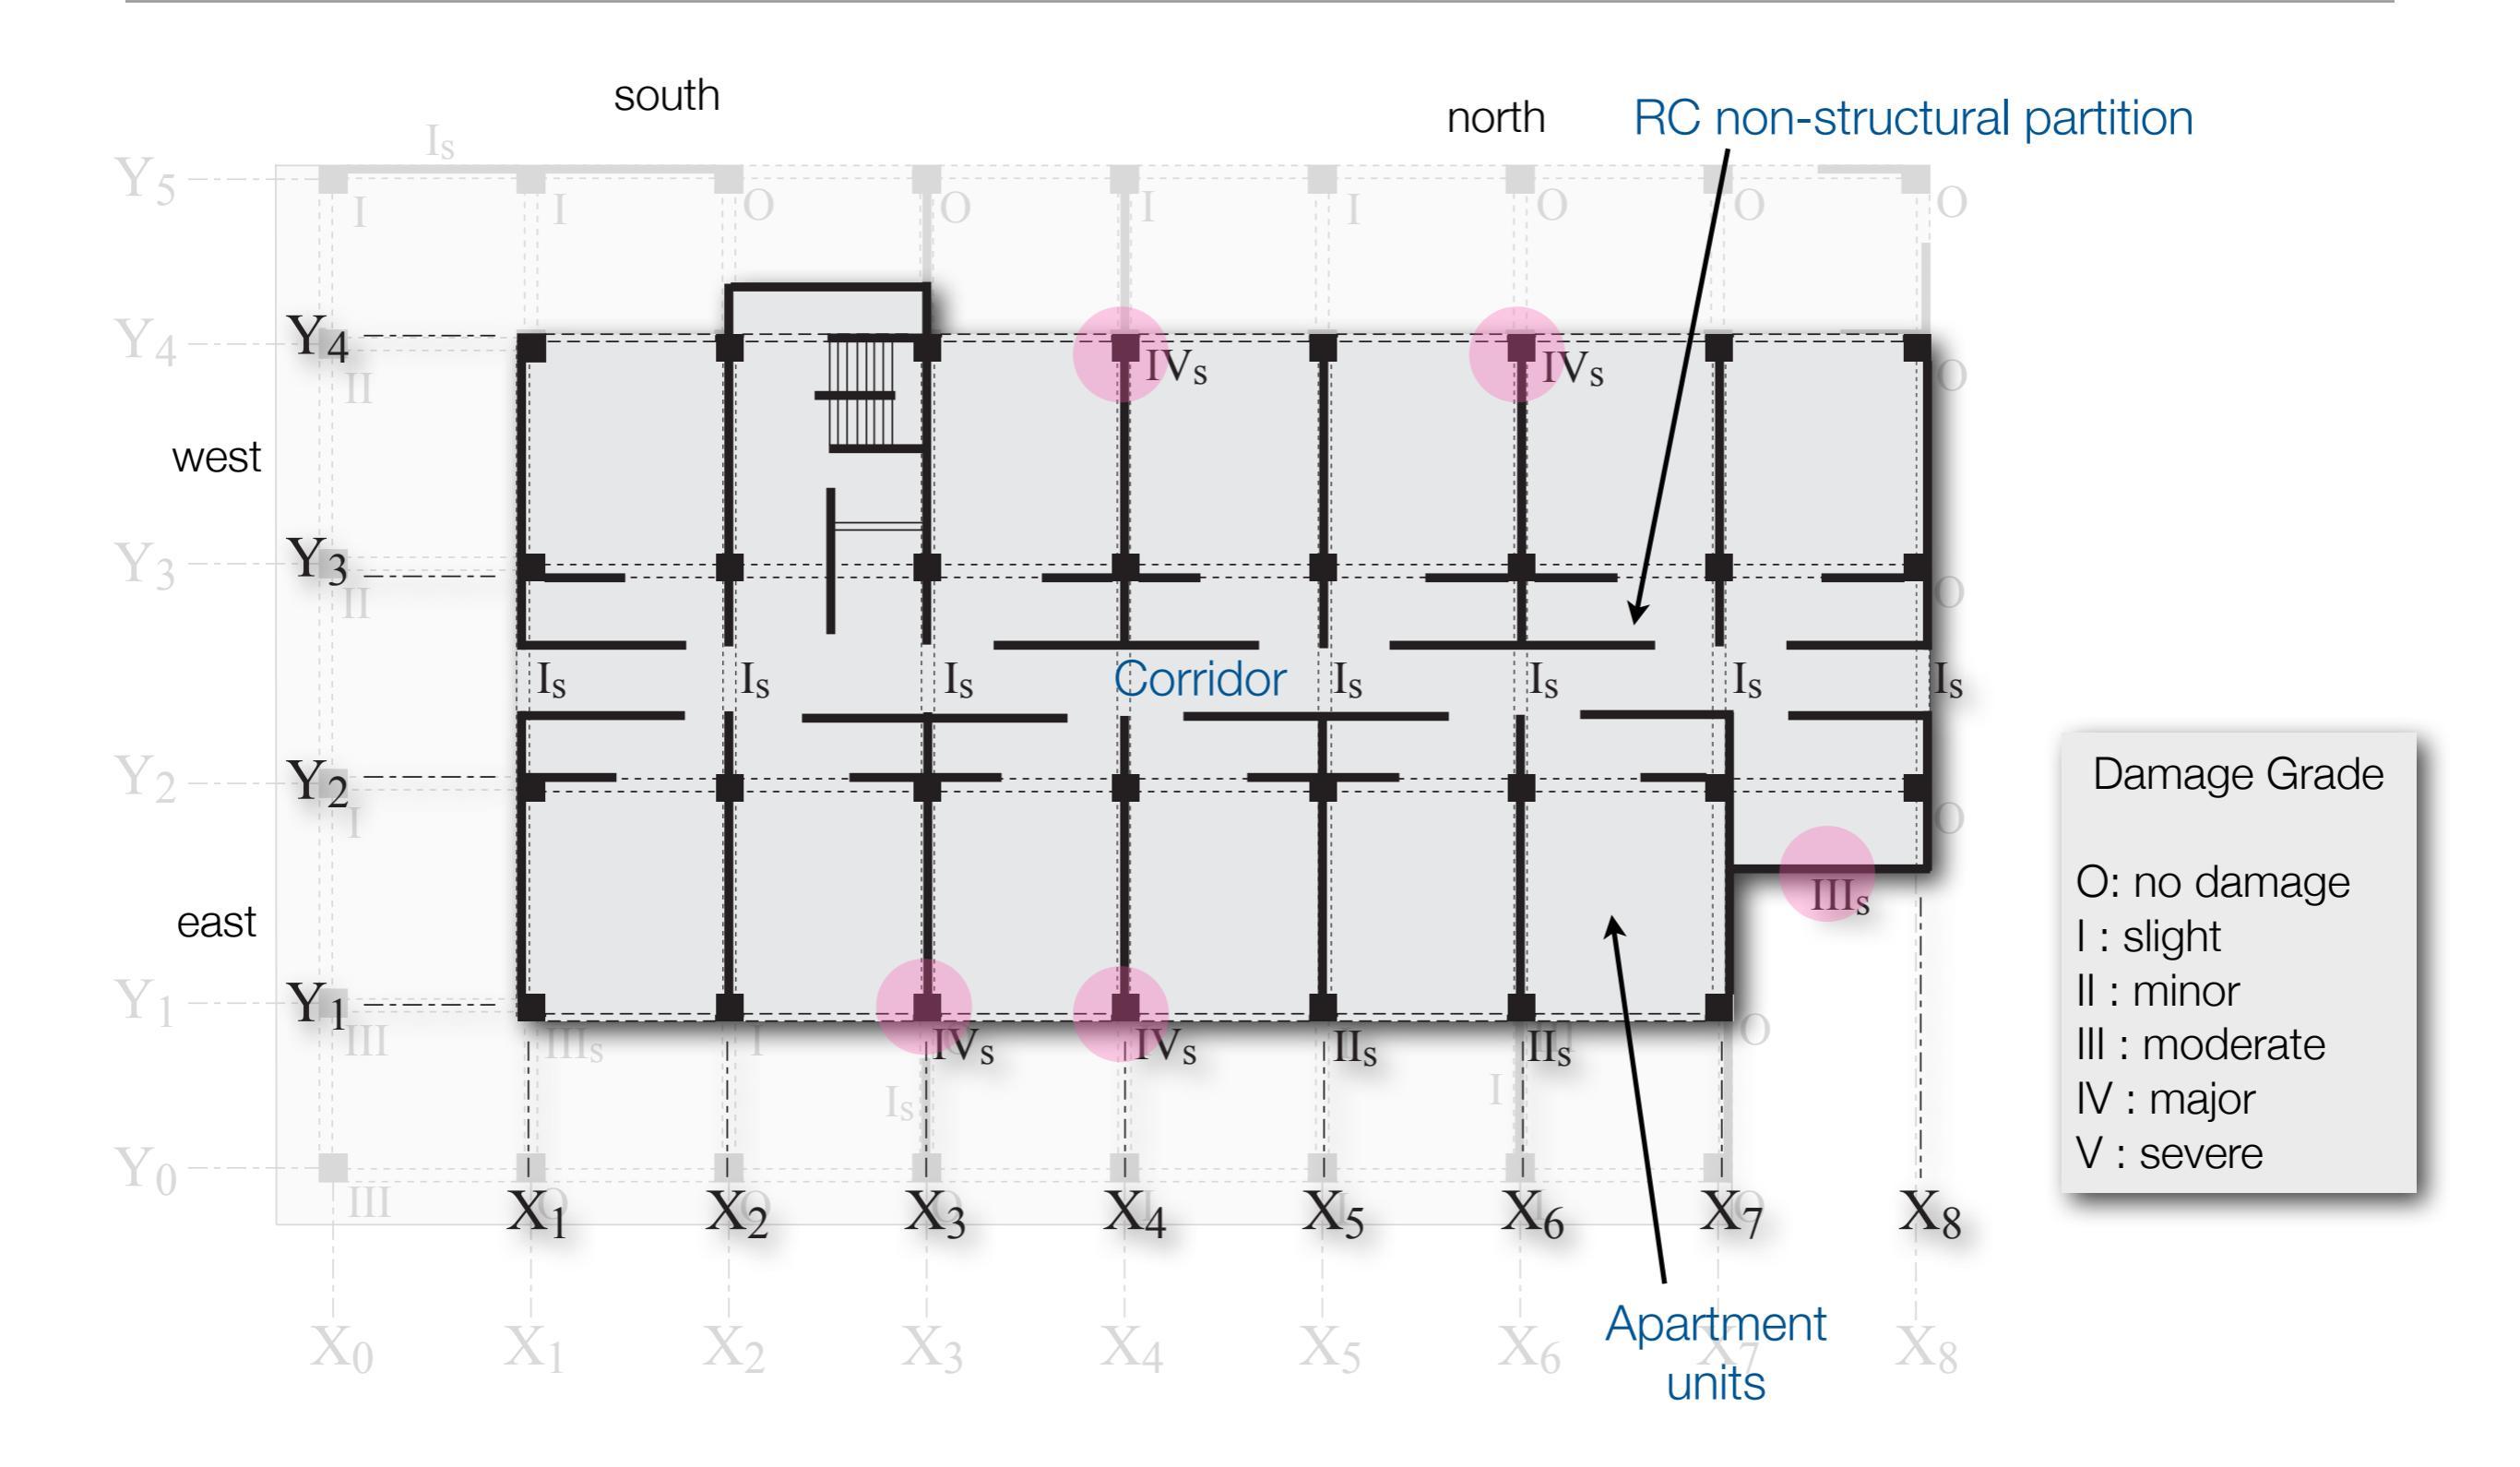
Elevation of X₁ frame in longitudinal direction

- Nagamachi Dwelling Complex Building
- Flexural failure of the first story SRC column
 - deficiency of steel lattice not embedded into the foundation which just ends at the first floor level.
 - abrupt change of section caused the damage.
- Shear failure of lightly reinforced beam-column joints.
 - calculated margin of joint shear strength is 2.0 or more.
 - column-to-beam strength ratio is in the range of 1.26 to 1.48.
 - vulnerablity of column-to-beam strength ratio between 1.0 and 1.5 are to joint shear failure.
 - problem in failure mode prediction
