## THE KUTCH EARTHQUAKE OF JANUARY 26, 2001

Masonori Hamada  
Waseda University, Department of Civil Engineering

Ömer AYDAN  
Tokai University, Dept. of Marine Civil Engineering, Shimizu

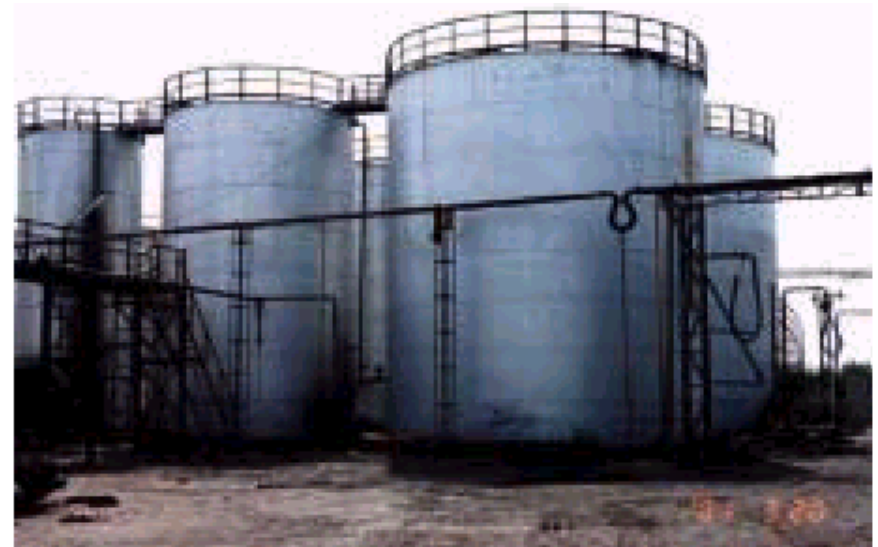
Most of tanks were non-damaged in the Tank farm of Oil India (Figure 22(a)). Nevertheless, some oil tanks were buckled or tilted. Some of damage to tanks was due to the liquefaction of the foundation soil. There were 6 steel tanks with a conical fixed roof. No damage to tanks was observed although it was very close to the epicenter of the earthquake (Figure 22(b)). The tanks had 2m thick concrete basement. The buildings in this complex, however, were heavily damaged. One of storehouses was completely collapsed while the roofs of other storehouses were partially collapsed.

(b) Non-damaged oil tanks at Trisuns Plant

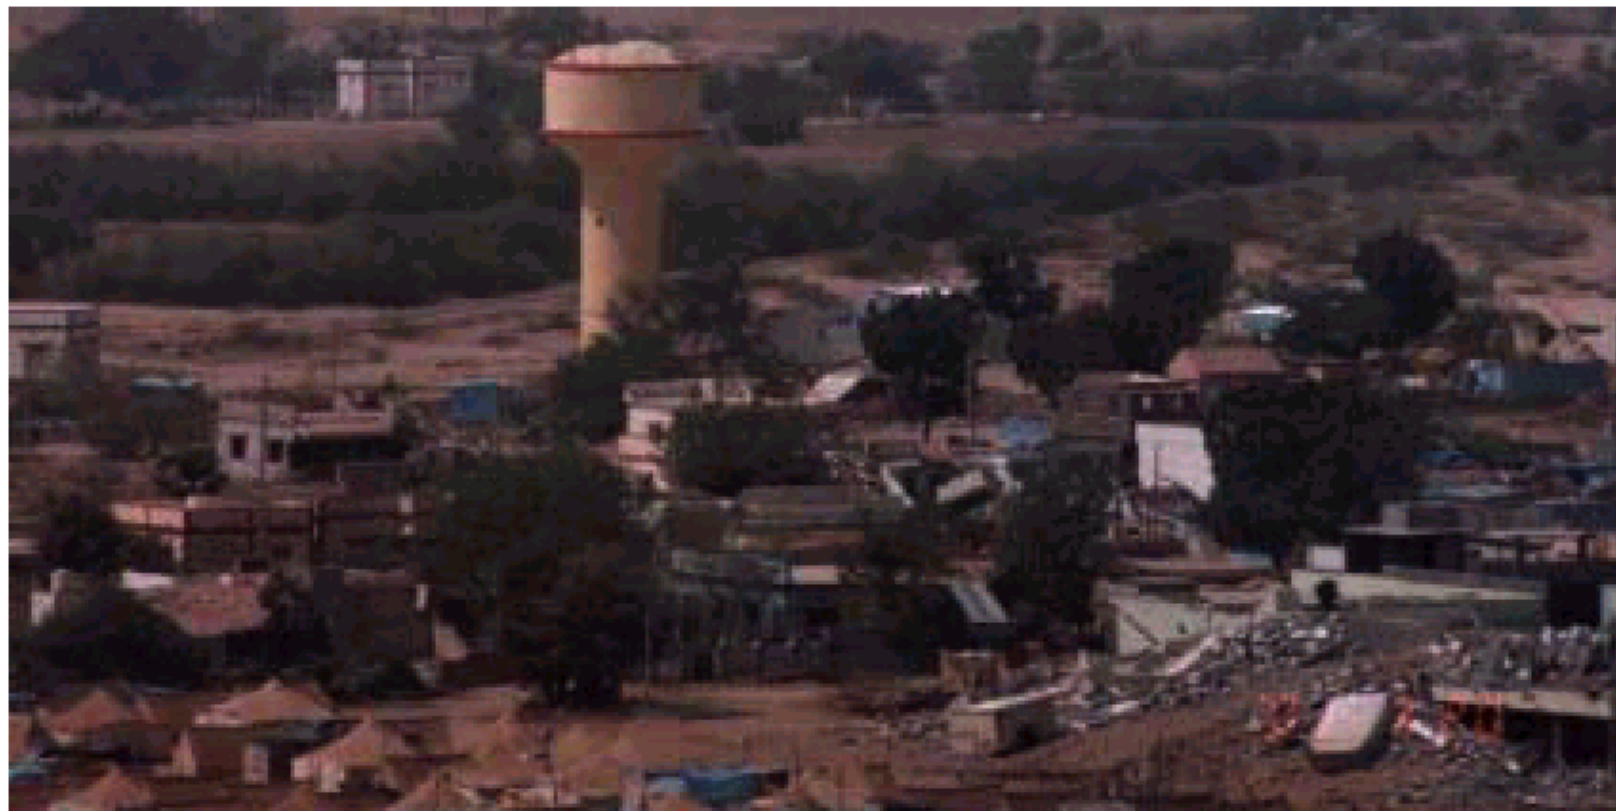
Many of the systems have elevated concrete storage tanks that are on the order of 30m high (Figure 31). Most of the water tanks, which are elevated, did not suffer any substantial damage although severe damage could be observed at nearby buildings and structures. The water tank at Chobari village was toppled (Figure 32). The water tower was fallen in the direction of S30E. The location is  $23^{\circ} 31' 22''\text{N}; 70^{\circ} 20' 64''\text{E}$ . The water tank in Bachau town also survived the earthquake. The water tank in Anjar was an RC structure with four piers and built in 1955 with a capacity of 20000 gallons. It seems that there is more 250 water tanks in the region. However, 5 elevated tanks failed in the Malya-Morbi region south of the Gulf of Kutch. All the tanks are designed in the same state office. However, it is unclear why the failures in the Malya-Morbi area would have occurred and this deserves further investigation.

Figure 29 Non-damaged typical elevated water tank in Bachau
