Kutch (Kutch) region in Gujarat State of India was severely shaken by a powerful earthquake at 8:46 am on 26 January 2001 of the India Standard Time, which has been the most damaging earthquake in the last five decades in India. The M7.9 quake caused a large loss of life and property. Over 20,000 persons are reported to be dead and over 167,000 injured. The estimated economic loss due to this quake is placed at around US\$5 billions. The entire Kutch region of Gujarat sustained highest damage with maximum intensity of shaking as high as X on the MSK intensity scale.

The investigation by the earthquake engineering sub-committee of The Japan Society of Civil Engineers (JSCE) has been undertaken between March 16 and 24, 2001. The investigation on the 2001 West India earthquake covered various aspects of the earthquake. This article presents an overview of the investigation results of the JSCE Kutch earthquake investigation team. The article covers the geology, tectonics and seismicity of the earthquake region, seismic intensity and the characteristics of strong motion records and damage to civil engineering structures. The findings and observations of the investigation aforementioned

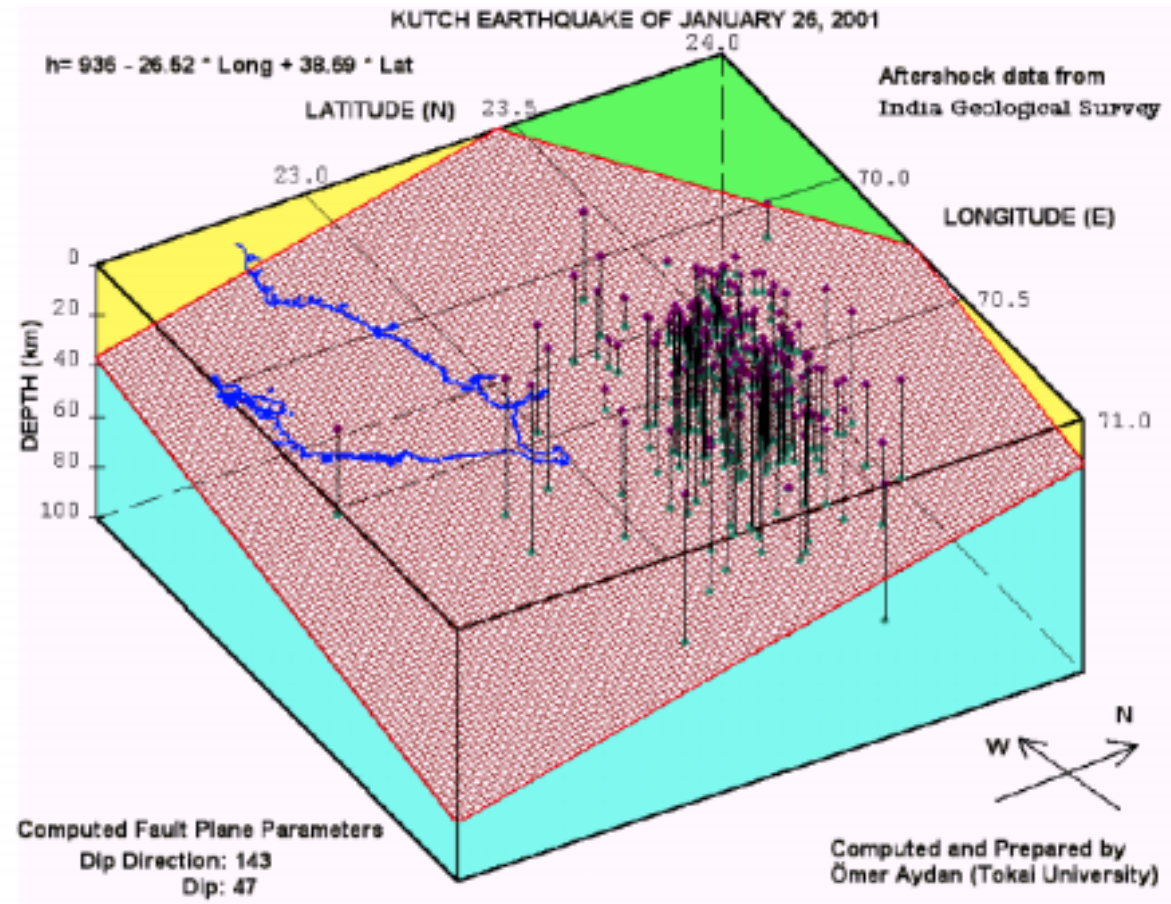
Figure 8 A perceptive view of the estimated fault plane from aftershock data

The unit of f is in kms. From this function, the fault plane has been inferred to be dipping SW with an inclination of 47° and its strike is N53E. This fault plane is quite similar to those found by HARVARD and USGS focal mechanism solutions. Figure 8 shows a three-dimensional perspective view of the determined fault plane with the epicenters and hypocenters of the aftershocks. Although this earthquake did not produce a remarkable fault scarp, the surface trace of the plane should appear along an alignment extending from Khadir Island, passing the north of Chobari and Lodai in Banni plains and it should terminate somewhere the 30km north of Bhuj. This estimation is quite consistent with the surface ruptures, cracks and deformation zones observed in the earthquake area.

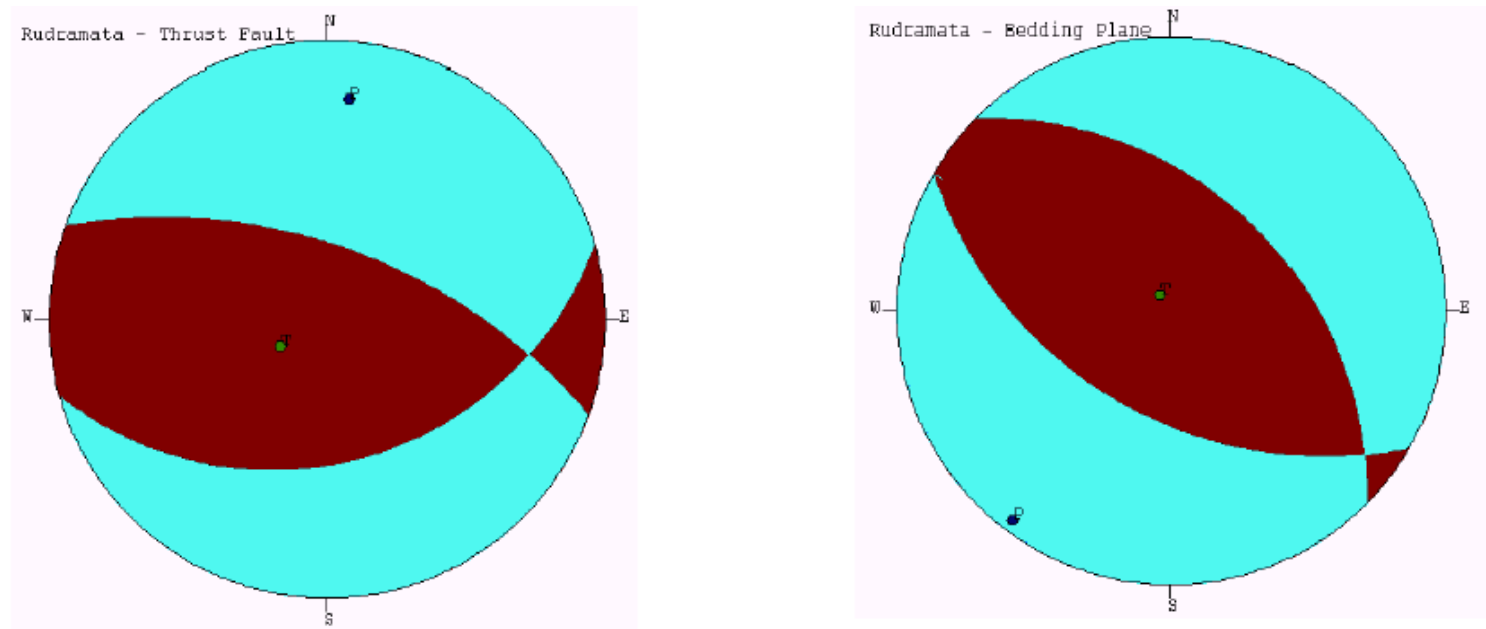
Figure 10 Inferred fault plane solutions for a thrust fault and bedding planes with striations at the northern embankment of Rudramata Bridge

embankment of the Rudramata Bridge. At the same location, the bedding planes of sandstone abruptly steepens. From the striations on the fault plane and bedding planes, the inferred mechanisms of earthquakes would look like as shown in Figure 10. The strikes of faults and bedding planes at this location are similar to the general trend of the strike of the Kutch mainland fault described in the previous sections. The fault plane solution for this thrust fault strikingly is similar to that of the main shock given by various institutes.

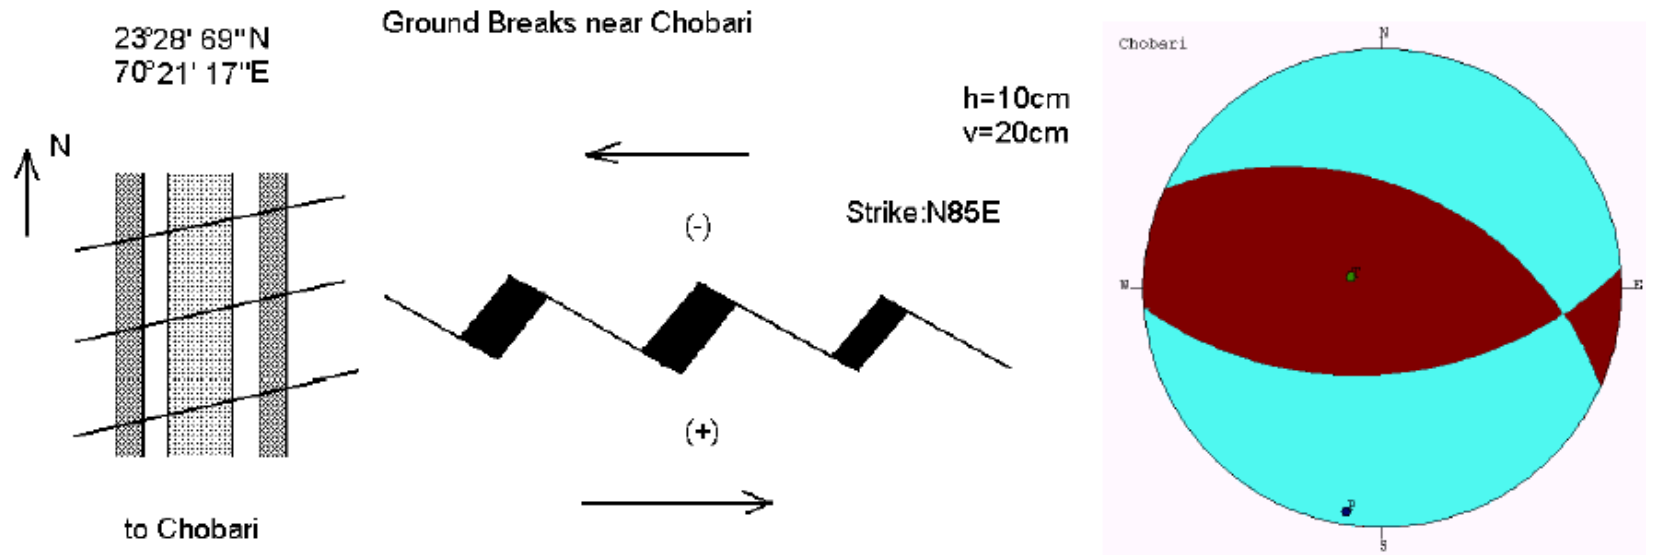
Figure 11 Sketches of ground breaks near Chobari village and its fault plane solution

A set of parallel ground breaks near Chobari on the roadway between Momaymora and Chobari and in the adjacent fields was observed (Figure 11). Their strike was N85E. South block is up with a vertical throw of 20cm and 10cm horizontal offset. The sense was sinistral. The inferred faulting mechanism shown in Figure 12 was obtained for this set of ground breaks by assuming that fault plane is dipping towards south with an inclination of 50° . It is quite interesting that the fault plane solutions are quite similar to those obtained by various institutes.

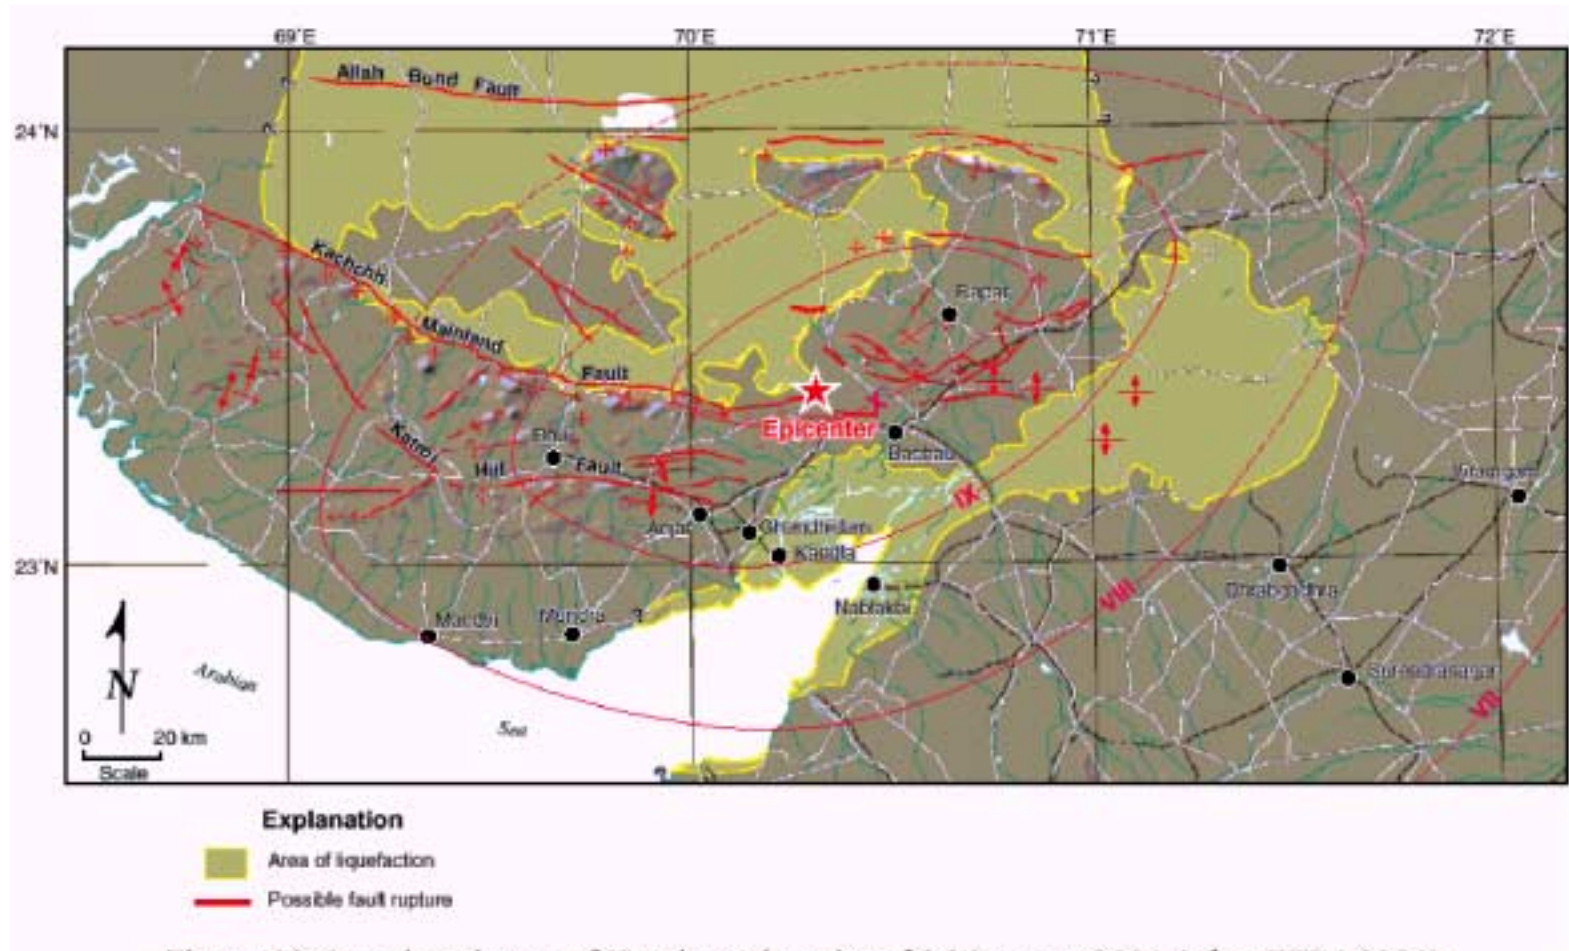
Figure 12: Isoseismal map of Kutch earthquake of 26 January 2001 (after EERI 2001).

have indicated that intensity X has been reached in an elliptical tract of about 2100 sq.km, which is characterized by complete destruction of adobe, brick and stone masonry buildings and many RCC buildings have suffered grade 4 to grade 5 damages; wide ground fissures and collapse of low height road embankments. This epicentral tract includes villages of Jawaharnagar, Dudai, Adoi, Chobari, Manfara, and Rapar. The long axis of this epicentral tract is aligned in ENE-WSW to E-W direction with maximum damage concentrated near its northern and southern boundaries. During the reconnaissance surveys only the southern boundaries of the isoseismals IX, VIII and part of VII could be constrained and the eastern, western and northern boundaries are tentative because complete area could not be traversed during the time frame of investigation. These will have to be verified by more detailed surveys. Their preliminary isoseismal map is shown in Figure 12.

The distribution of intensity VII is quite interesting and has deviated from the general E-W elongation, consistent with higher isoseismals, to almost north-south pattern along the area occupied by deep seated Quaternary and Cenozoic cover sediments along the Cambay Graben. The accentuation of the motions because of this thick cover has resulted in modification of boundaries of isoseist VII. In all the isoseists there were isolated areas of lower or higher intensities depending upon the geotechnical characteristics of the ground. One such conspicuous area is the township of Limbdi located within isoseist VII that shows damages similar to those of isoseist VIII.

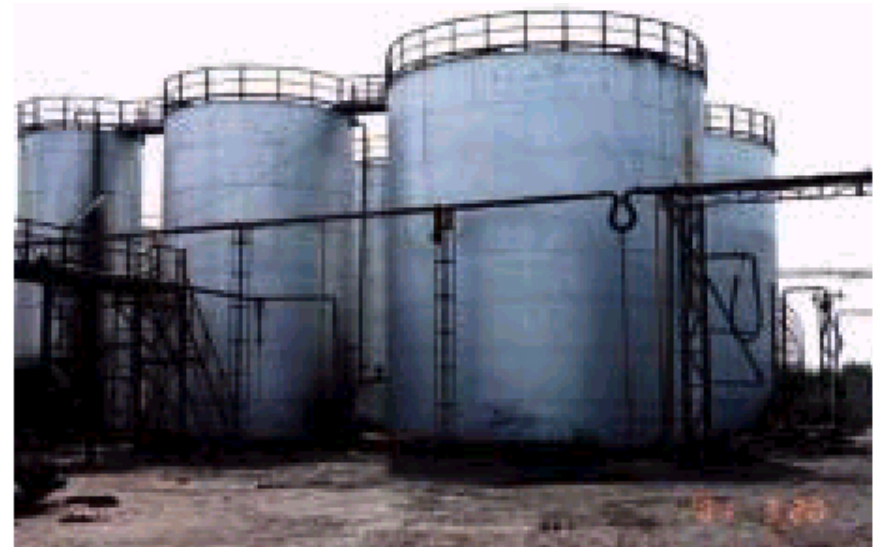
Most of tanks were non-damaged in the Tank farm of Oil India (Figure 22(a)). Nevertheless, some oil tanks were buckled or tilted. Some of damage to tanks was due to the liquefaction of the foundation soil. There were 6 steel tanks with a conical fixed roof. No damage to tanks was observed although it was very close to the epicenter of the earthquake (Figure 22(b)). The tanks had 2m thick concrete basement. The buildings in this complex, however, were heavily damaged. One of storehouses was completely collapsed while the roofs of other storehouses were partially collapsed.

(b) Non-damaged oil tanks at Trisuns Plant

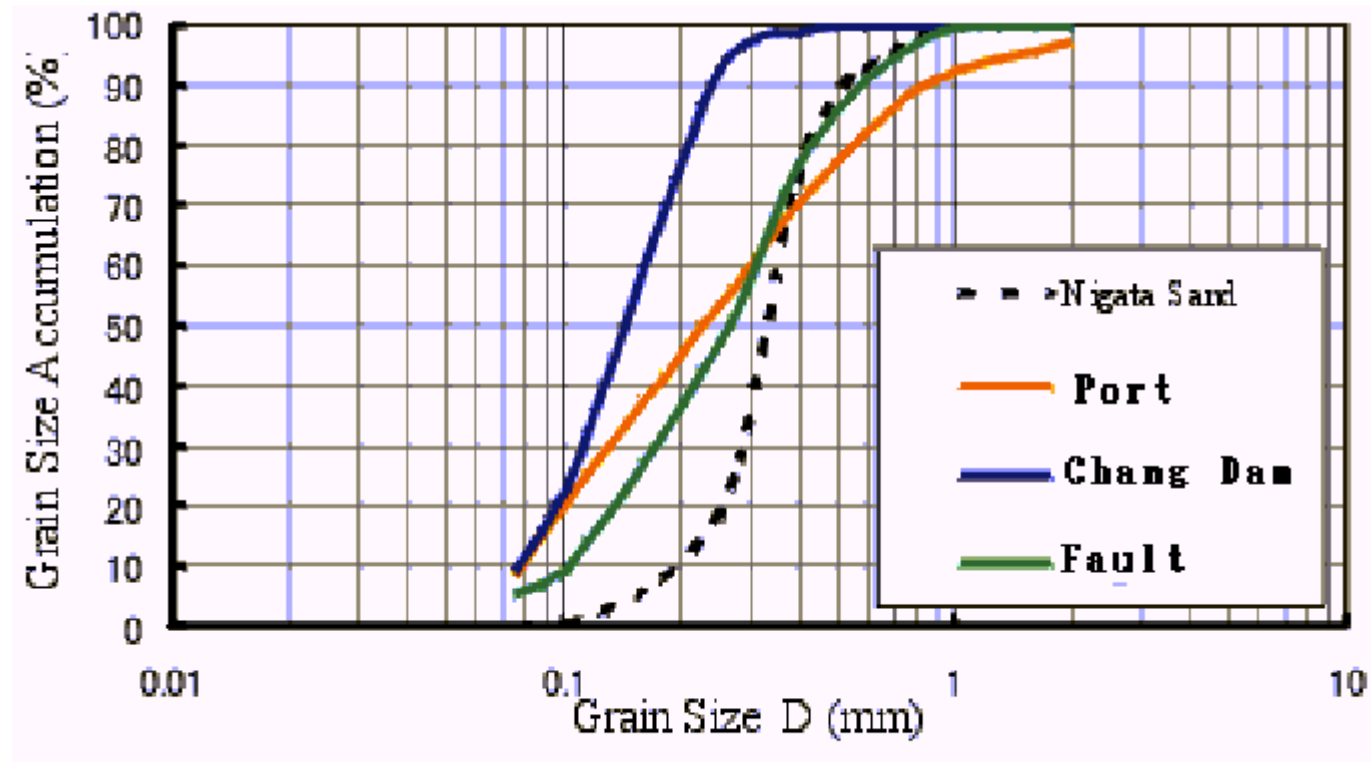
Figure 27 Grain size accumulation of the boiled-out sands

Figure 27 shows the grain size accumulation curve of the boiled-out sands at Kandla port, Chang dam and Chobari with the sand from Niigata City. The samples mostly consisted of liquefiable fine sands with mean grain sizes of 0.15~0.30mm, respectively.
