LAS COLINAS LANDSLIDE CAUSED BY THE JANUARY 13, 2001 OFF THE COAST OF EL SALVADOR EARTHQUAKE

ABSTRACT: El Salvador was struck by two devastating earthquakes within a month. The first quake of Jan. 13, 2001, which was centered off El Salvador's southern coast, damaged and/or destroyed nearly 108,000 houses, and killed at least 944 people, including hundreds of residents buried in a huge amount of soil slipped down Las Colinas mountainside in the city of Neuva San Salvador (Santa Tecla). This report outlines the findings obtained through the reconnaissance by the JSCE team and laboratory tests that followed it.

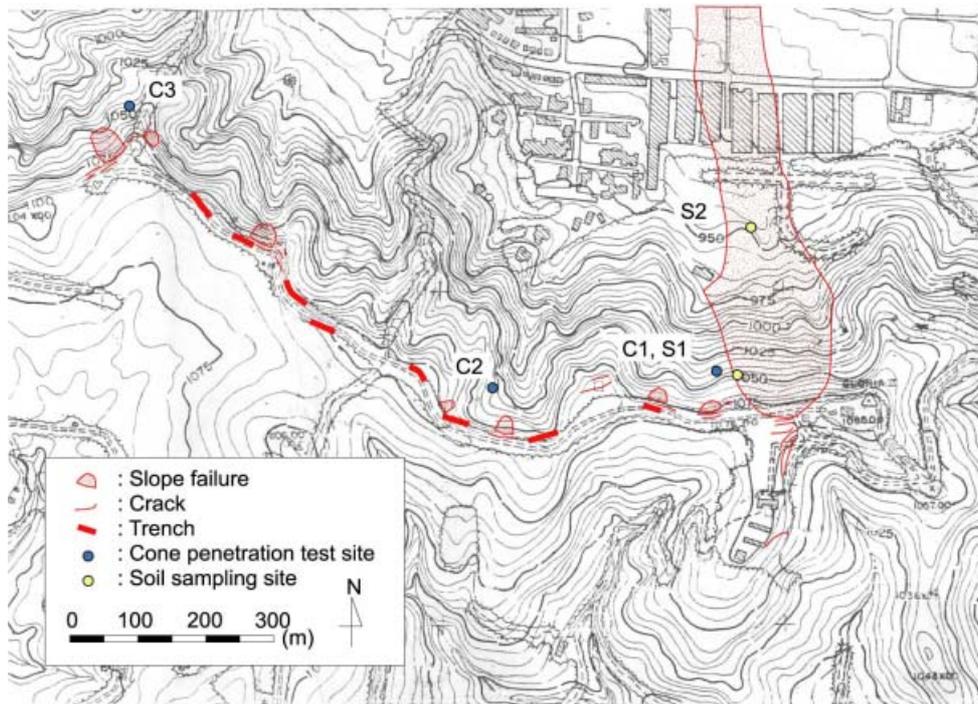
Fig. 14. In-situ tests and sampling sites in Las Colinas
(Topography: Ministerio de Obras Públicas, 1970)

Total 43 points were marked along the perimeter of the scar using a GPS receiver (**Fig. 6, next page**). Behind the scar, there were extensive cracks running in almost west-east (See **photos in Fig. 6**). Crack openings (12 visible cracks; **Table 3.2.1** and **Figure 6**) were measured along Line A-A'. Total 1.25 m's opening was reached over the 22 m's distance of Line A-A'. Namely, about 5% average strain was induced within the soil behind the scar. Extensive cracks were found along the ridge crest even in areas that did not slide (see **Fig. 14**); the cracks can certainly cause further slides.

In order to sound the strength of the soils in Las Colinas Mountain, portable cone penetration tests (Japan Geotechnical Society, 1995) were performed at three points along the mountain ridge. Among them, Point C1 is located slightly west off the main scarp (see **Figure 14**).

Variations with depth of the equivalent N_s -values at the three points are shown in **Figure 15**. As contrasted with other points, all equivalent N_s -values at Point C1 are considerably low as a whole. Among them, extremely low values reaching zero were found at about 1.2m and 2.5m depths. These two small N_s values suggest the presence of two weak layers, which can be the pumice and/or fragmental volcanic products judging from their depths.

- (1) Crack maps
- (2) Stopping water to permeate soils through cracks
- (3) Continuous monitoring of crack openings

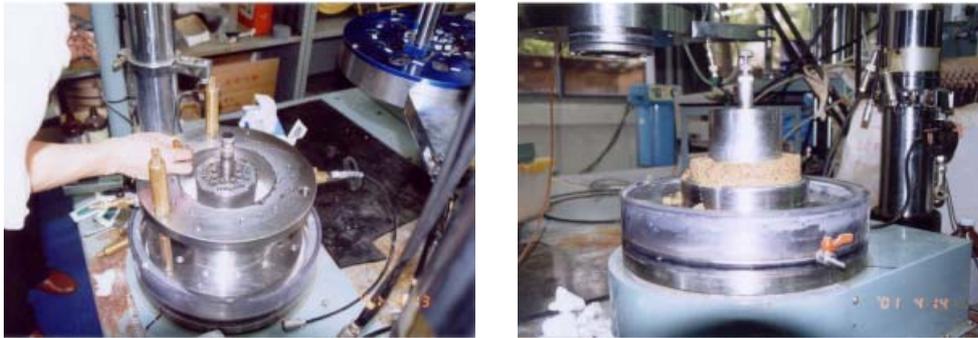
Fig. 16. Ring shear apparatus

The undrained ring shear apparatus (DPRI-5: **Fig. 16**) was used to examine dynamic characteristics of the pumice in rapid shear (Sassa, 1998). Outer and inner diameters of the cylindrical shear box are 120 and 80 mm, respectively. The maximum shearing velocity of 10 cm/sec is realized within this box.

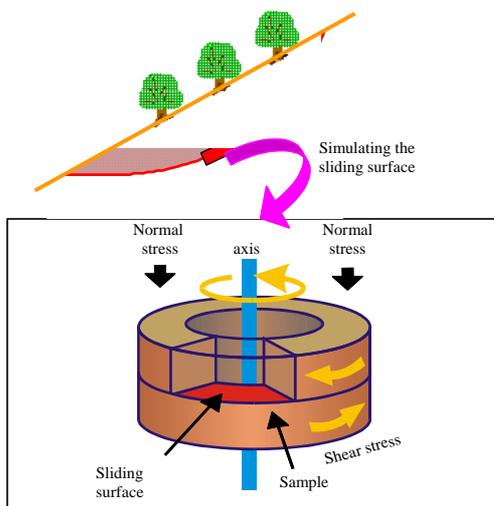
Fig.17 Concept of ring shear landslide simulation test (Sassa, 2000)

The concept of ring shear landslide simulation test is illustrated in **Fig. 17** (Sassa, 2000). Shear/normal stresses along a sliding surface in place are realized in the interior of the shear box, and necessary physical quantities of the soil sample in shear (resistance, pore water pressure, shearing velocity and accordingly the mobilized apparent friction angle) are monitored in real time. An upright cross-section of the shear box with the pore pressure measuring system built in is shown in **Fig. 18** (See Sassa (1998 and 2000) for further details).

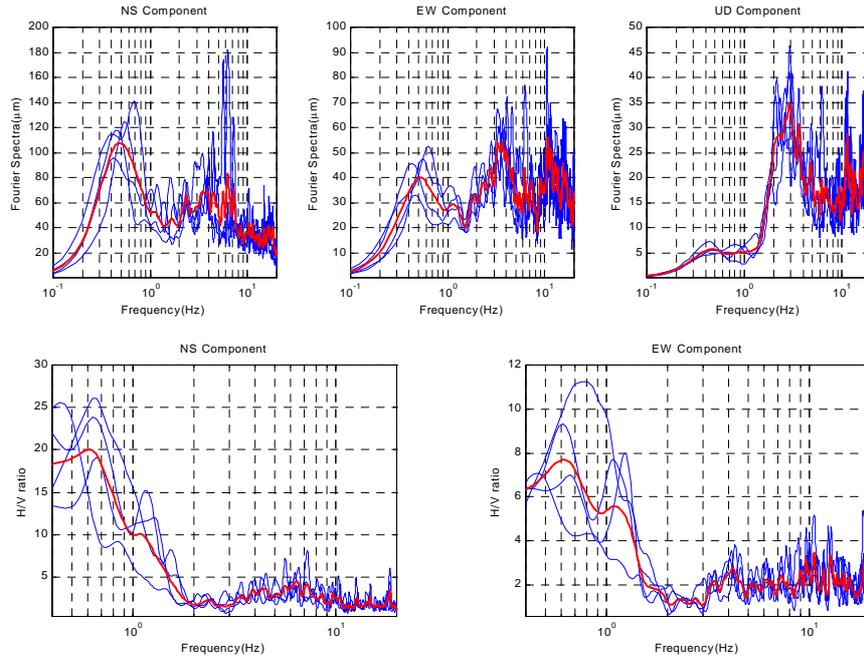
Fig. 20. Fourier spectra of microtremors at the top of El Balsamo ridge

Fourier Spectra of three components of the tremor as well as the H/V ratios are shown in **Figs 20** and **21**. Thin (blue) lines correspond to four separate windows of 40.96sec opening and the thick (red) lines show the averages. At the top of the ridge, two peaks at 0.6 and 1.1Hz (on the H/V diagram) are distinguished for the EW and NS components, while 0.75Hz component in NS direction is predominant at the toe, and no clear peak is observed for the EW component there.

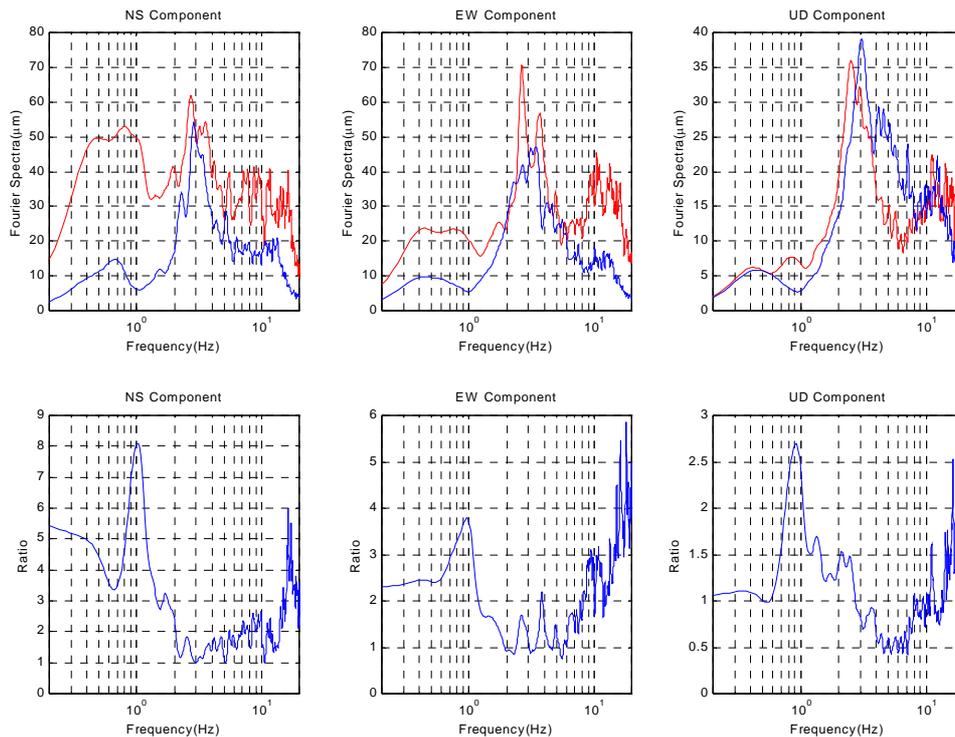
Fig. 22. Ratios of Fourier Spectra (top of the ridge / toe of the ridge)

In order to evaluate the topographical effect at Santa Tecla, the microtremors at the top and toe of the El Balsamo ridge were compared. The Fourier Spectra of the three components at the top of the ridge were divided by the corresponding components at the toe. The results are shown in **Fig. 22**. The three upper graphs depict the average of the Fourier Spectra at the top (red) and the toe (blue) of the ridge, respectively. The three lower graphs show the ratios of the Fourier Spectra (top of the ridge /toe of the ridge). The spectral ratios of all NS, EW and even UD components show clear peaks equally at around 1Hz, and the peak is the highest in NS direction, the direction normal to the rim of the ridge, probably reflecting the topographical effect.
