RESEARCH AND PRACTICES ON REMEDIAL MEASURES FOR RIVER DIKES AGAINST SOIL LIQUEFACTION

Yasushi SASAKI¹, Seiji KANO², and Osamu MATSUO³

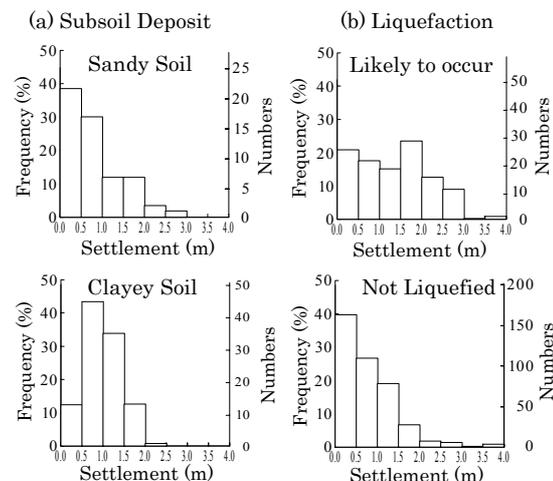
Fig.4 Histogram of the seismic settlement of dike crest

It has been found that the locations of the dike damage during earthquake are well correlated with the subsoil conditions. **Figure 4** shows the histograms of the seismic settlement of dike crests during the past earthquakes such as the Nobi (1891), the Kanto (1923), the Fukui (1948), the Niigata (1964), and the 1968 Tokachi-oki earthquakes (Sasaki 1980).

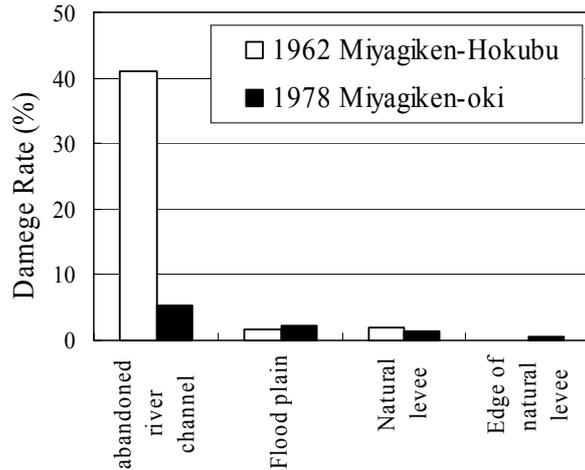
Fig.5 Damage rates of dike in relation to the geomorphologic condition

Kikkawa et al. (1965) pointed out that dike damage had often been seen at locations where the dikes were situated on abandoned river channels or former ponds. These kinds of facts offer valuable knowledge for the purpose of filtering out potentially susceptible sections. **Figure 5** shows an example of the comparison of the damage rate to river dikes with the geomorphologic condition. This figure shows that damage along the Eai River, branch of the Naruse River, during the Miyagiken-oki earthquake, is concentrated to a section on the old river bed (Sasaki 1980).

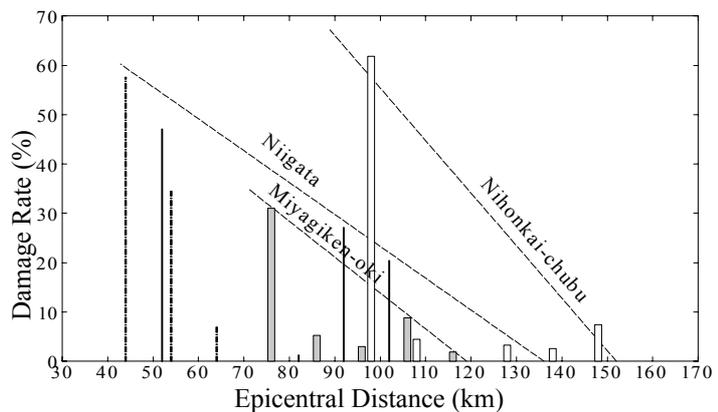
Fig.6 Damage rates of dike in relation to the distance from the epicenters

As mentioned before, about seven percent of the whole length of dike was damaged during the Miyagiken-oki earthquake. But it is known that the ratio of the damaged length to whole length was not uniform. Sasaki (1983) reported that the ratio of the length of the damaged section to total length decreased with the epicentral distance during the earthquakes of the Niigata, the Miyagiken-oki, and the Nihonkai-chubu as shown in **Fig. 6**.

It is known from this figure that the envelopes of the damage ratios tend to diminish at certain distances from the epicenter for each earthquake occasion.

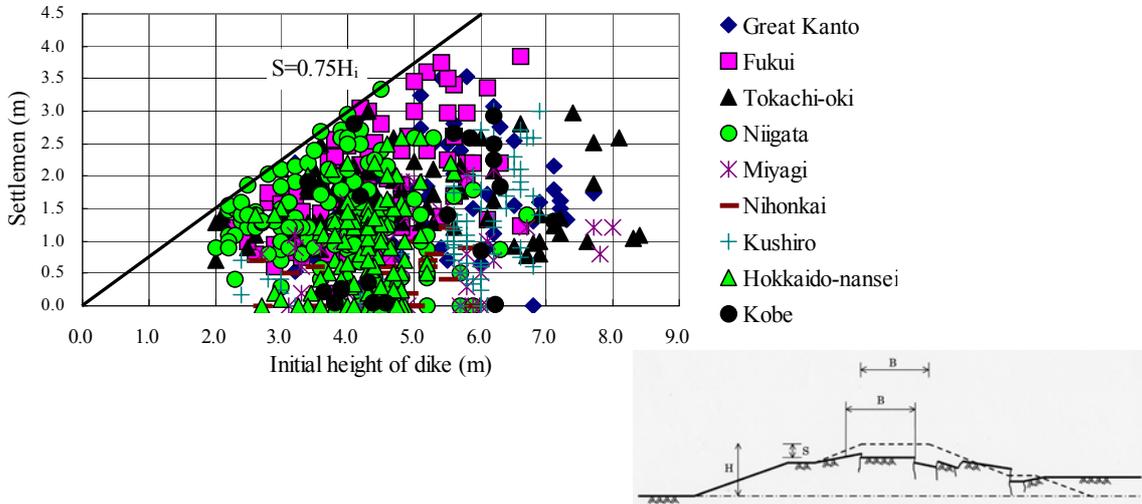
Fig. 7 Settlement of river dikes during past earthquakes

Figure 7 shows the observed settlement of river dikes during past earthquakes (Sasaki et al. 1999). The distance from the original elevation of the top to a certain level of the damaged dike where the original width is assured at this height was taken as the settlements in this figure.

The reason for this is that the maximum possible amount of an embankment subsidence is governed by the balance between the buoyant force acting to the embankment from the liquefied layer and the weight of the embankment (Towhata et al. 1999). This implies that the liquefied layer behaves like a liquid in the worst case.

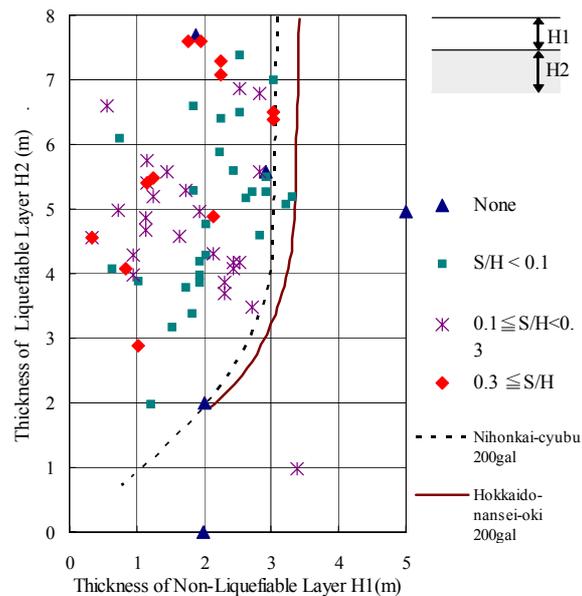
Fig.8 Depth and thickness of liquefiable layer

When the liquefiable layer exist shallow portion of the foundation ground and the thickness of the liquefiable layer is large, then the settlement of the dike tends to appear as shown in Fig.8.

This finding was explained by Sasaki et al. (1996) as stress dispersion in the non-liquefiable layer using a bearing capacity formula for a two layers system.

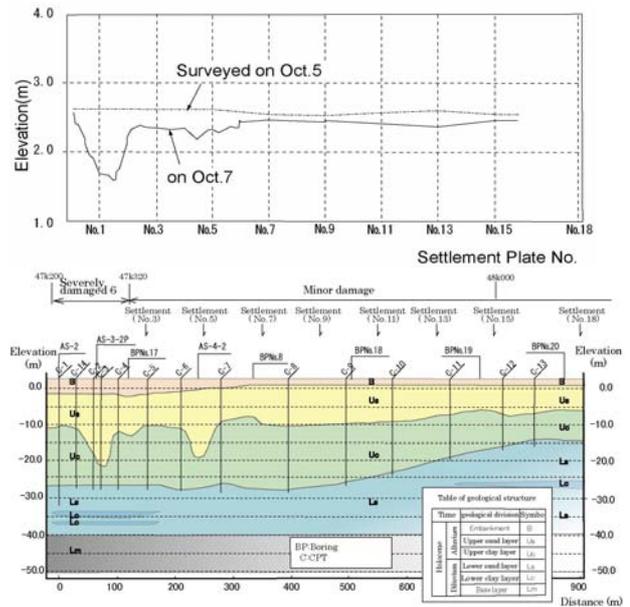
Fig.22 Comparison of the crest elevations

In October, 2000, a survey was conducted on October 5 just the day before the Tottoriken-seibu earthquake and an additional survey was conducted as soon as possible on the day after the event, on October 7. Therefore a record of embankment settlement during an actual earthquake was obtained as shown in **Fig. 22**.

From the survey results, it was revealed that the section which seemed to be sound subsided by about 5-20 cm even though no cracks were observed on the embankment crest or on the side slope. No emergency treatment of the dike was necessary even though the settlement were about 20 cm.

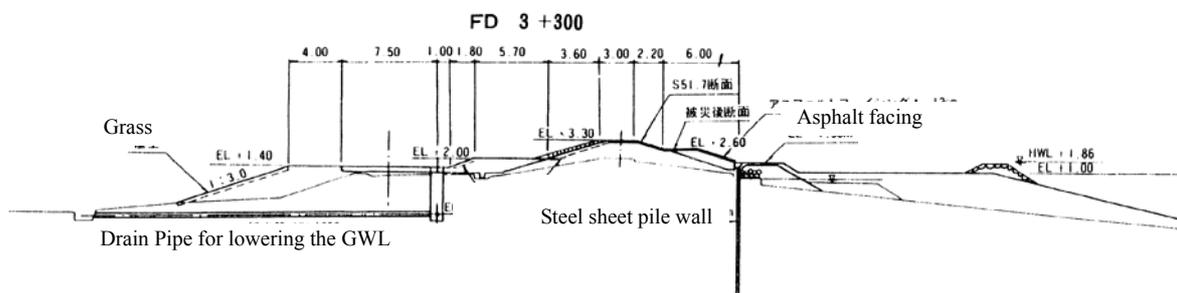
Fig. 31 Lowering the ground water table in the Front dike at Hachirogata

Since the total length of the damaged sections of the dike was so long, it was necessary to seek a very economical solution. After a lot of study lowering the ground water level beneath the dike was taken as the basic measure for improving the stability of the damaged dike sections against possible future earthquakes.

The solution was to place a sheet pile cutoff wall at front toe of the dike, and also to install drainage pipe to lower the groundwater table in the dike as illustrated in **Fig. 31** (Hashimoto et al. 1985).

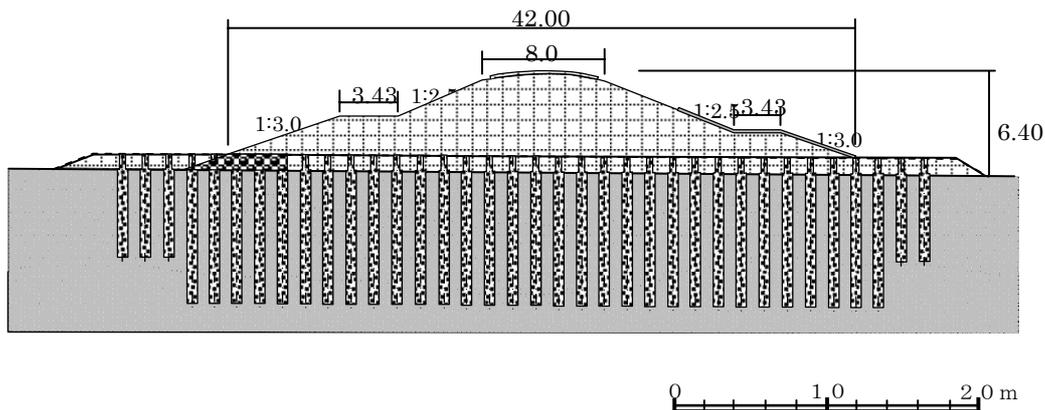
Fig. 32 Restoration work for the Tokachi River and the Kushiro River dikes damaged by the Kushiro-oki earthquake in 1993

As pointed out earlier, the main cause of dike failure at severely damaged sections of the Tokachi and the Kushiro River dikes during the 1993 Tokachi-oki earthquake was the liquefaction of the loose saturated lower part of the embankment. It was decided to densify the loose layer at severely damaged sections by the SCP method as illustrated in **Fig. 32** (Oshiki and Sasaki 2001).

There was concern about that the SCP method could effectively densify the saturated loose sand layer at shallow depth because of low overburden pressure. Therefore a thicker than usual working mat was placed above the foundation ground based on the results of pilot tests. Since this working mat became a part of the dike embankment, it had to have a low enough permeability, therefore the construction material for the mat was selected to match this demand and was compacted by bulldozer.

Since the damaged embankment had to be removed and the ground surface be made flat for the SCP work, temporary protection to prevent flooding during the restoration work was needed. Therefore a steel sheet pile cofferdam was constructed outside the damaged section, the damaged dike was removed, ground treatment by SCP method was completed and the new embankment section was constructed.

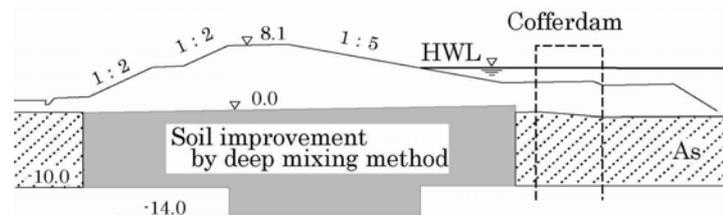
Fig. 35 Remediation of the Torishima dike by DMM

This part of the dike section was armored by a concrete facing on outer slope and parapet wall was constructed on its shoulder as shown in Fig. 34. This prevented access to the waterfront for public enjoyment, so the cross section of the rehabilitated dike was changed to have a moderate slope at front side to the river channel. Figure 35 shows the typical cross section of the restored section.
