# LESSONS OF THE 2011 GREAT EAST JAPAN EARTHQUAKE FOCUSED ON CHARACTERISTICS OF GROUND MOTIONS AND BUILDING DAMAGE

Masato Motosaka<sup>1</sup>

<sup>1</sup> Disaster Control Research Center, Graduate School of Engineering, Tohoku University, Sendai, Japan, motosaka@ archi.tohoku.ac.jp

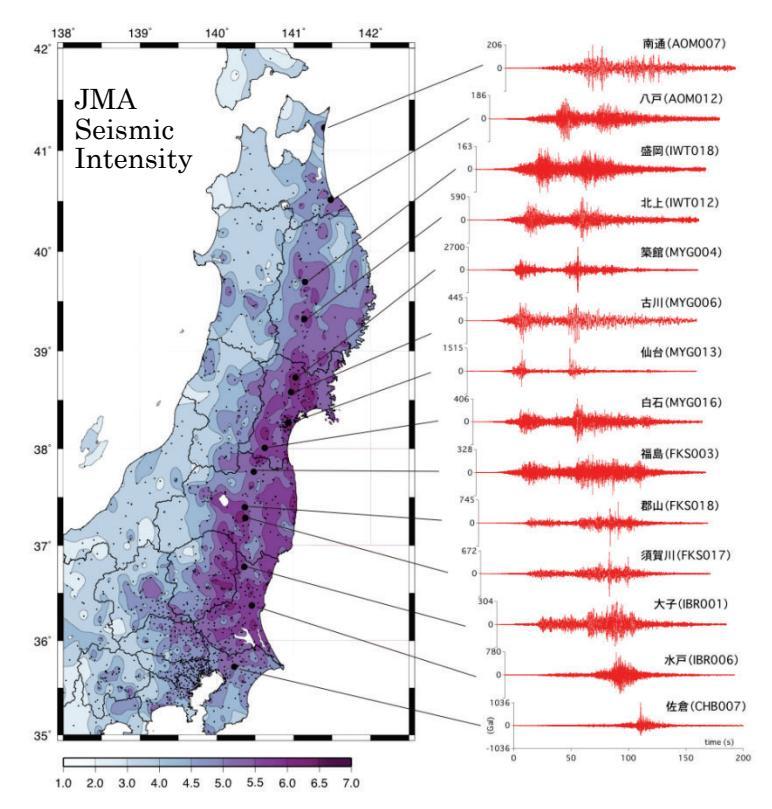
Fig.1Slip distribution on the fault plane Fig. 2 Instrumental JMA Seismic Intensity and Observed acceleration waveforms at K-NET stations

Fig. 2 shows the observed acceleration waveforms in the Tohoku and Kanto regions. In Tohoku region, the characteristic two phases are recognized but in Kanto including Tokyo the only one big phase. Table 1 shows a list of large amplitude observation records in order of JMA seismic intensity, instrument intensity (AIJ, 2011). The large intensity stations are concentrated in Miyagi prefecture, especially in the cities of Kurihara, Sendai and Ohsaki. As for the records in Sendai, detailed information is described in section 3.

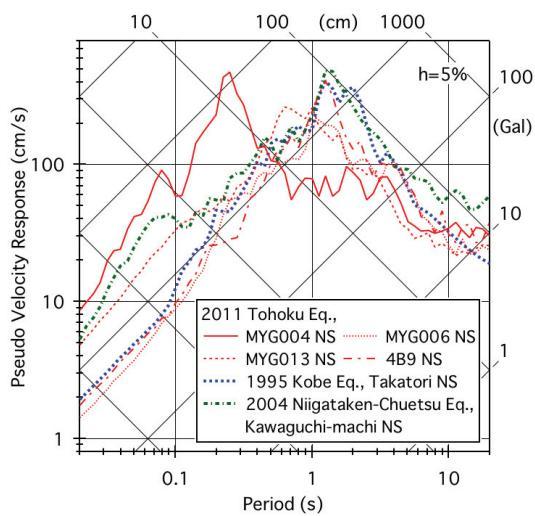
Fig. 3 shows 5%-damped pseudo velocity response spectra for the major stations in Table 1, together with spectra of Takatori record at the 1/17/1995 Kobe earthquake and Kawaguchi-machi record at the 10/23/2004 Mid Niigata Prefecture earthquake as representatives of the earthquake records in the heavily damaged zone by the past disastrous earthquakes.

Spectra of Takatori and Kawaguchi-machi records are predominant around 1-2 seconds, while spectrum amplitude at MYG004 (Terrace) is large at the shorter periods but the 1-2s amplitude is smaller. On the other hand, MYG006 (Ohsaki plain) and MYG013 (Sendai plain) have larger 1-2s amplitude compared with MYG004, and 4B9 at the center of Furukawa (Ohsaki plain) have similar amplitude level to that of Takatori. Spectral characteristics of MYG004 and MYG006 are discussed next.

Fig.3 Pseudo velocity spectra at observation stations with larger seismic intensity in Tohoku earthquake and past damaged earthquakes

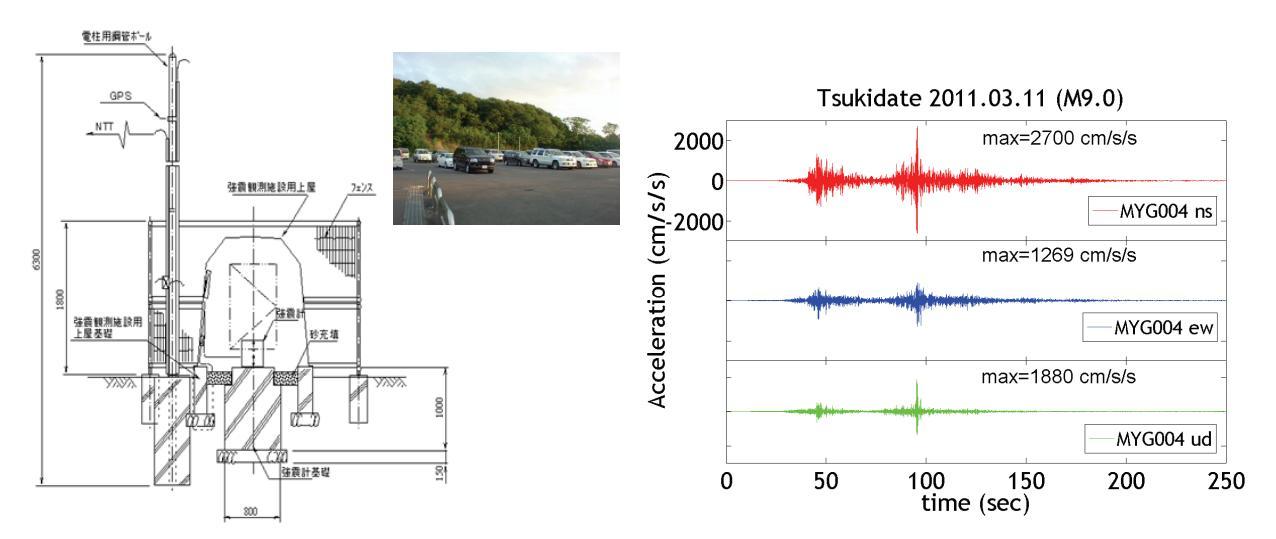
The K-NET Tsukidate station (MYG004) is located at the south of parking lot of Kurihara Culture Hall. Observation hut is on a cliff with the EW directionality and height of 3m. The configuration of the observation site including the hut with foundation is shown in Fig.4. The foundation of the seismometer is concrete mass with dimension of 80cm x 80cm and the height of 100cm. Fig.5 shows the observed acceleration waveforms of the 3 components during the March 11, Tohoku earthquake. The horizontal PGA in the NS component is 2,700 gal and that in the EW component is 1,269. Findings from the waveform characteristics of the observation records at K-NET Tsukidate station are as follows.

Fig.4 Configuration of observation site and section of seismometer's foundation (after NIED)

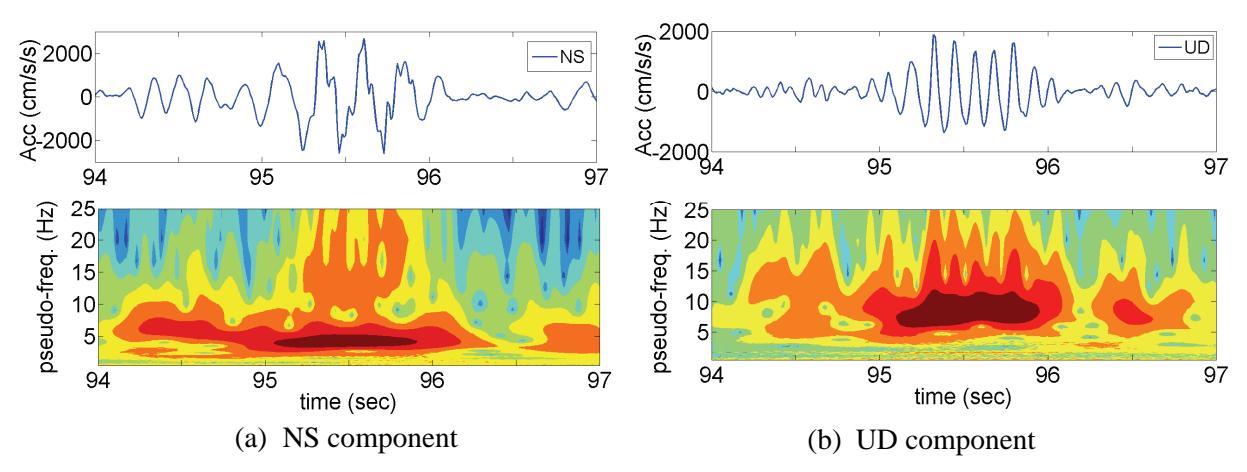
Fig.6 shows acceleration waveforms and the corresponding wavelet basis non-stationary spectra of NS- and UD-components for 3 seconds (from 94s to 97s) at around the time of peak acceleration generation showing in Fig.5. In the wavelet analysis, complex continuous Morlet wavelet is adopted as mother wavelet. Fig.7 shows Fourier amplitude spectra for the same time section. Findings from those figures are as follows.

- 1) For the dominant frequency of 4.2Hz in the horizontal (NS) component, odd number higher harmonics are induced at around 12.6Hz (3 times) and 21.0Hz (5 times).
- 2) Vertical motion with even number higher harmonics is induced at around 8.4Hz (2 times) and around 16.8 Hz (4 times).

These characteristics are consistent with the higher harmonic motion due to partial uplifting of the foundation (Motosaka and Nagano, 1994).

Fig.6 Acceleration waveforms for 3 seconds at around the peak value generation time and the corresponding wavelet basis non-stationary spectra

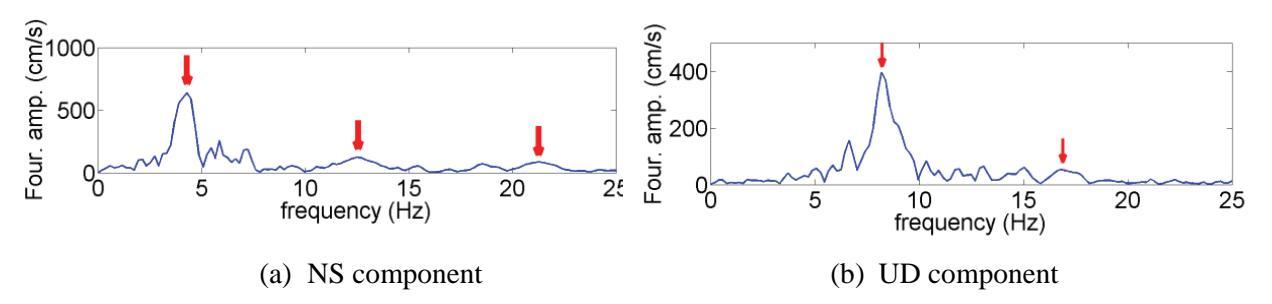
Fig.7 Fourier amplitude spectra for 3 seconds at around the peak value generation time

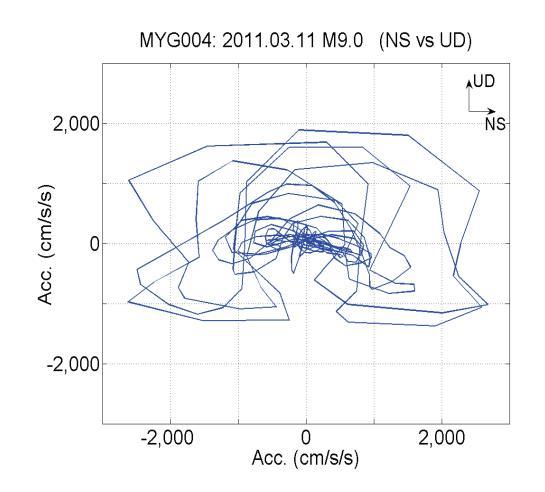
Fig.8 shows acceleration orbit of NS-UD plane in the time section for 3 seconds from 94s to -97s. Non-symmetric behavior is clearly shown. The particle orbit suggests unfavorable behavior with partial uplifting and slipping of the foundation of the seismometer.

Fig.8 Acceleration Particle Orbit of NS-UD plane

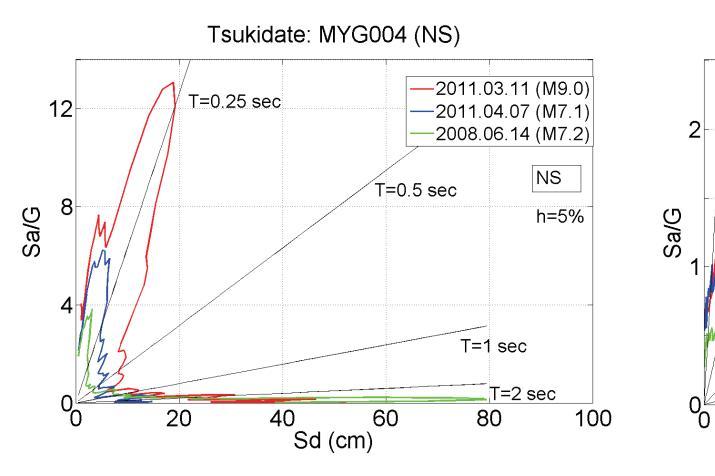
Fig.9 and Fig. 10 show acceleration-displacement response spectra (Sa-Sd spectra) in the larger amplitude horizontal direction at MYG004 and MYG006. In these figures, the spectra due to the 7/4/2011 after shock and 14/6/2008 Iwate-Miyagi Nairiku earthquake are shown for comparison. It is found form these figures that the observed motion at Tsukidate with JMA seismic intensity 7 is consisted of shorter period contents than 0.3 sec and the displacement at around 1 sec is small as 10cm even if the amount is larger compared to that for the 2008 earthquake.

Fig.9 Sa-Sd spectra for the earthquake records at MYG004

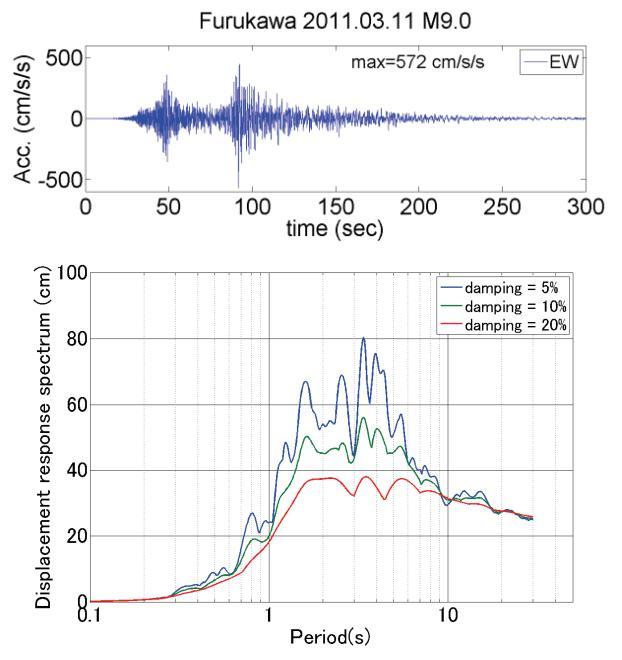
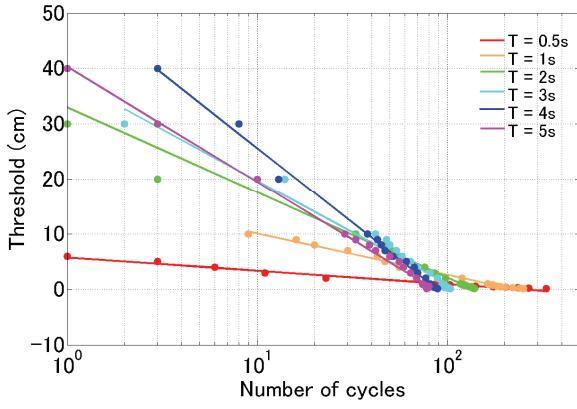
Fig. 11 shows observed acceleration waveform in EW component at K-NET Furukawa station (MYG006) and its displacement response spectra. The dominant period at around 4s is due to sedimentary basin. Fig.12 shows relation between the numbers of displacement cycles and threshold

Fig.11 Observation Record at K-NET Furukawa (EW-comp) and its displacement response spectra

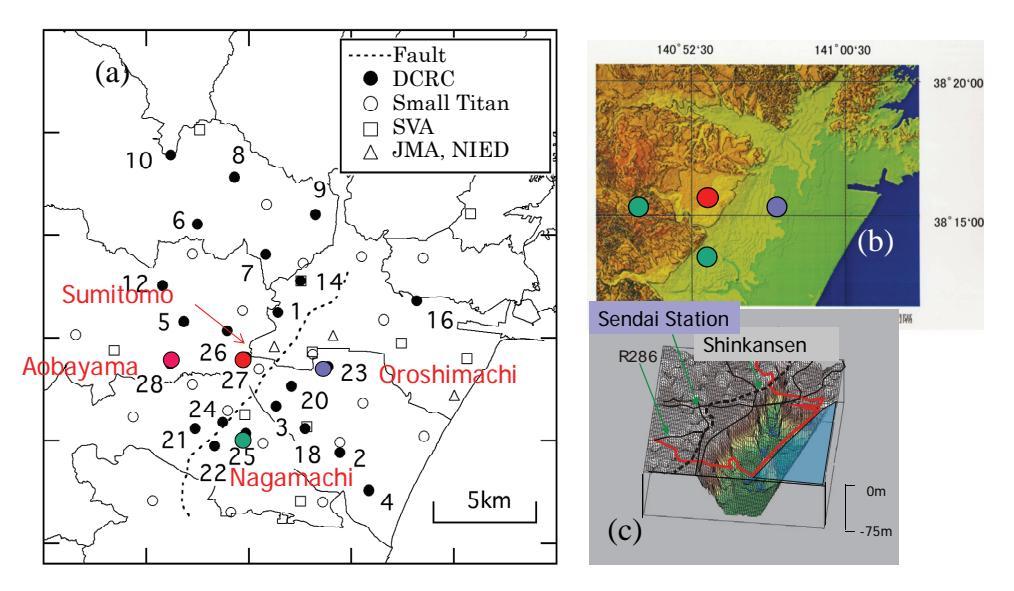
The author's Disaster Control Research Center (DCRC), Tohoku University, has strong motion network in Sendai City and valuable observation records were obtained during the Tohoku earthquake (Ohno and Motosaka, 2011). Seismometers are installed at ground floor (some are also at top floor) of public buildings (Ohno et. al, 2004). Site locations and geological information are shown in Fig. 15.

Fig.15 Site locations of DCRC strong-motion network and surface geological information. (a) Obs. Site (b) surface topography (c) Quaternary layer bottom

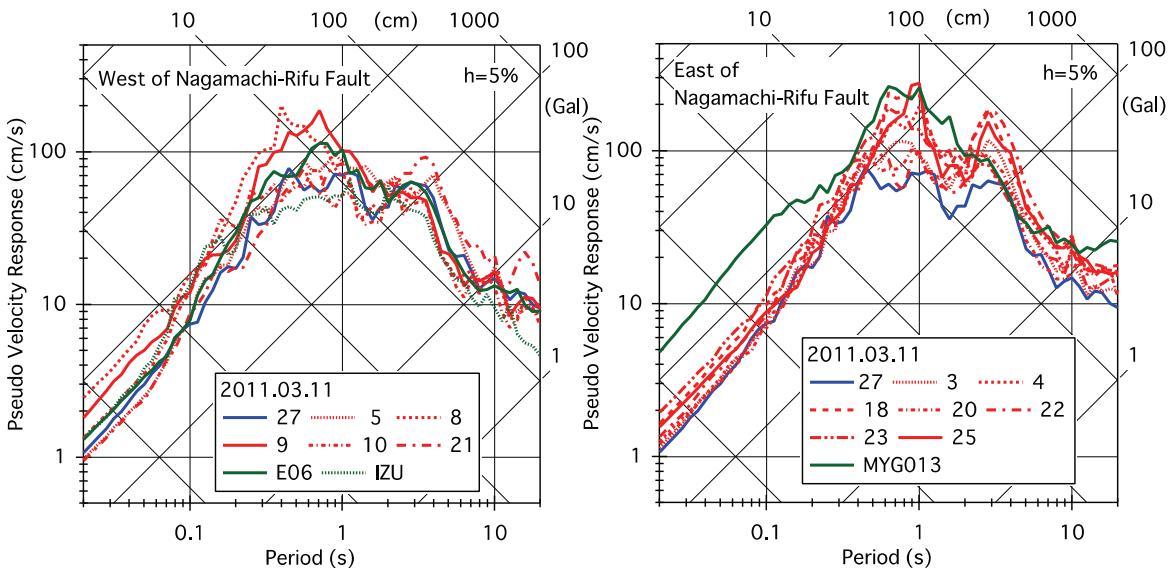
Fig.16 shows pseudo velocity response spectra at east and west sides of Nagamachi-Rifu fault. The spectrum at No.27, locating near Sendai station, is commonly plotted in each sides as a reference. Spectra at west sides are equal to or relatively larger at short period (less than 1 second) than the No.27 spectrum, while the spectra at east sides are significantly larger than the No.27 spectrum, especially around 1 and 3 seconds. Such spatial difference may be due to the difference of geological structure: west side of the fault is terrace and east side is lowland (alluvial deposits) in Sendai.

Fig.16 Comparison of pseudo velocity response spectra of DCRC strong-motion network

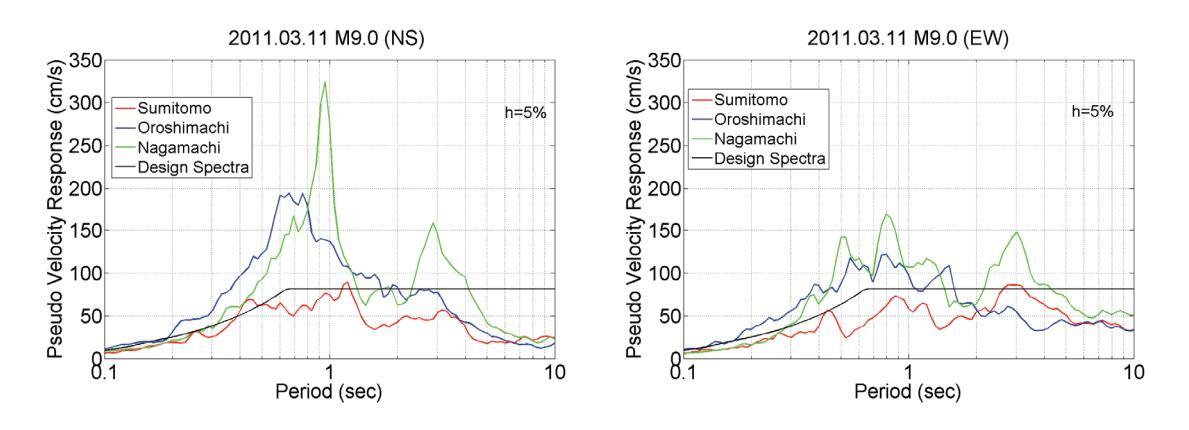
Fig.17 shows pseudo velocity response spectra (damping 5%) at Oroshimachi (No.23), Nagamachi (No.25) compared to Sumitomo Building near Sendai Station (No.27). The safety limit design spectrum is also shown in this figure. It is found that the period contents less than 1s are amplified by 3 times in Orishimachi, and that 1s period content at Nagamachi is 4 times amplified in NS direction compared to Sumitomo site and shows the very large response value of 300cm/s. But in EW direction the spectral amplification of 1s period content is not significant compared to NS direction. It is also noted that 3s period content is dominant at Nagamachi and amplified by 3 times in NS direction. This is effect of deep underground structure. Ground motion amplification characteristics in Aobayama are discussed in the later section.

Fig.17 Comparison of velocity response spectra due to different soil conditions

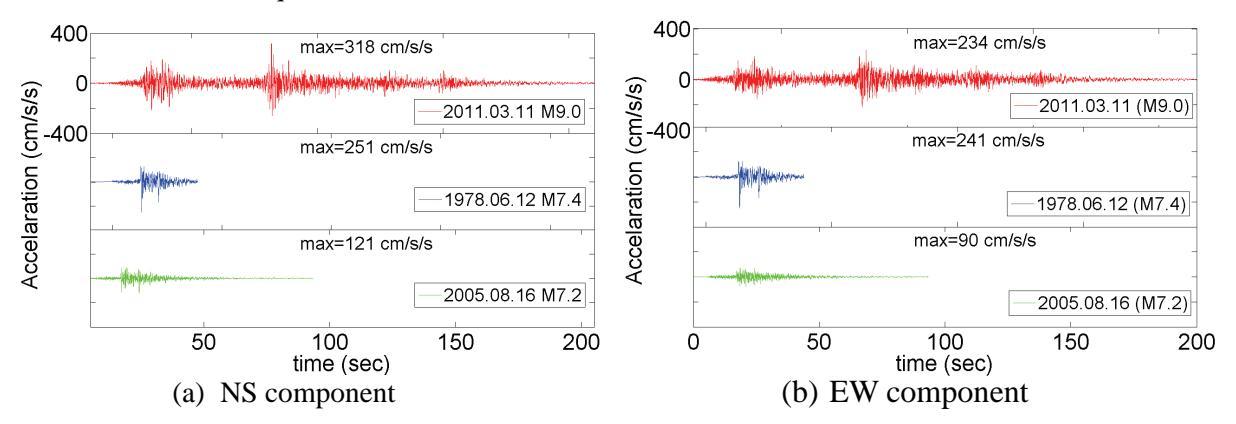
Fig.18 shows the acceleration waveforms of horizontal two directions for 2011 Tohoku earthquake (M9.0), 1978 Miyagi-ken Oki earthquake (M7.4), and 2005 Miyagi-ken Oki earthquake (M7.2). In this figure, the maximum acceleration values are shown for the three earthquakes. Fig.19 shows the corresponding pseudo velocity spectra. Findings focused on the comparison of the 1978 earthquake from these figures are as follows.

- 1) The envelope shape of the 1978 earthquake is almost same as the first phase of the 2011 earthquake.
- 2) Period contents shorter than 1.5s of the 2011 earthquake is larger than those of 1978 earthquake, about 20% larger at 1s, and twice as large at 0.5s
- 3) The period contents around 3s of the 2011 earthquake is more than two times as large compared to those of 1978 earthquake.

Fig.18 Comparison of observed acceleration waveforms for 2011 Tohoku earthquake and two Miyagi-ken Oki earthquakes

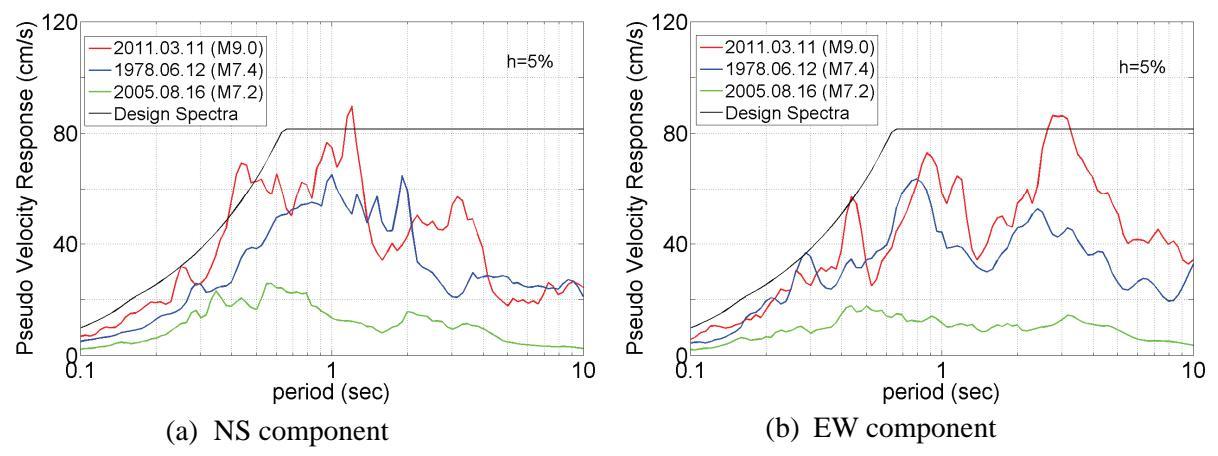
Fig.19 Comparison of observed acceleration waveforms for 2011 Tohoku earthquake and two Miyagi-ken Oki earthquakes

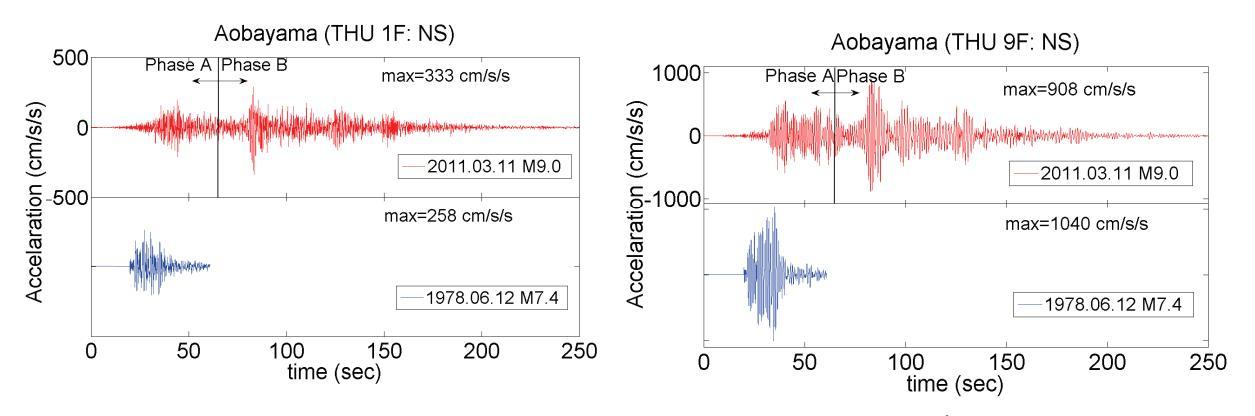
Fig.20 shows acceleration waveforms in the NS direction (Transverse direction) at 1<sup>st</sup> floor and top (9<sup>th</sup>) floor of THU building for the 2011 earthquake and the 1978 Miyagi-ken Oki earthquake.

Fig.20 Comparison of acceleration records at 1<sup>st</sup> floor (left) and 9<sup>th</sup> floor (right)

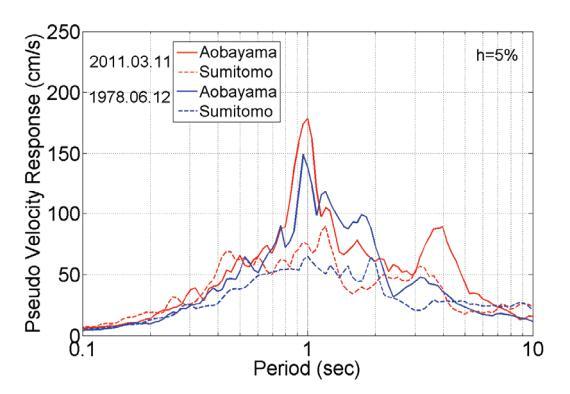
Fig.21 shows the site specific ground motion spectral amplification in Aobayama for the two earthquakes, the 2001 Tohoku and the 1978 Miyagi-kun Oki earthquakes. Fig.22 shows the spectral amplification in the THU building for the two earthquakes. It is noted that the amplification characteristics of the 1<sup>st</sup> phase (phase A) and the 2<sup>nd</sup> phase (phase B) are different. In NS direction, the second phase is amplified by more than two times at around 1s period content at Aobayama campus compared to Sumitomo building near Sendai station. The amplification characteristics are almost the same as those of the 1978 Miyagi-ken Oki earthquake and the THU building was strongly amplified by resonance.

Fig.21 Site specific ground motion spectral amplification in Aobayama

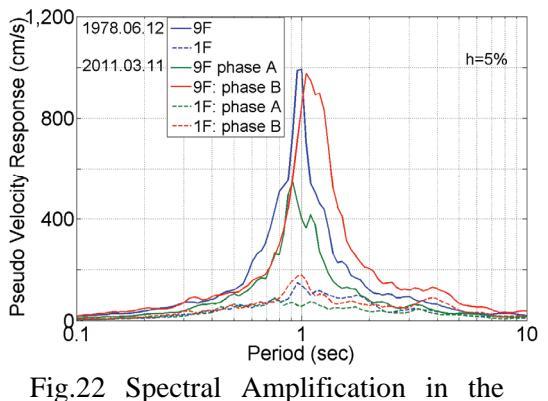
THU building for the 2011 and 1978 earthquakes

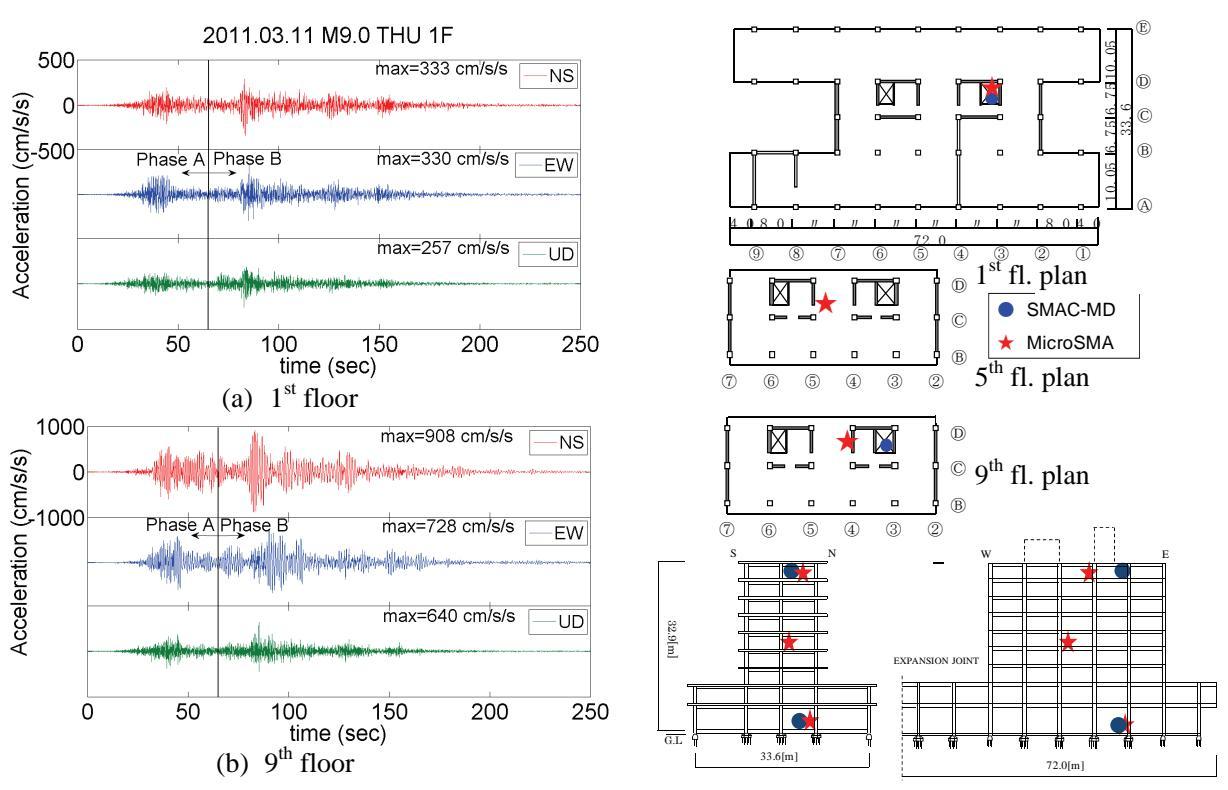
The THU building is a 9 story SRC (non-full web type) building and was constructed in 1969 and experienced 1978 Miyagi-ken Oki earthquake. The observed acceleration waveforms of the 3 components at 1<sup>st</sup> floor and 9<sup>th</sup> floor are shown in Fig.23. The configuration of the building and sensor locations are shown in Fig.24. In the building, SMAC-MD type seismometer is installed at 1<sup>st</sup> and 9<sup>th</sup> floor. From December, 2007, a continuous monitoring system (NetDAS/ MicroSMA) with sensors at

Fig.23 Observed records during the main shock

Fig.24 Configuration of THU Building and Sensor location

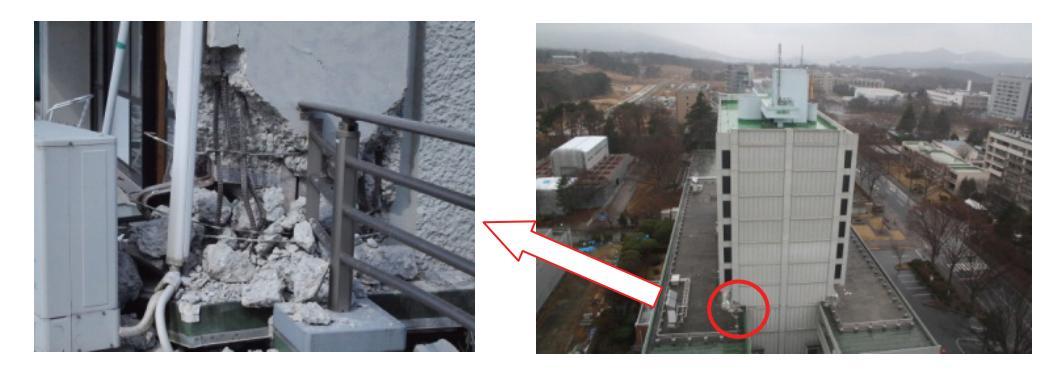
Photo 1 shows the damaged THU Building. The building was heavily damaged at bottom of 4 corner columns. The severe crack of the side shear wall due to possibly partial uplifting was suggested at the level of third floor (Tsamba and Motosaka, 2011).

Photo 1 Damage feature of bottom of one of the damaged four corner columns of THU building

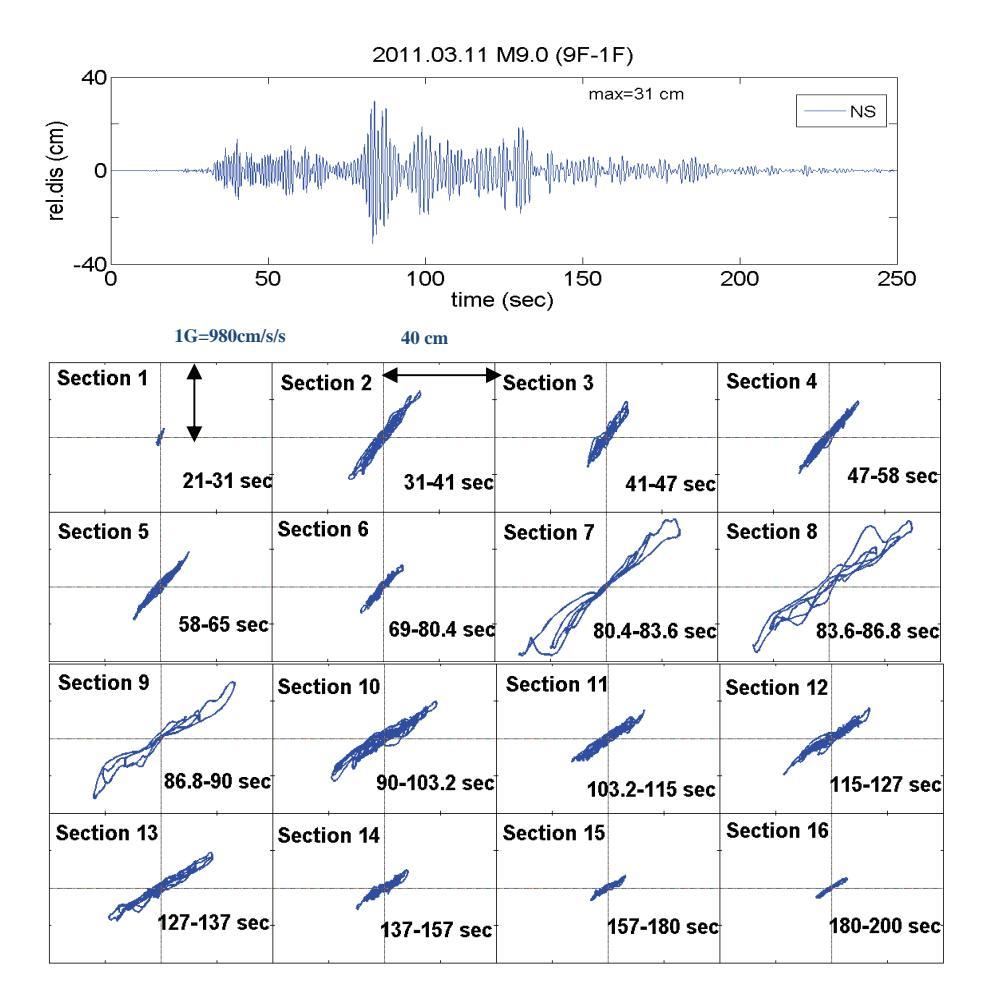
Fig.25 shows the dynamic hysteretic behavior based on force-displacement relation for the 16 time sections which are obtained from acceleration waveform at 9th floor and the relative displacement. Findings from this figure are as follows.

- 1) Starting from linear behavior at smaller amplitude level, hysteresis shows the inverse S shape slightly as recognized in section 5. Then shows linear behavior but the stiffness is reduced in section 6 compared to section 1.

- 2) Then, with increasing displacement, the hysteresis shows softening and hysteretic loop is recognized only for the larger displacement level. The hysteresis shows origin oriented behavior as recognized in (section 7).

- 3) Then decreasing the displacement, the hysteresis shows the characteristic inverse S shape in section 9. Although the amplitude decreases from Section 9 to Section 10, this hysteresis leads to stiffness reduction, which consistent with the dominant frequency reduction.

- 4) Then decreasing displacement gradually returns to linear behavior with the reduced stiffness in sections from 13 to 16 compared to section 6. The stiffness change is consistent with microtremor observation before and after the earthquake.

Fig.25 Relative displacement waveform and Hysteresis loops for each time section (NS-Direction)

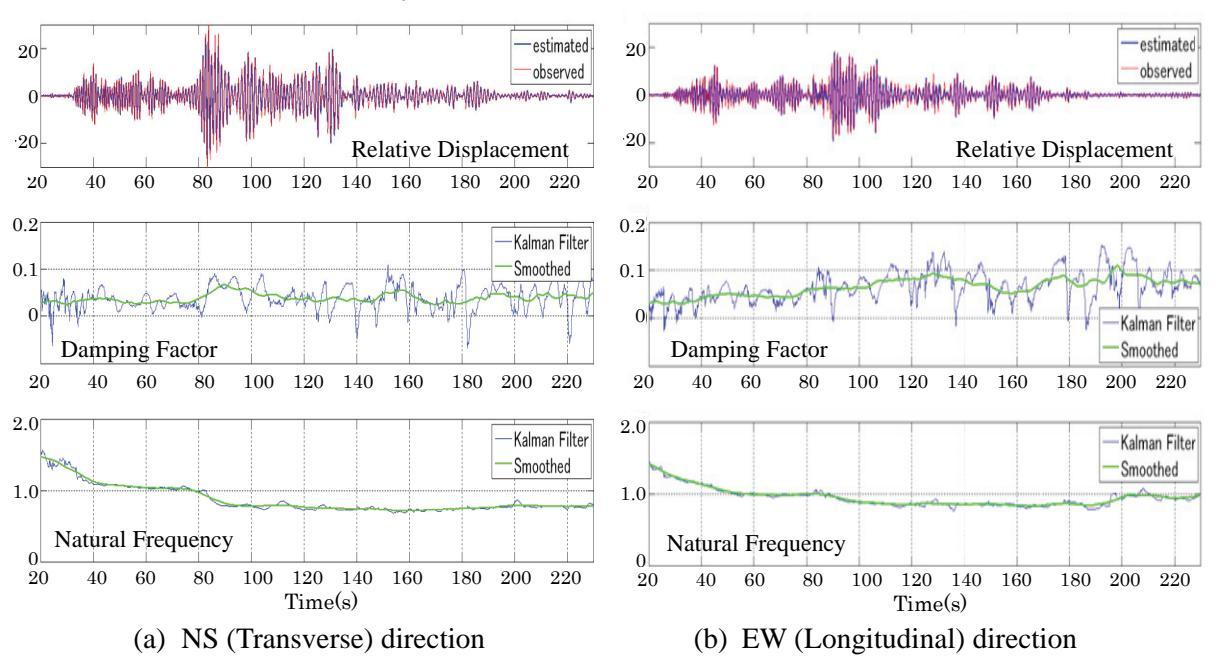
Fig.26 show the result of the identified system parameters, natural frequency and damping factor for NS direction and EW direction, respectively. In these figures, the calculated relative displacement waveform is compared to that obtained from observed records. As for the identified system parameters, natural frequency and damping factor, the smoothed curves are shown in these figures. Findings from the system identification results are as follows.

- 1) In the transverse (NS) direction, dominant frequency decrease down to about 0.8 Hz with increasing amplitude and the dominant frequency is not changed even if amplitude is decreased.
- 2) The damping factor in the transverse direction increases with increasing the amplitude at time section 7 in Fig.25 At the time sections with the inverse S type hysteresis, damping factor is decreasing with increasing the amplitude.
- 3) In the longitudinal (EW) direction, dominant frequency decrease down to about 0.9 Hz but return to about 1 Hz when amplitude level becomes small.
- 4) The smoothed damping factor in the longitudinal direction seems to be lager compared to the Transverse direction. This may be due to difference of hysteretic energy consumption.

Fig.26 Identified damping and Natural Frequency

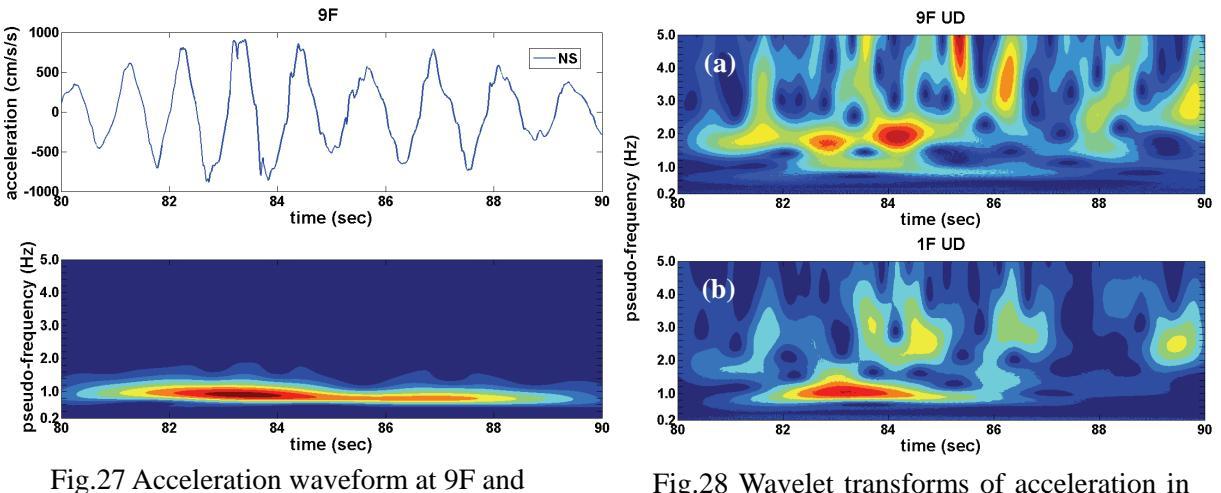
But the dominant frequency is not seen at the 1st floor.

2) This suggests the occurrence of partial uplift of the damaged building at the 3rd floor.

Fig.27 Acceleration waveform at 9F and wavelet transform

Fig.28 Wavelet transforms of acceleration in the vertical direction at (a) 9F and (b) 1F

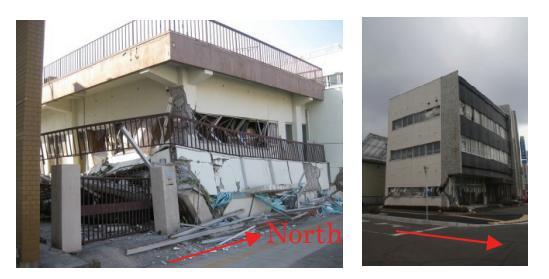
Considering many buildings were heavily damaged during the 1978 earthquake, the buildings in this area became strong due to effectiveness of the new building code and seismic reinforcement/retrofit. Photo 2 shows the collapsed two buildings during the main shock. Both were constructed in 1969 and experienced the 1978 earthquake. Estimation of

Photo 2 Collapsed two buildings in Oroshimachi, Wakabayashi-ku, Sendai

accumulated damage is important. Both the collapsed buildings are damaged in NS direction, which is consistent with the ground motion characteristics in Fig.30. The author confirmed through witness by two survived persons who were at the 1st floor of the left building in Photo 2 that the building was not collapsed during the first phase (phase A) but collapsed during the second phase (phase B).

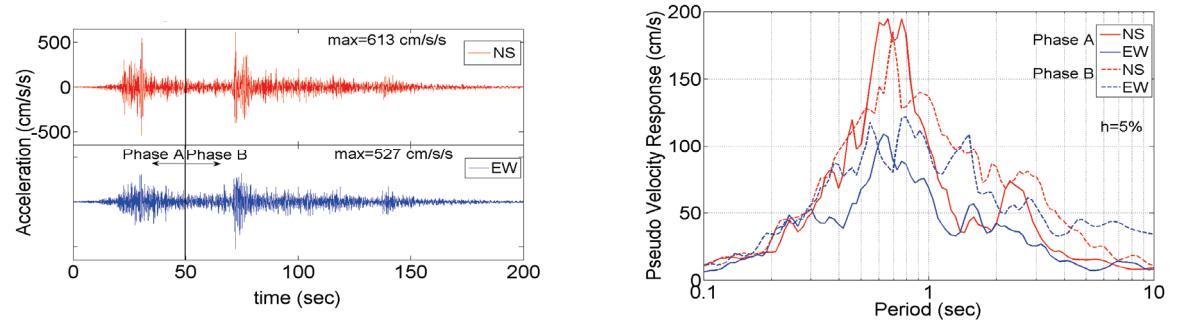
Fig.30 Comparison of observation record in the two horizontal directions at Oroshimachi and response spectra

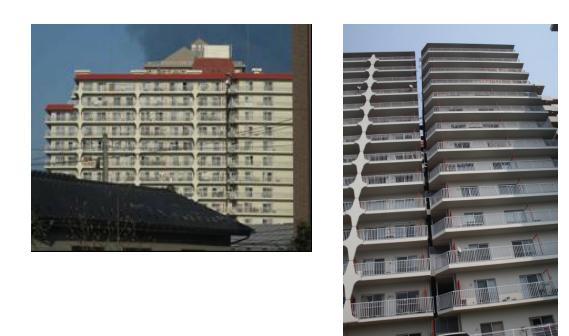
The authors inspected the damaged pile foundation buildings during the 1978 earthquake immediately after the 2011 Tohoku earthquake. It was reported that 7 piles are inspected and two among 7 piles were repaired but not reinforced at that time (Shiga, 1980). Photo 3 shows the 14-story SRC building for condominium, one of L shaped two buildings, connected by exp. joint each other, was inclined by 1/56 due to main shock and extended the inclination up to 1/45. Fig.31 shows the result of subsidence measurement at 11 points. The measured values in meter (shown as blue) are

relative elevation from the reference point. In the inclined right building, the level differences are 31cm for 14m arm length in the south (No.10 and No.11) and center (No.4 and No.3), which are consistent with the inclination angle of 1/45. This subsidence measurement suggests the pile failure of east side due to dominant ground motion in the NS direction.

Photo 3. Inclined 14-story SRC pile foundation building; (left) Overall view, (right) Opening of expansion point part

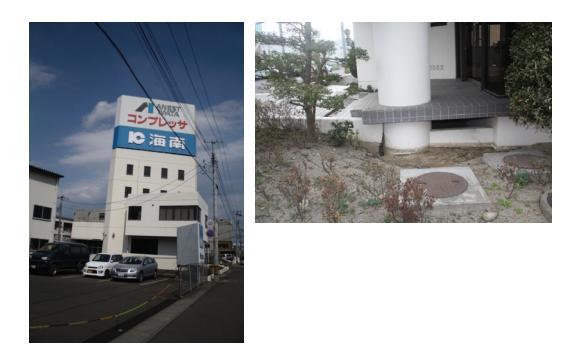
Photo 4. Inclined 4-story RC pile foundation building; (left) Overall view (right) Subsided bottom part of the south east corner column

A 4-story RC building with pile foundation (Photo 4) was inclined by 1/30 due to pile damage. No damage was recognized in the superstructure. The building was constructed in 1983 after execution of the new building code. It was recognized the surrounding soil was liquefied.

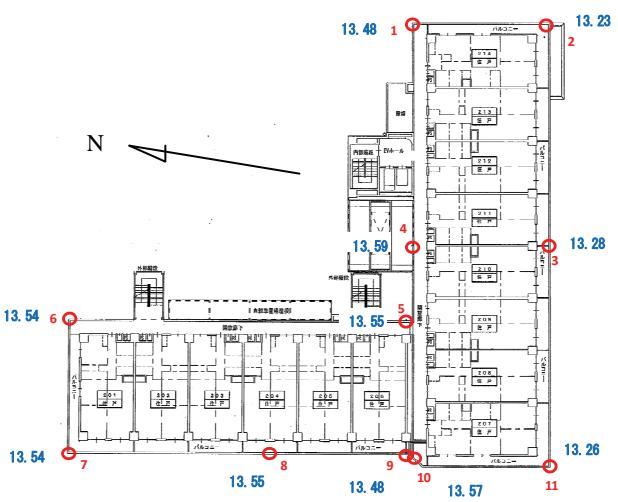
Fig.31 Measurement of subsidence of the damaged building

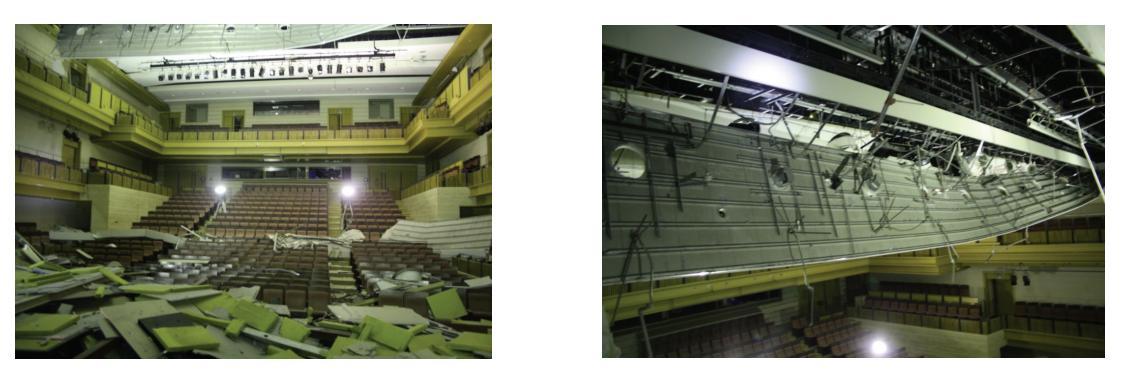
Photo 5 show the damage feature of suspended ceiling board drop at a culture center hall in Sendai, which the author inspected and investigated vibration characteristics based on microtremor observation. Fig.32 shows the Fourier spectra at roof of the building. It is noted that the vertical motion is induced at the roof due to horizontal input motion. In the design of the ceiling board, the ceiling board system would be taken into the induced vertical motion as well as enough clearance for horizontal motion. Judging from the damage feature, the drop seems to be caused by the lack of strength to the vertical motion and the unexpected collision between hanging bold and equipments such as air conditioning duct. The seismic standard for vertical load of the ceiling board system would be reconsidered especially for large span structures and also for the many numbers of displacement cycles due to ground motion with long duration and also due to accompanied many aftershocks. It is also important to recognize that the response of the ceiling board is affected by the vibration characteristics of earthquake supporting soil and structure including roof slab. If resonance phenomena occur, applied earthquake force would significantly large. For a lager ceiling board with area more than  $1,000m^2$ , floor response spectral method would be needed. It is also important to consider that ceiling board system is recognized as the bending board supported by springs and vibration energy should not be propagate horizontally (Motosaka, 2006).

Photo 5 Damage feature of ceiling board drop at a culture center hall in Sendai

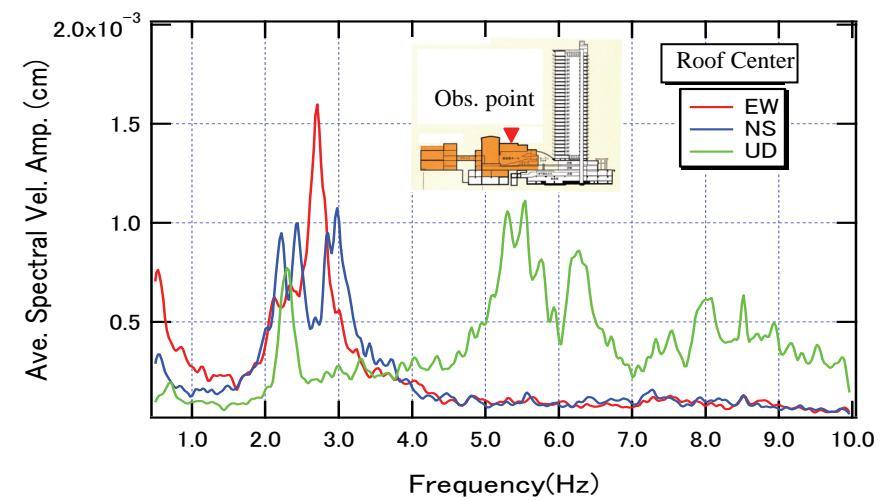
Fig.32 Dominant frequencies based on microtremor measurement at the center of roof at the damaged culture center hall in Sendai
