Earthquake and Tsunami Disaster in Solomon Islands, 2 April 2007

Tapurai, Simbo Is.

JAEE Tsunami Survey Team H. Matsutomi K. Fujima Y. Shigihara

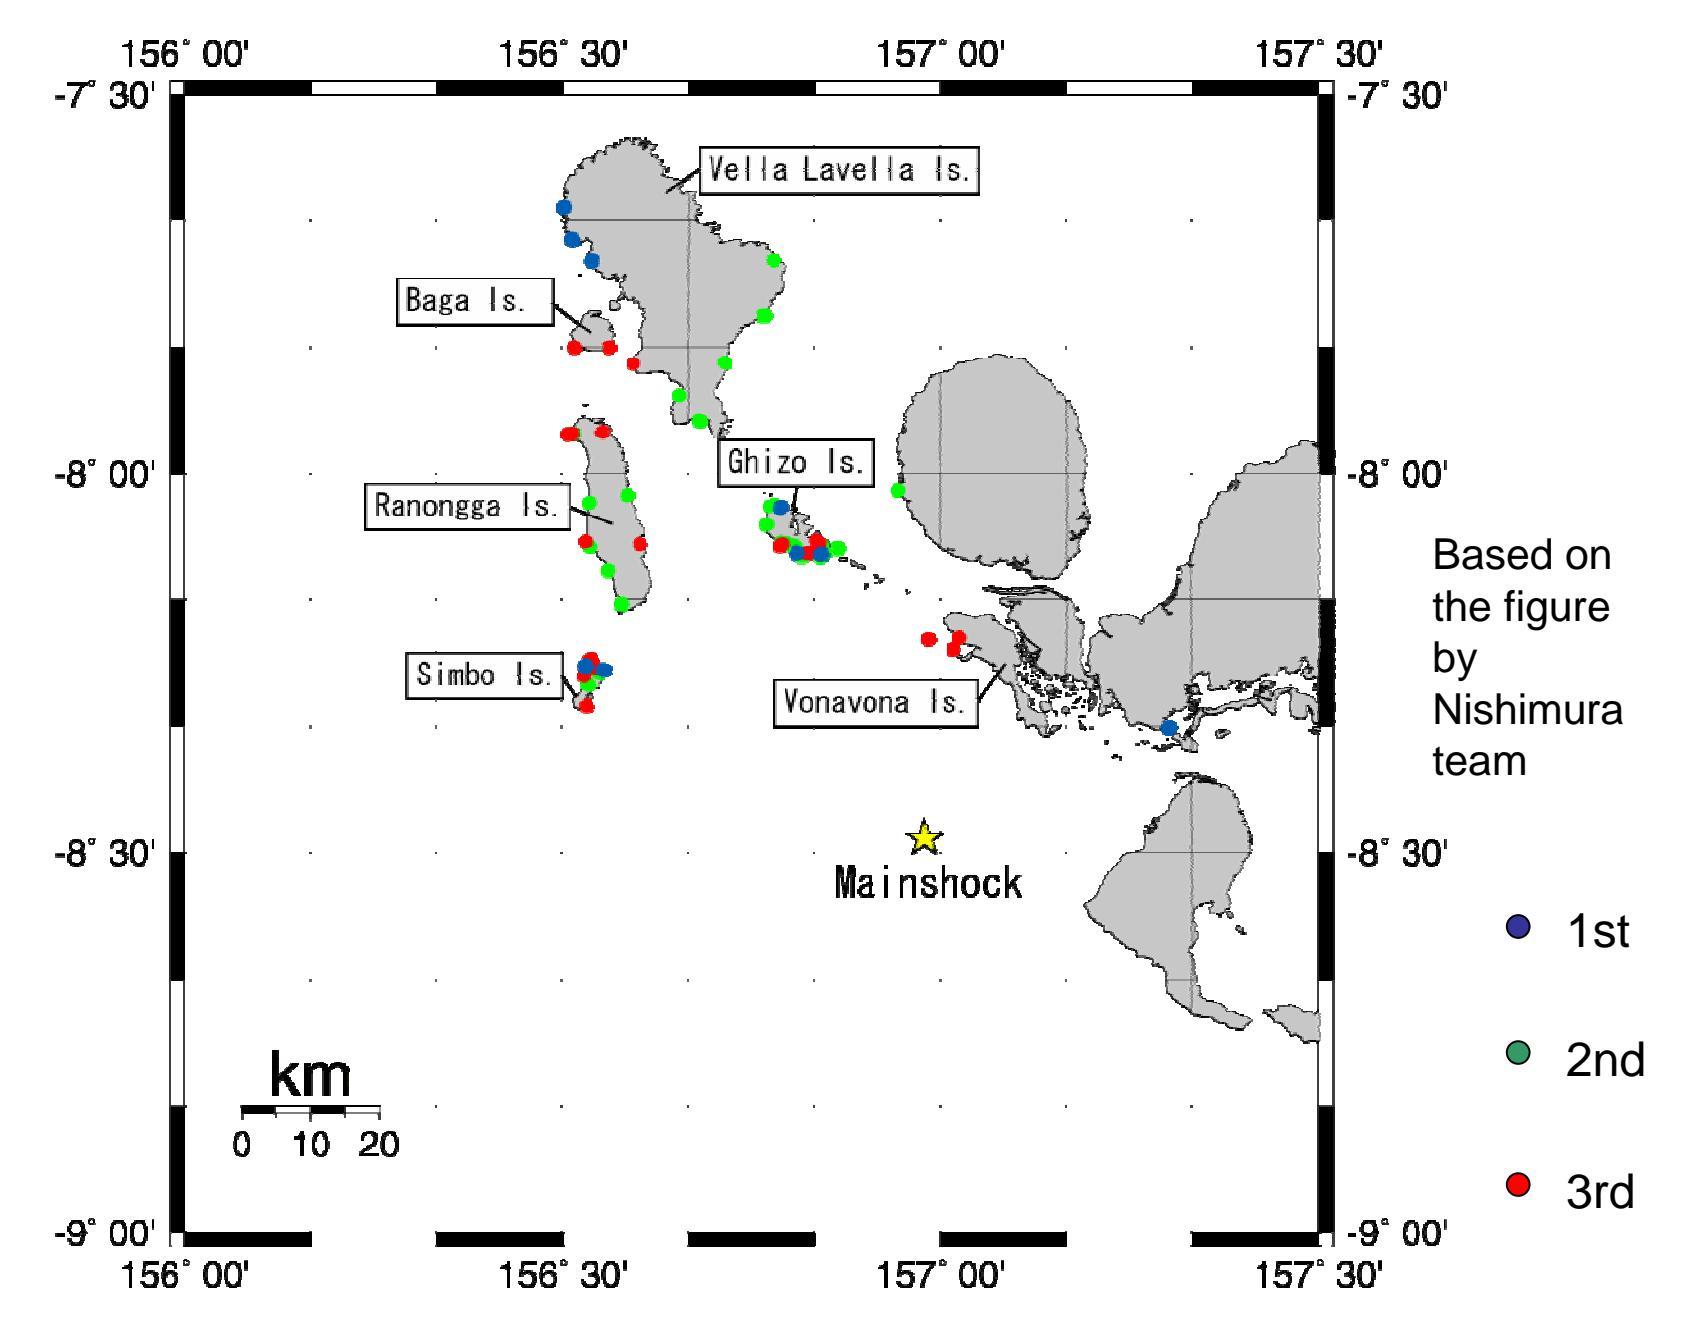
Tsunami Survey Points

Survey Result of Ground Deformation

地震前(後)の満潮(干潮)位を証言等から判断し,測量. Ex.1 Kundu, Ranongga Is.
