## DEVELOPMENT OF SURVEY MANAGEMENT SYSTEM FOR BUILDING DAMAGE ASSESSMENT

**ABSTRACT:** This paper proposed the new system for building damage assessment using photos of damaged house taken by residents or volunteer fire corps in damaged area. Specialists outside the damaged confirm these photos on the website and assess their damage levels. All the data used for building damage assessment is managed with GIS database on the management server located outside the damaged area under cloud condition. This kind of digital management system can contribute to enhance the accuracy and efficiency of the procedures for issuing the Victim Certificates for residents. In this paper, the total system for supporting building damage assessment was designed and its prototype system was developed. The system for uploading the photos of damaged houses was developed as mobile communication service. The remote system for specialists to assess the damage level was developed as web service.

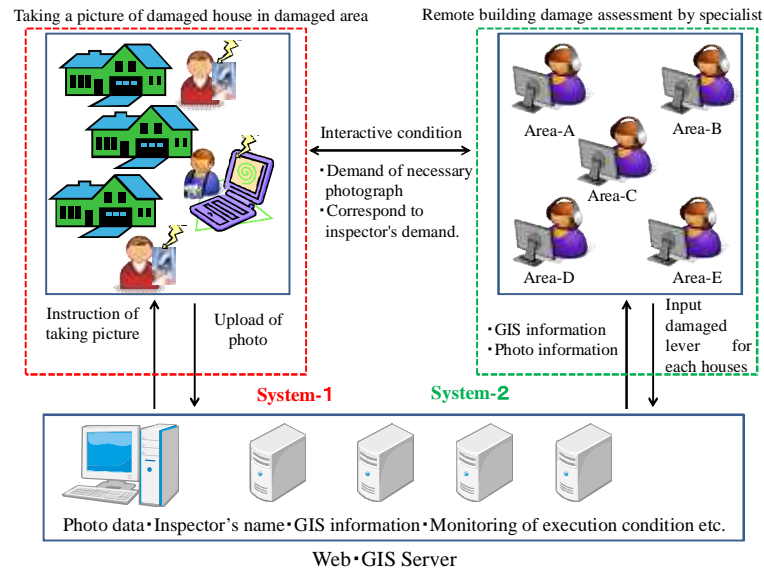
Fig. 1 Concept of remote system for building damage assessment

As a new system for achieving all the solutions for the problems reported at the past building damage assessments as shown in table 1, we proposed a new remote system for supporting building damage assessments during large-scale earthquake disaster. The concept of the system is illustrated in figure 1. The total system consists of two sub-systems. The first one is photo upload system in damaged area. Photos of a damaged house are taken by residents or volunteer fire corps in damaged area and those data is uploaded to the server. The second one is remote assessment system for specialists. Specialists located outside the damaged area confirm these photos through the website, and assess their damage levels and area. All the data used for building damage assessment is managed with GIS database on the management server located outside the damaged area under cloud condition. This kind of digital management system can contribute to enhance the accuracy and efficiency of the procedures for issuing the Victim Certificates for residents.

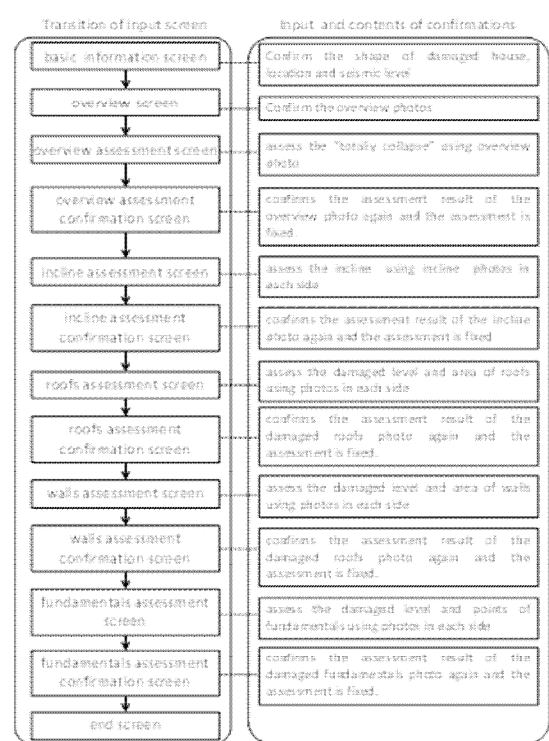
Fig. 3 Flow of remote assessment system

Here, prototype of “remote assessment system of photos of damaged houses was developed. Specialists outside the damaged area confirm these photos on the website and assess their damage levels. All the data used for building damage assessment is managed with GIS database on the management server located outside the damaged area under cloud condition. Flow of remote assessment system is shown in figure 5. Firstly, specialists who are registered architects and experienced workers outside the damaged area confirm the basic information such as shape of damaged house, location and seismic level on the web system and overview all the photos of a damaged house. Secondary, they assess the damage level and area using some photos such as overview of damaged house, incline of damaged house and damaged point of roofs, walls and fundamentals. Finally, specialists confirm the input data and some photos. Then result of first

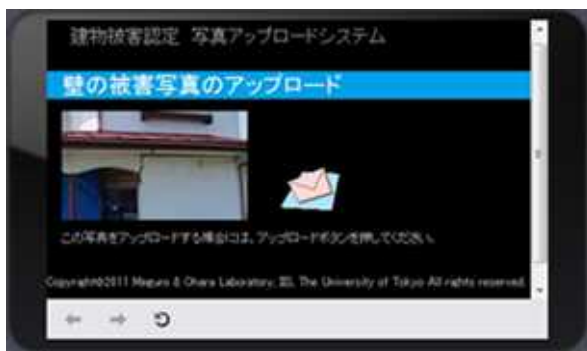
Fig. 4 Photo upload system in damaged area (upload page)

in almost all the smart phones except iPhone. Photo upload application is installed to each Android smart phone by inspectors who are residents or volunteer fire corps in damaged area. Flow of photo upload system is shown in figure 2. Firstly, residents or volunteer fire corps as inspectors input the basic information such as GPS information, address and owner name. Secondary, they upload some photos such as overview of damaged house, incline of damaged house and damaged point of roofs, walls and fundamentals. Finally, they confirm the input data and some photos. Method of completing for photo upload in damaged area using upload application is as follows. Inspectors take some damaged house photos which are full views of a damaged house (north side, east side, south side and west side) and closeup views of damaged points. They select some photos for upload in each factors page, and fill in the comments about damage level and location of a house etc. as shown in figure 3. Inspectors should take pictures of damaged house concerning three factors: externals, inclination and building element (roof, exterior wall and foundation). Furthermore, they have to relate closeup views of damaged points to full views using touch screen functions as shown in figure 4. Figures 3 and 4 are the prototype images of the system for the primary inspection. The prototype images of photo upload system were developed based on the data of totally damaged houses due to the 2011 off the Pacific coast of Tohoku Earthquake. After taking some pictures, inspectors need to upload them to an exclusive server in cloud condition using upload application. Using this application makes it easier to select and upload photos which are taken by inspector in damaged area. The reason is that smart phone has touch screen functions which are tap, drag, flick and pinch out/in operations.

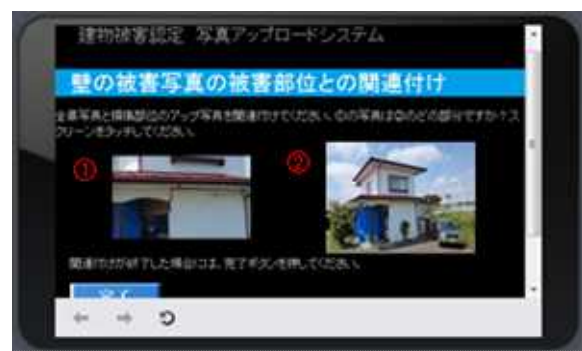
Fig. 5 Photo upload system in damaged area (relationship page)

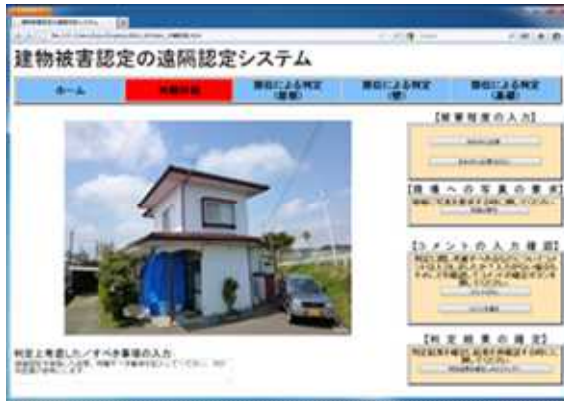
Fig. 6 Remote assessment system (overview assessment page)

assessment is passed to the next specialist to carry out double check. Figures 6 and 7 show the prototype images of the system for primary inspection. These images were developed based on the data of totally damaged houses due to the 2011 off the Pacific coast of Tohoku Earthquake. Total damage level of a house is decided based on damage levels of three factors: externals, inclination and building element. Assessment for one damaged house should be conducted by two or three specialists to double-check the result and keep accuracy, damage level and area from pull down choice set in each factor page. In addition, they can request additional photos for accurate assessment to inspectors in damaged area through the each assessment page. In final page, fill in the special or caution comments of assessed damaged house and pass to the next specialist. When the assessment ends here, Victim Certificates for resident is issued from local government.

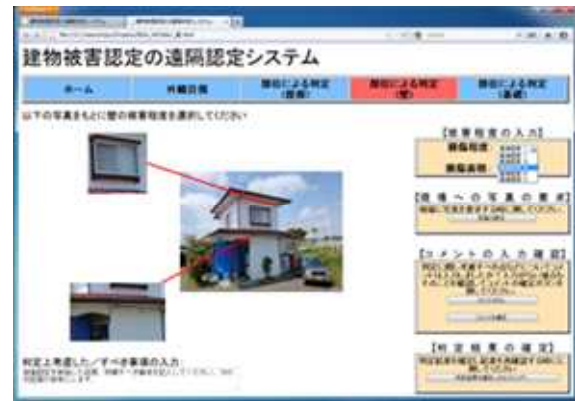
Fig. 7 Remote assessment system (wall assessment page)
