# **EARTHQUAKE AND TSUNAMI DAMAGE ON STEEL BUILDINGS CAUSED BY THE 2011 TOHOKU JAPAN EARTHQUAKE**

**ABSTRACT:** The 2011 Tohoku Japan earthquake and tsunami caused extensive damage to steel building structures. Large slippage over a large inter-plate fault produced very high tsunami waves that attacked the east coast of Japan. The Committee of Steel Structures of the Architectural Institute of Japan carried out earthquake damage reconnaissance over cities where severe ground shaking was recorded among the prefectures of Miyagi and Fukushima. Tsunami damage reconnaissance was also conducted along the coastlines of Iwate, Miyagi, and Fukushima.

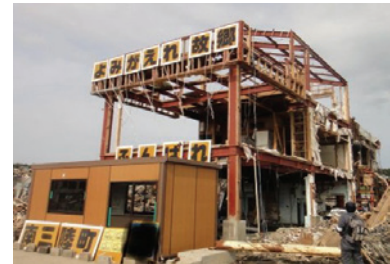
Photo 64 Store A: external view.

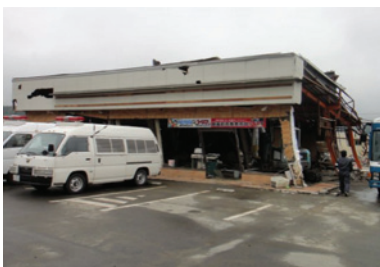
Photo 77 Store C: external view.

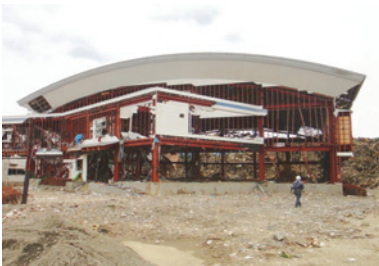
Photo 95 Gymnasium C: external view.

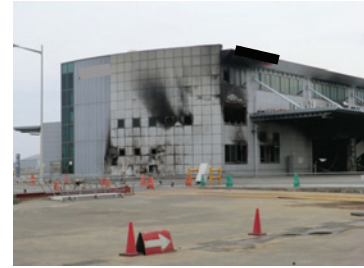
Photo 115 Building  
(Miyagino, Sendai)

Damage in some buildings was exacerbated by fire that initiated after the earthquake and tsunami. The cause of fire is unknown. (Photos 114-116)
