A QUICK REPORT ON PAZARCIK AND EKİNÖZÜ EARTHQUAKES (TÜRKİYE) OF FEBRUARY 6, 2023

Ömer AYDAN* and Reşat ULUSAY**

15 February 2023

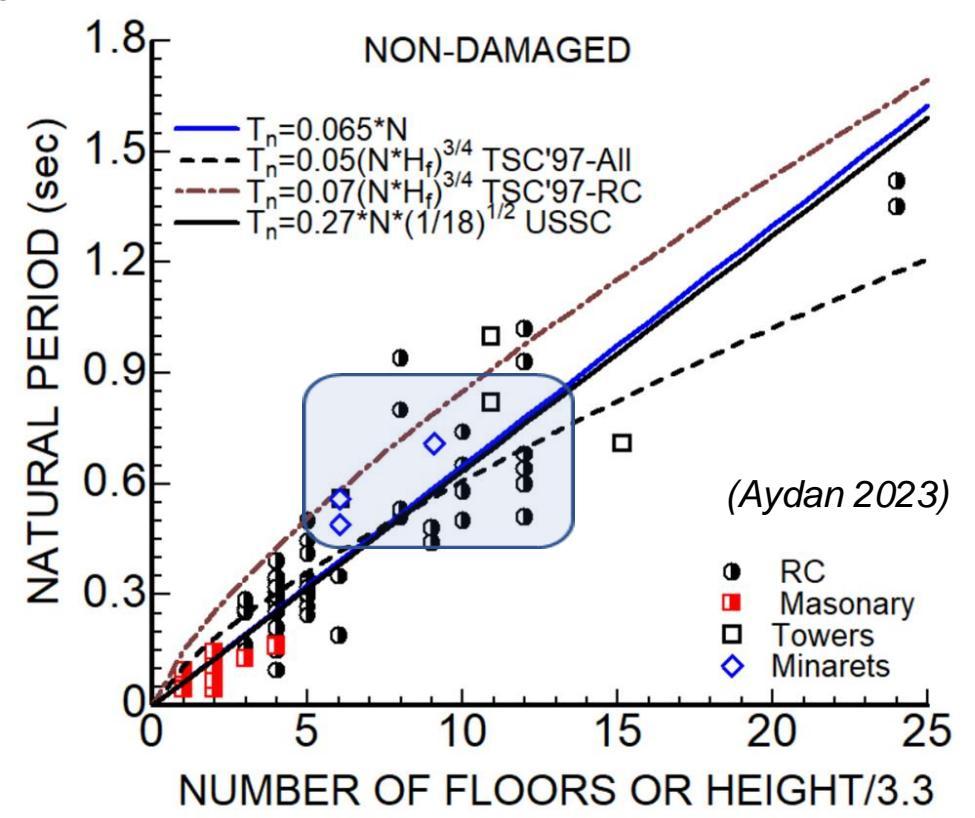
Most of RC buildings has 5 to 14 stories. The estimated natural frequency for the first mode ranges between 0.3 to 0.9 seconds, this might have an influence on their collapses. If the design and construction were properly done according to the Turkish Seismic Code, this scale damage would not occur

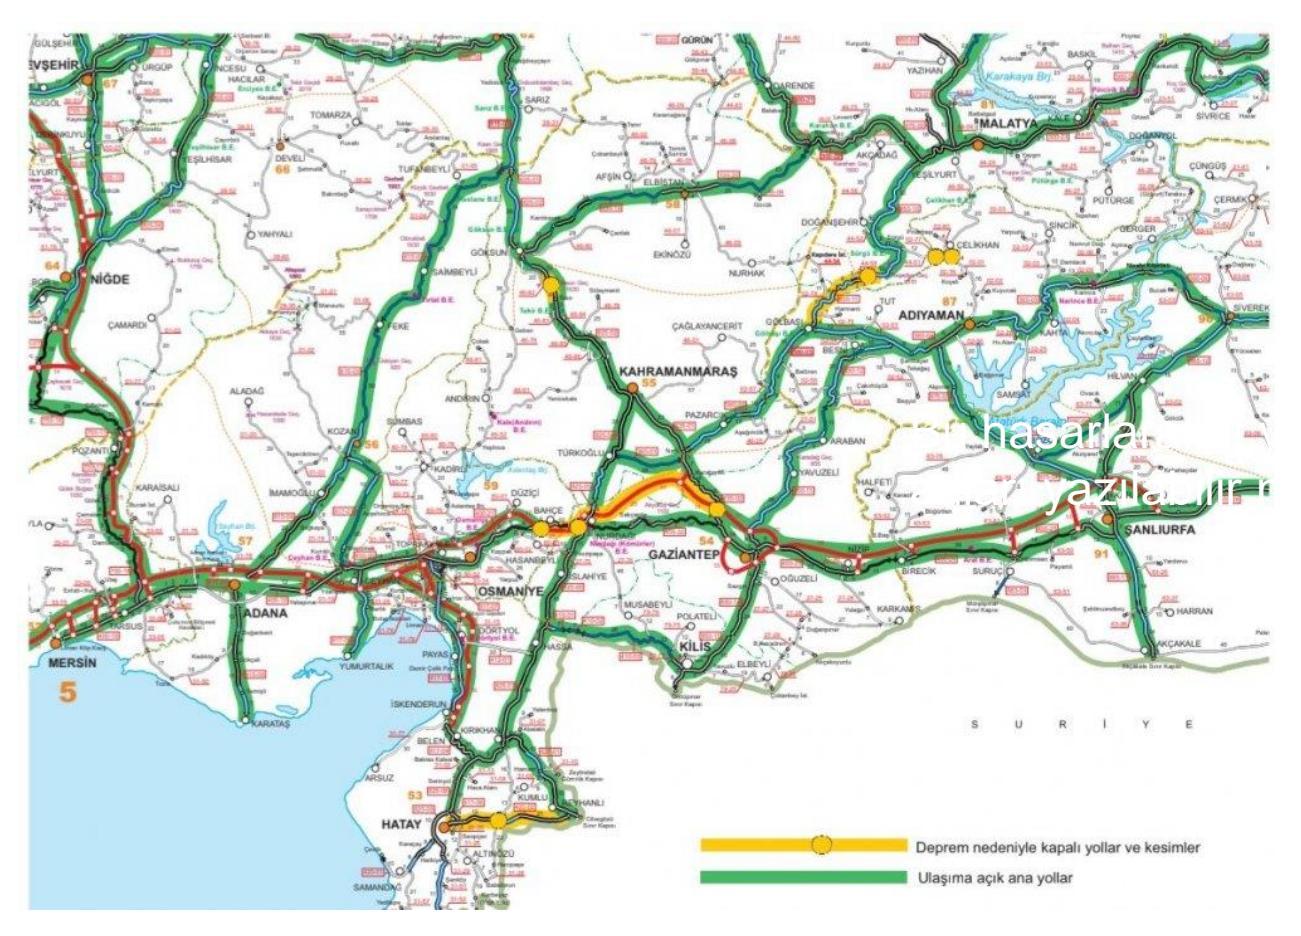
The map of Damaged Roadways from KGM (General Directorate of Highways of Turkey) (yellow lines indicates roadways closed to traffic due to damage)

- 1) Separation or collision of bridge deck with abutments
- 2) Faulting induced deformations
- 3) Retaining wall failures
- 4) Deformation of pavement (separation or buckling=)
- 5) Fall of bridge decks
- 6) Tunnel damage
- 7) Embankment failures

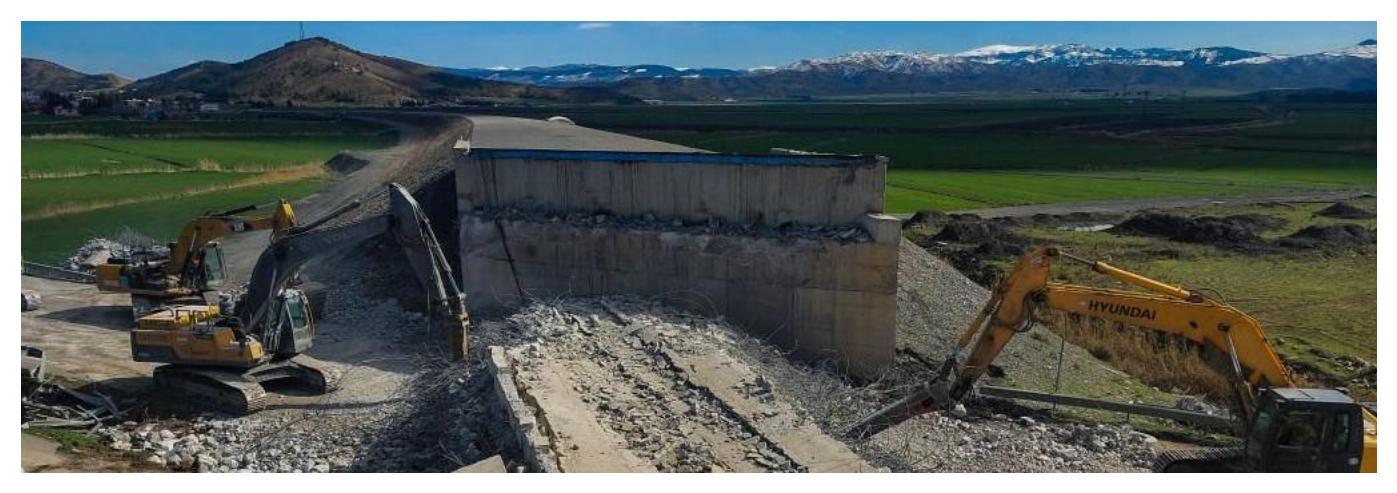
Bridge deck fall

Hatay Airport road

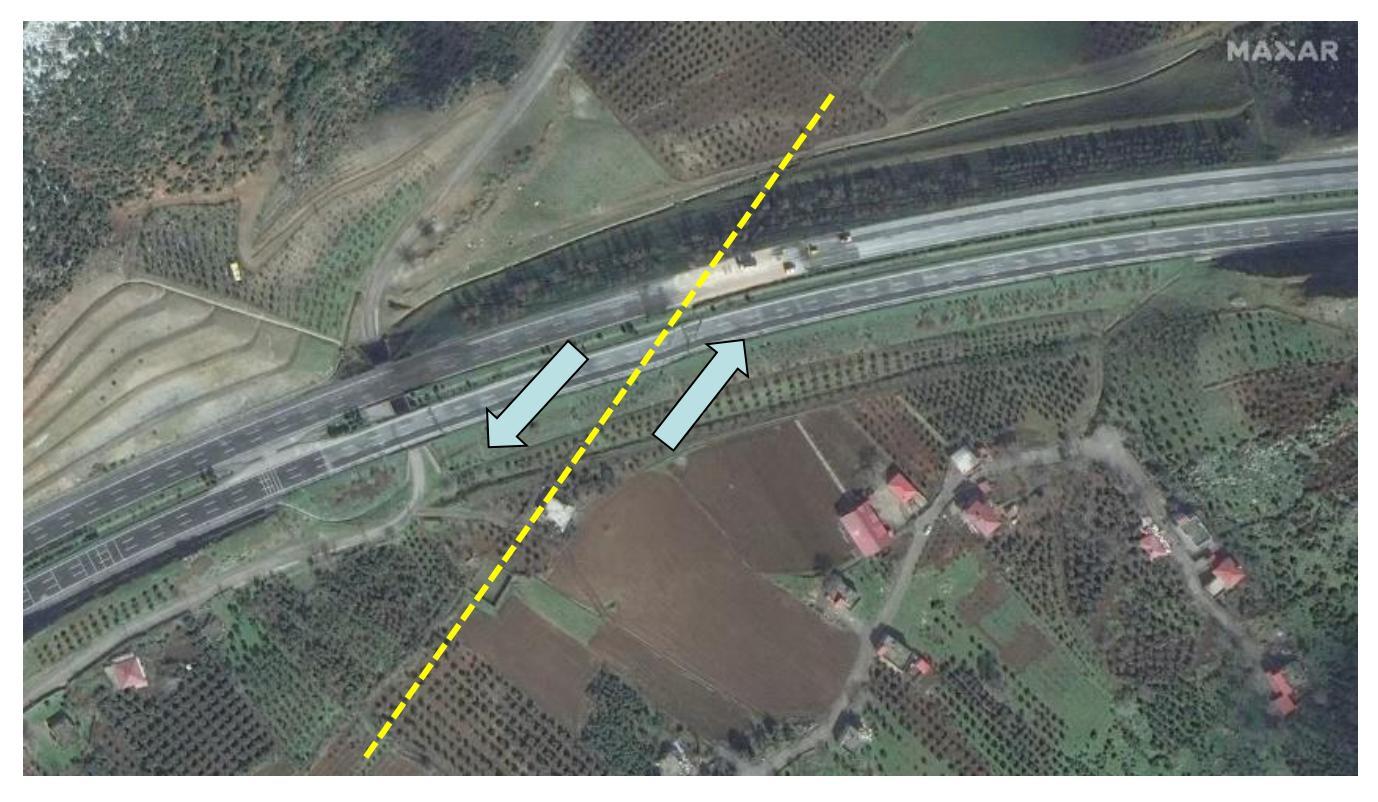
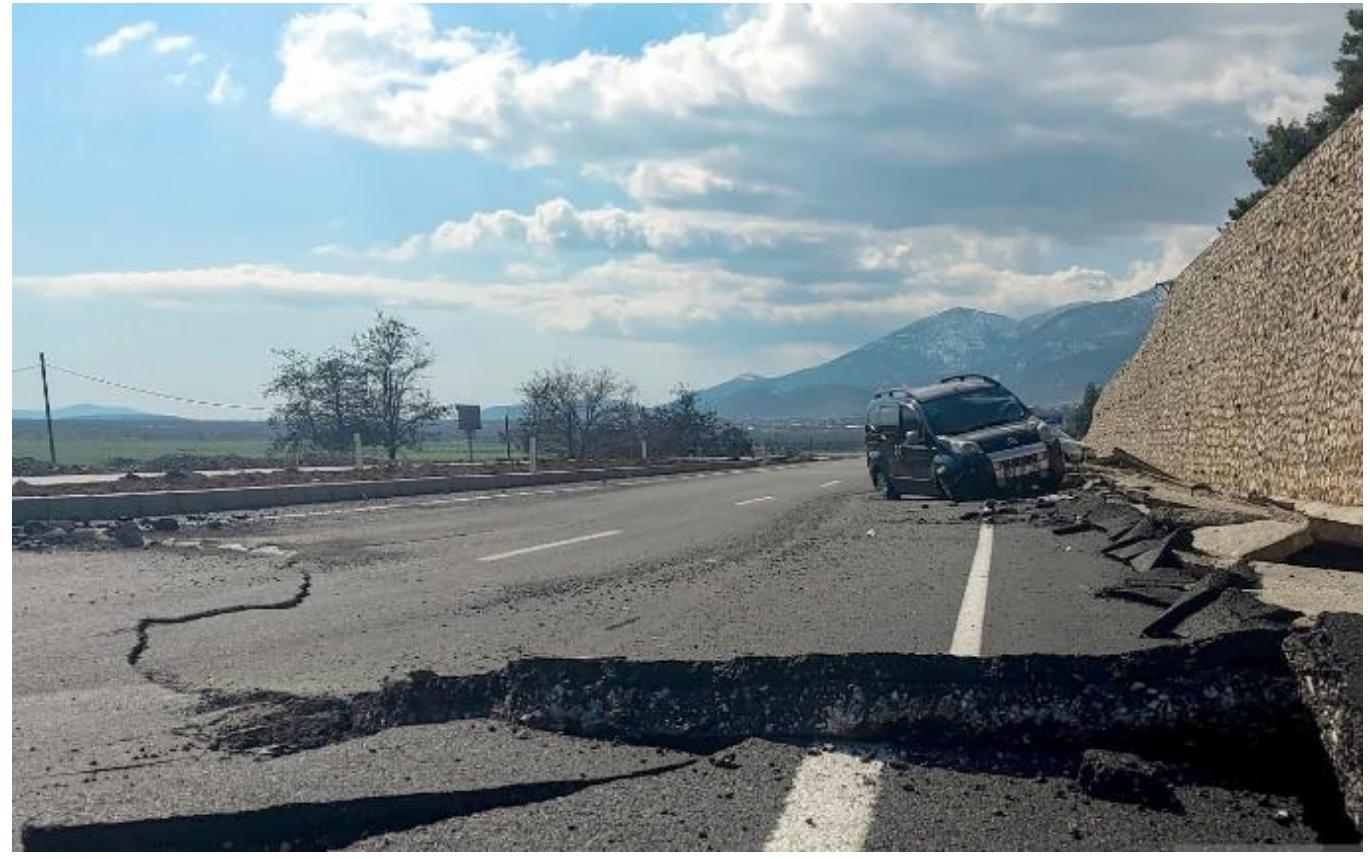
Damage of Tarsus Adana Gaziantep (TAG) near Islahiye by the fault rupture

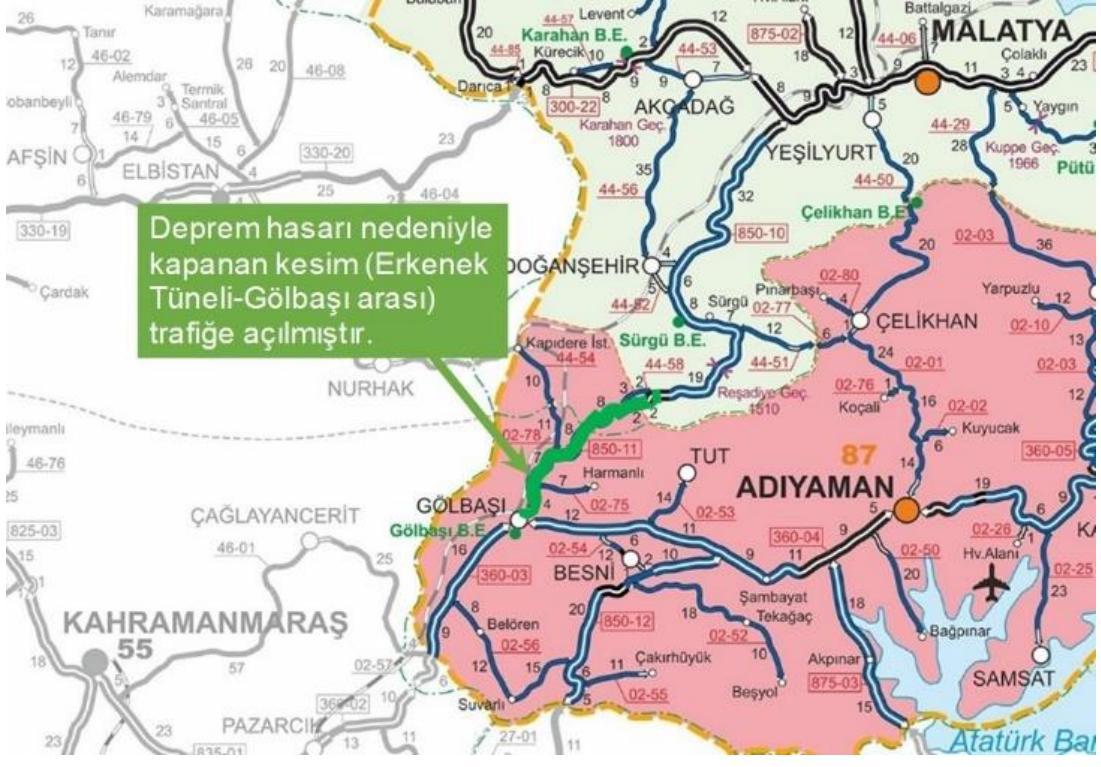
Location of Erkenek tunnel

Rockfalls at the portal and spalling of concrete lining of the Erkenek Tunnel occurred as reported by KGM. One of Erkenek Tunel tubes is closed to traffic while the other is utilised for traffic despite some spalling location of the lining were reported at some locations. The tunnel was almost on the activated Erkenek fault.

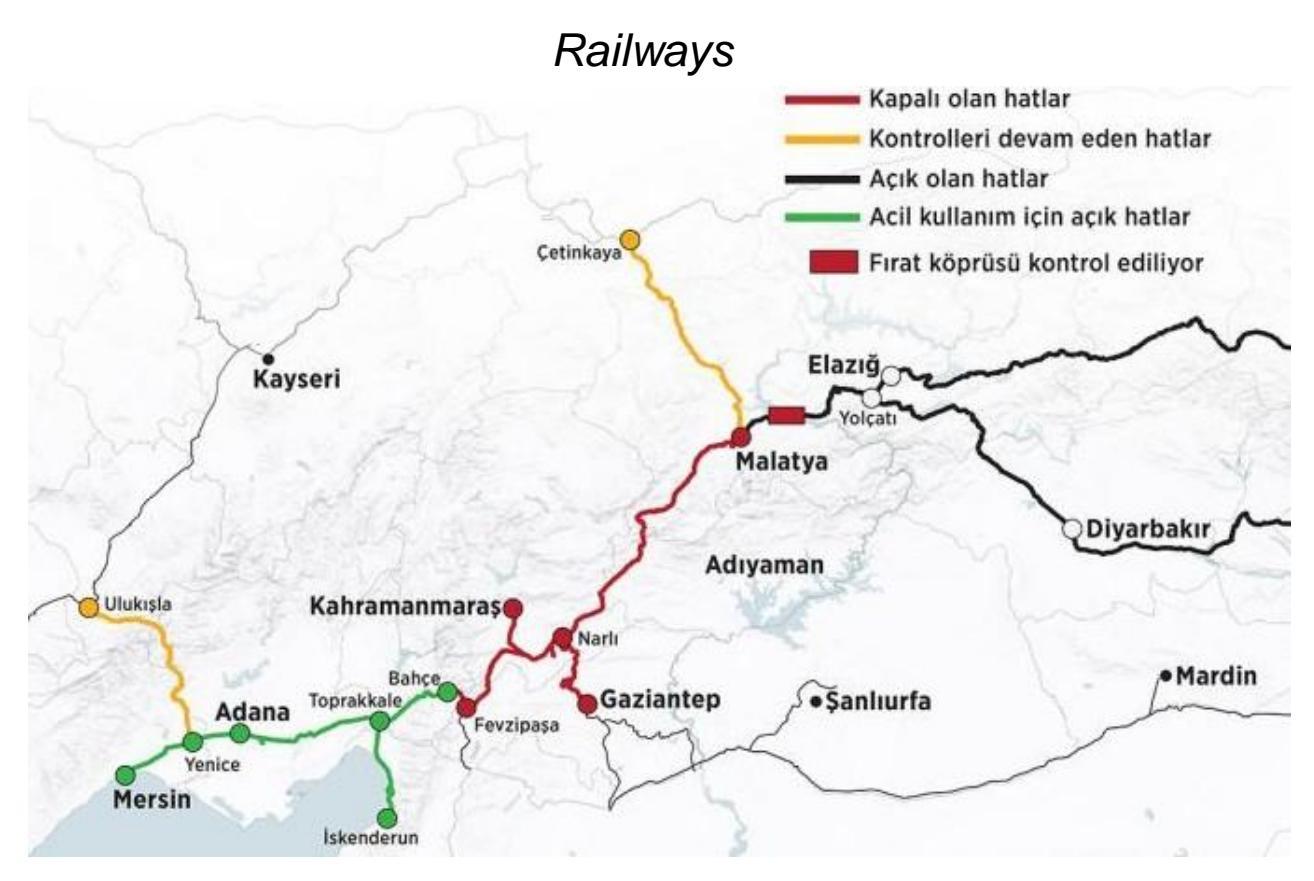
Locations of the damaged railway lines (from TCDD)

Damage was mainly caused by deformation of rails whereever earthquake faults crossed. In addition, trains and wagons were derailed or toppled. Rockfalls and slope failures also caused obstructions.

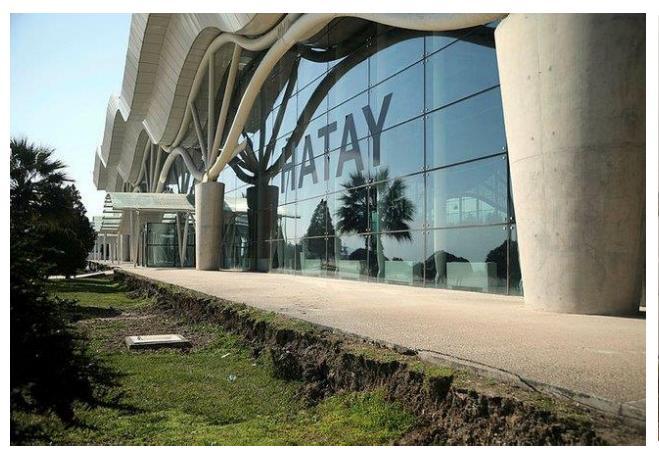
Ground settled around the terminal building at Hatay Airport

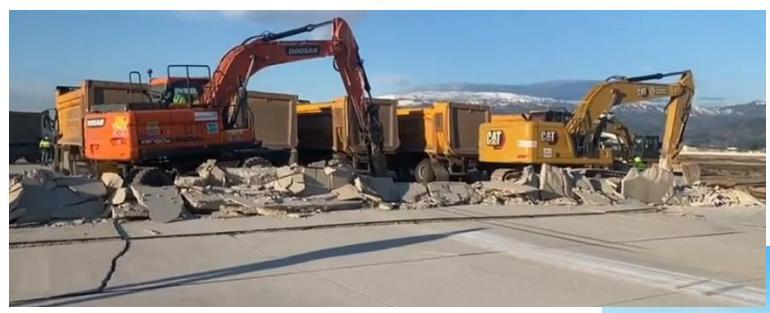
Runway buckled at Hatay Airport

Under reparation

Runway was repaired on February 11, 2023

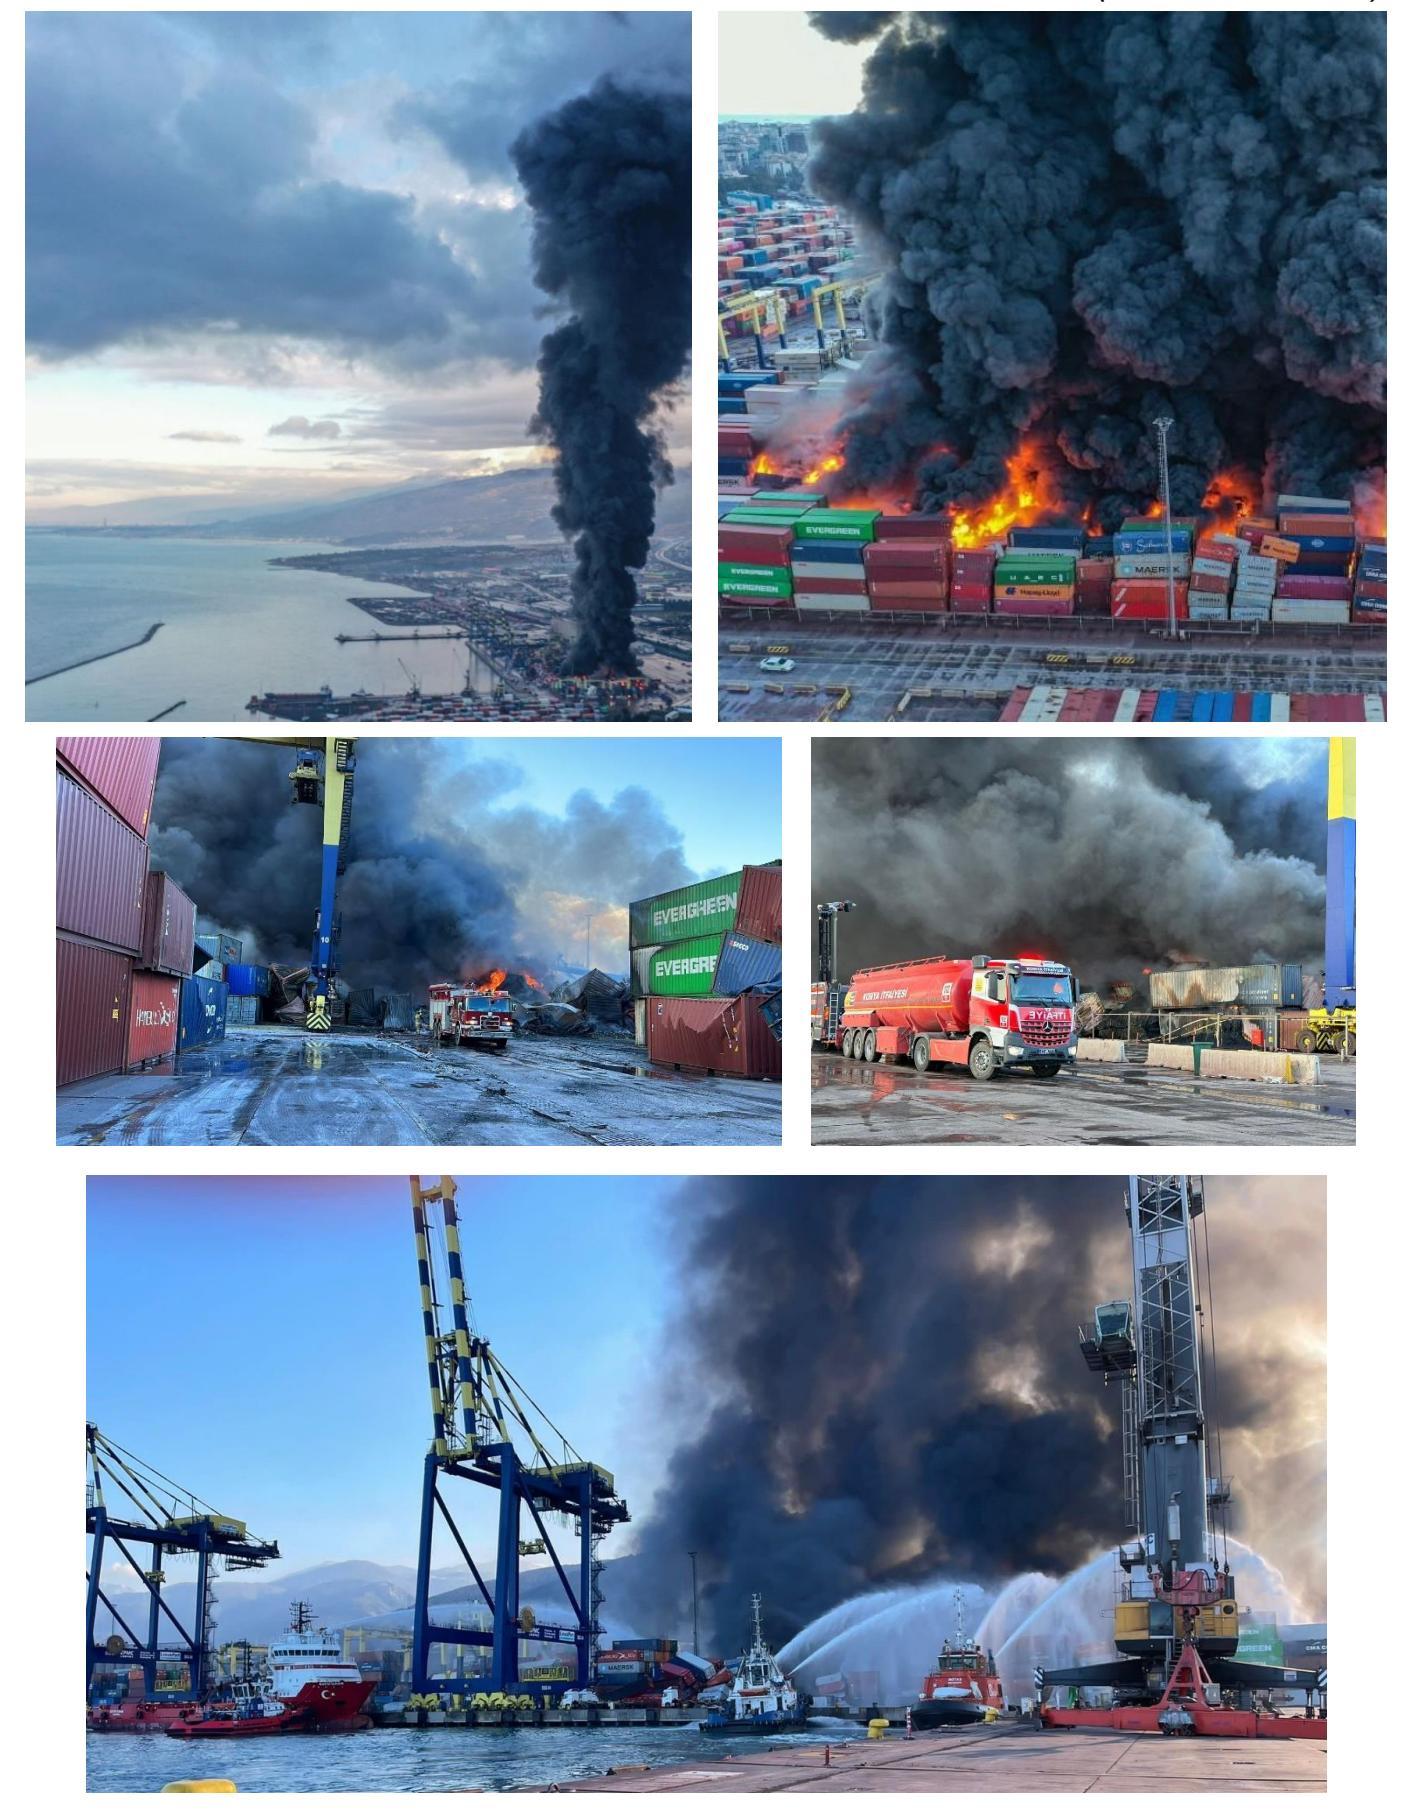
Fire at Iskenderun Port

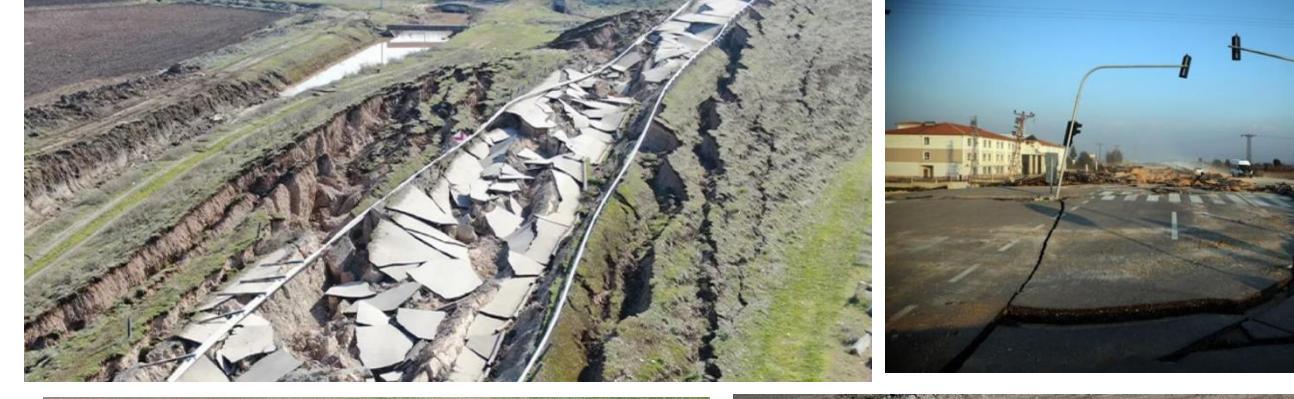
Antakya-Reyhanlı Highway

Liquefaction and Lateral Spreading

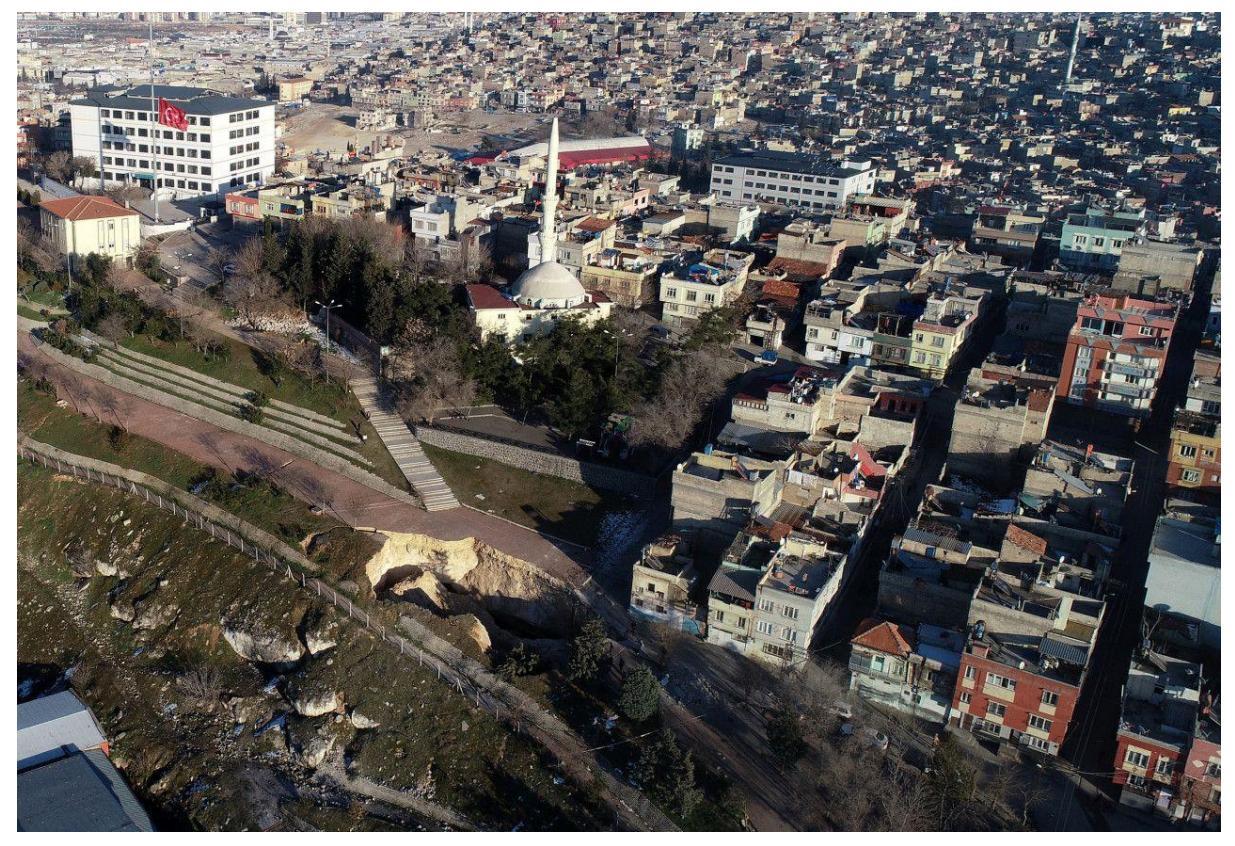
Sinkholes

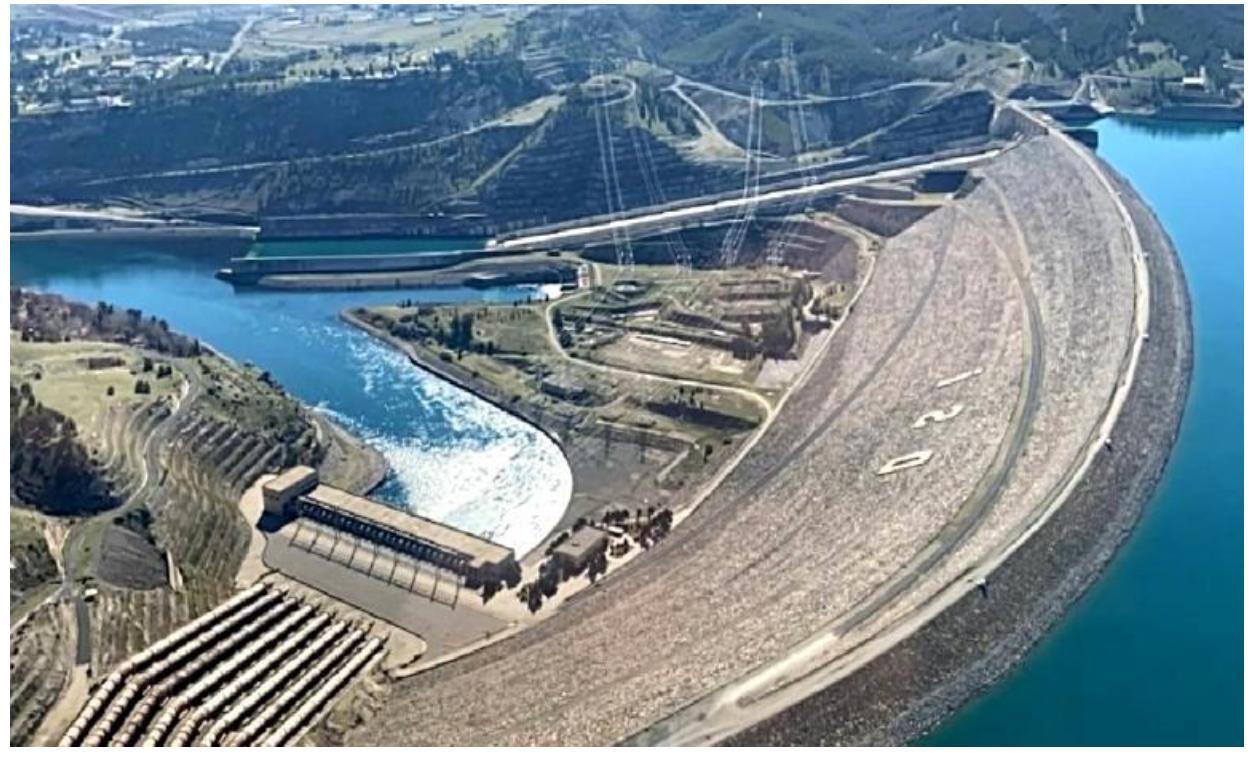
Atatürk Dam

The third largest rockfill dam in the world. 169 m high and epicentral distance is about 90 km. No damage was reported.

Areal view after the earthquakes

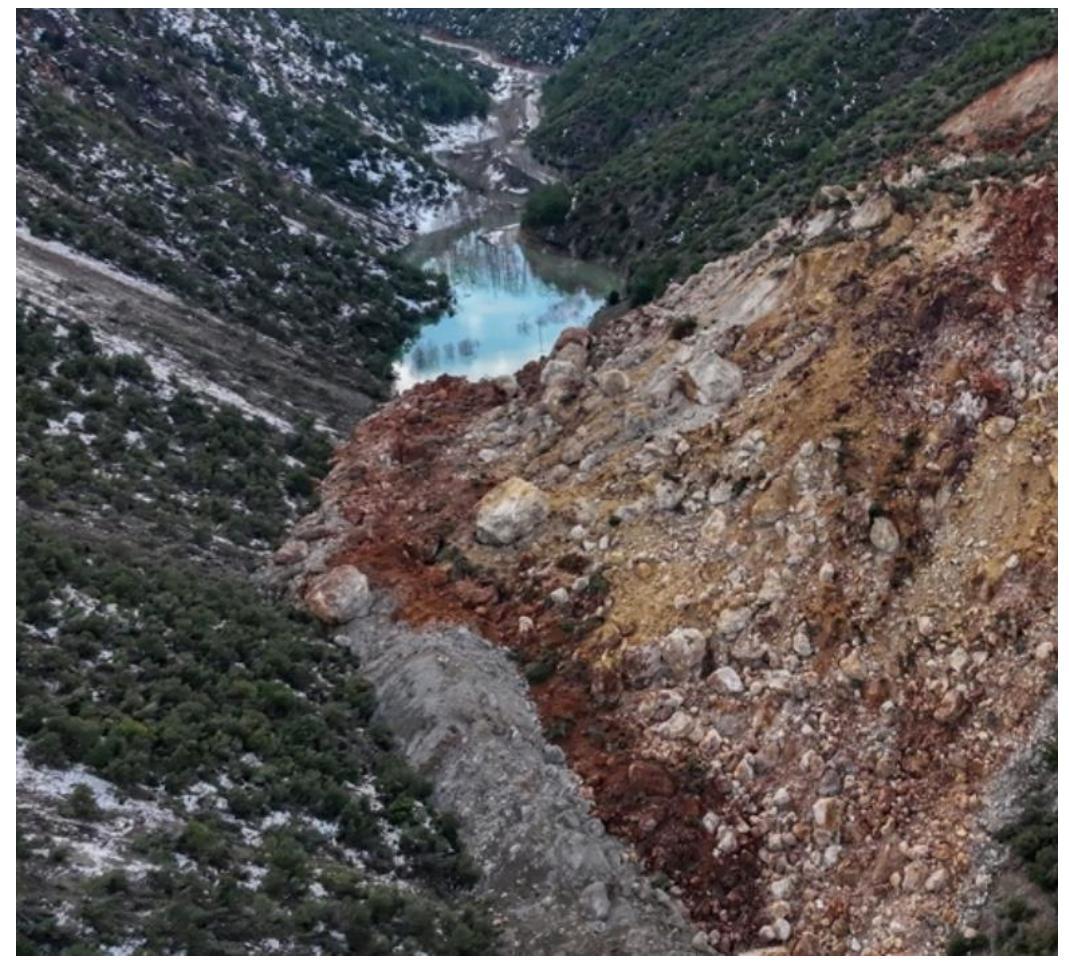
Islahiye

Landslide Dams

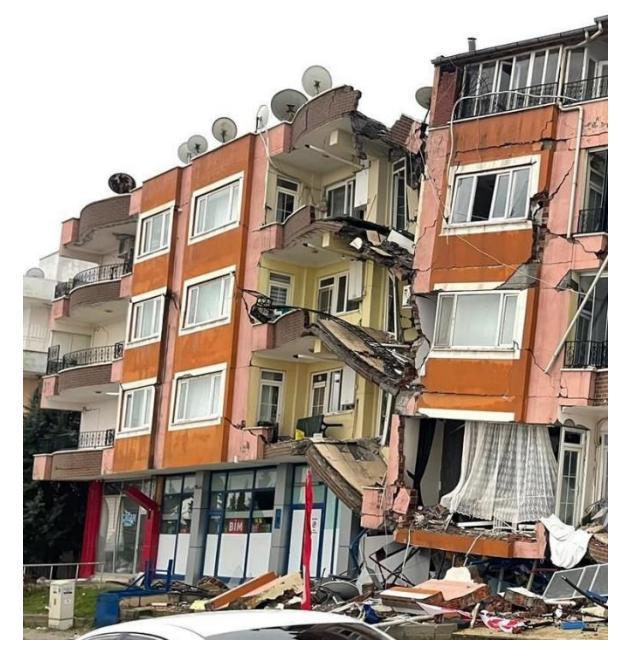
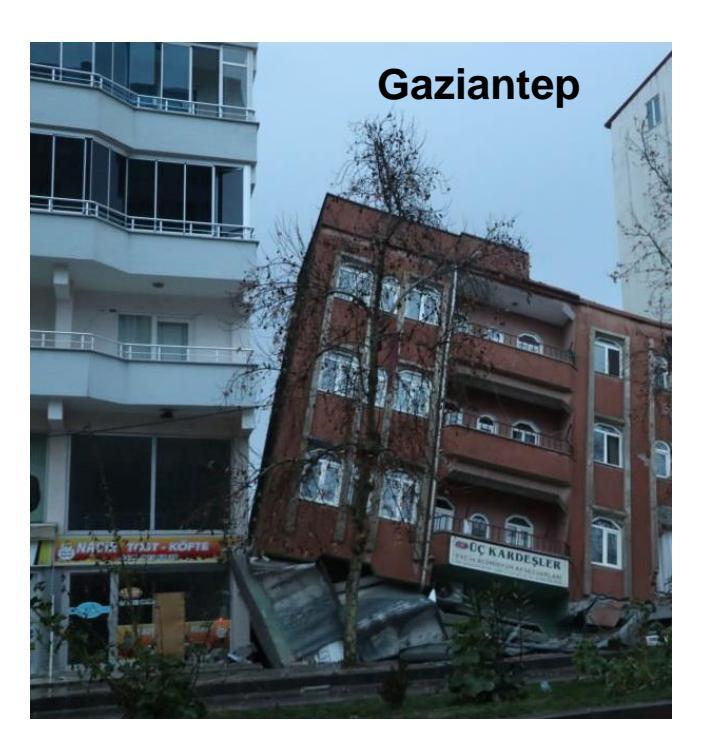
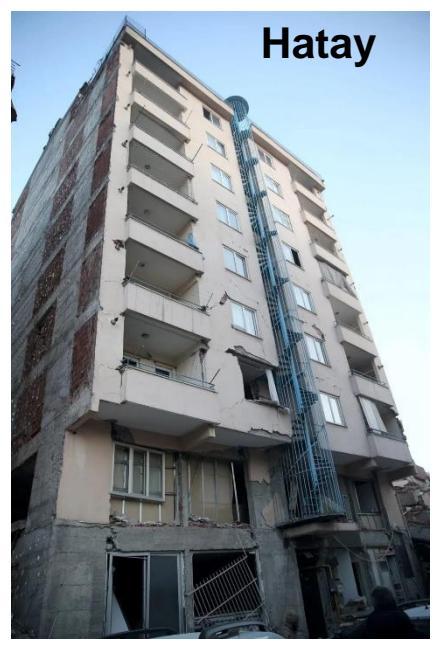
Adıyaman

The totally collapsed or heavily damaged school, residential and office buildings had mainly 3-14 stories. These structures are designed as moment-resistant frame structures with in-fill walls made of hollow bricks. The failure of RC structures was due to soft-story (weak-floor) situation as it is a common problem resulting in high casualties in earthquakes since 1960. The ground floors of collapsed buildings were mostly used as either shops, depots or garages. As a result, this type of usage constitutes a weak(soft)-floor situation. Furthermore, many buildings had heavy balconies of cantilever type.

The causes of the damage were almost the same as those seen in the previous earthquakes of Turkey. The causes listed below are taken from the reports by the first author on March 13, 1992 Erzincan Earthquake with few amendments and additions from the reports of the Turkish earthquakes occurred after 1992 (Aydan et al., 1998: Aydan et al., 2000a, b; Ulusay et al., 2002; Aydan et al., 2003; Aydan et al., 2012):

Soft Story: Many buildings had shops at their ground floor. As there are generally no shear-walls to take up the load during earthquakes, the total load is transferred onto the columns. The super structure acts as a top-heavy structure on the columns and in-fill walls, which are in poor contact with columns and beams, has no effect against the earthquake loading and they fail subsequently.

Buildings with problematic issues mentioned above (Photos: Internet)

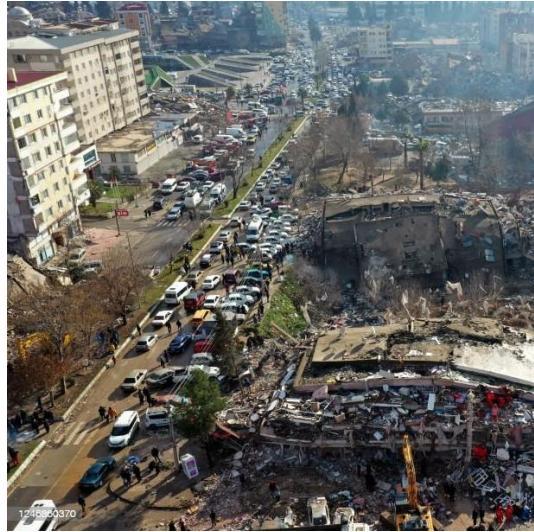
Kahramanmaraş

Views of Building Damages

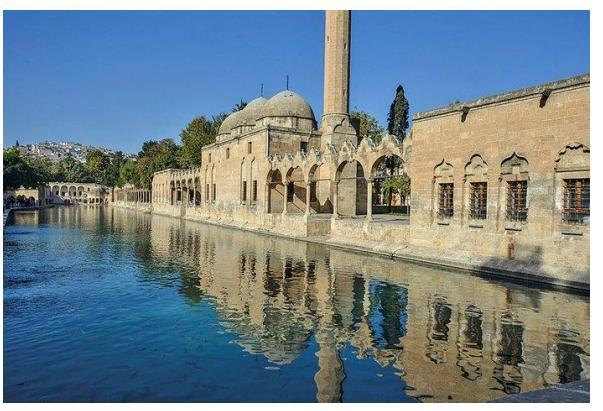
Before the earthquake transparent Balıklıgöl, Şanlı Urfa

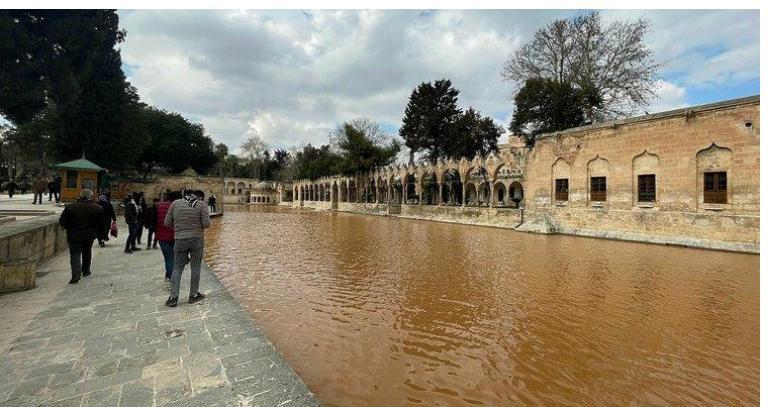
After the earthquake muddy Balıklıgöl, Şanlı Urfa

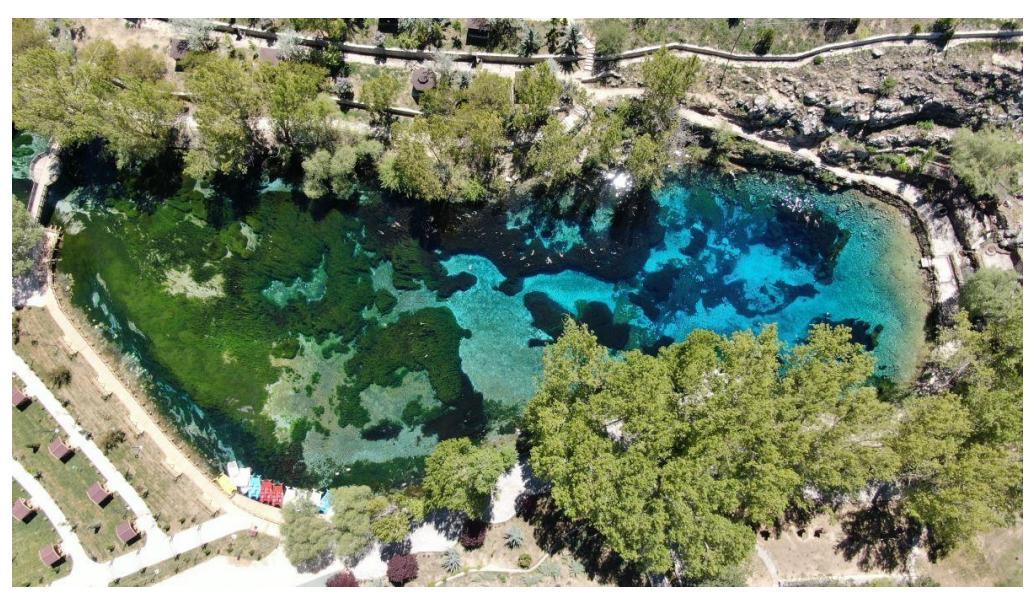
Before the earthquake transparent Gökpınar Lake, Gürün, Sivas (124 km from M7.8 epicenter

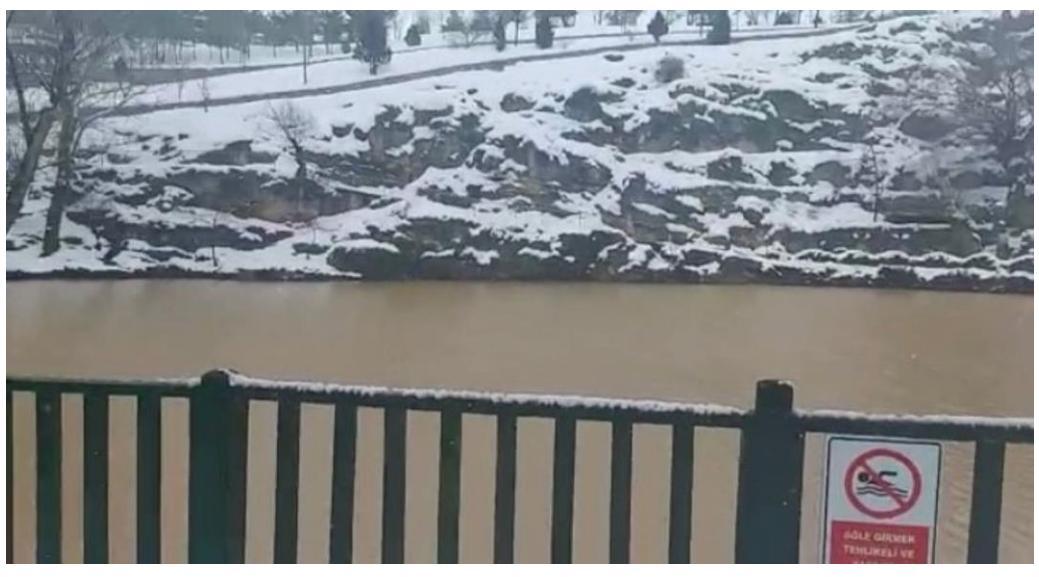
After the earthquake muddy Gökpınar Lake, Gürün, Sivas
